# Flood Damage Reduction Segment / System Inspection Report

Name of Segment / System: East Jackson Flood Control Project

Public Sponsor(s): Rankin-Hinds Pearl River Flood and Drainage Control District

Corps of Engineers Inspector: (b) (6) Inspection Start Date: 9/28/2016

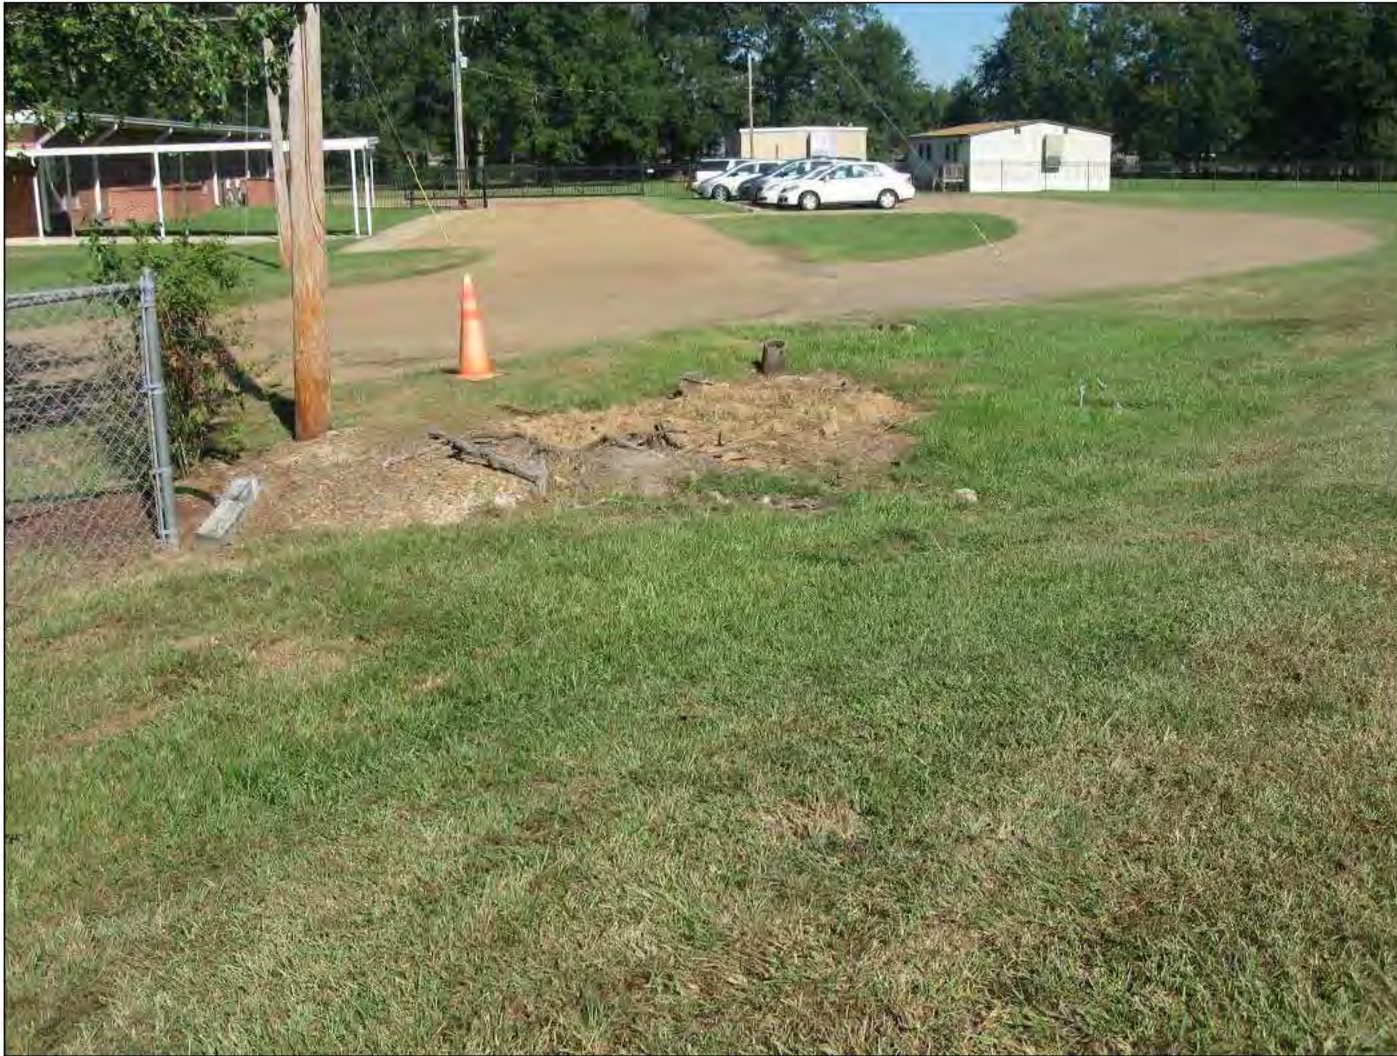
**Inspect ID:** EJFC\_2016\_a\_0001 **Title:** USACE\_CEMVK\_EJFC\_2016\_a\_0001\_1.jpg **Rated Item:** 1. Unwanted Vegetation Growth **Caption:** Rating: Acceptable;  
**Remarks:** STA 0+00 Previously noted tree has been removed.; Station\_1: 0+00

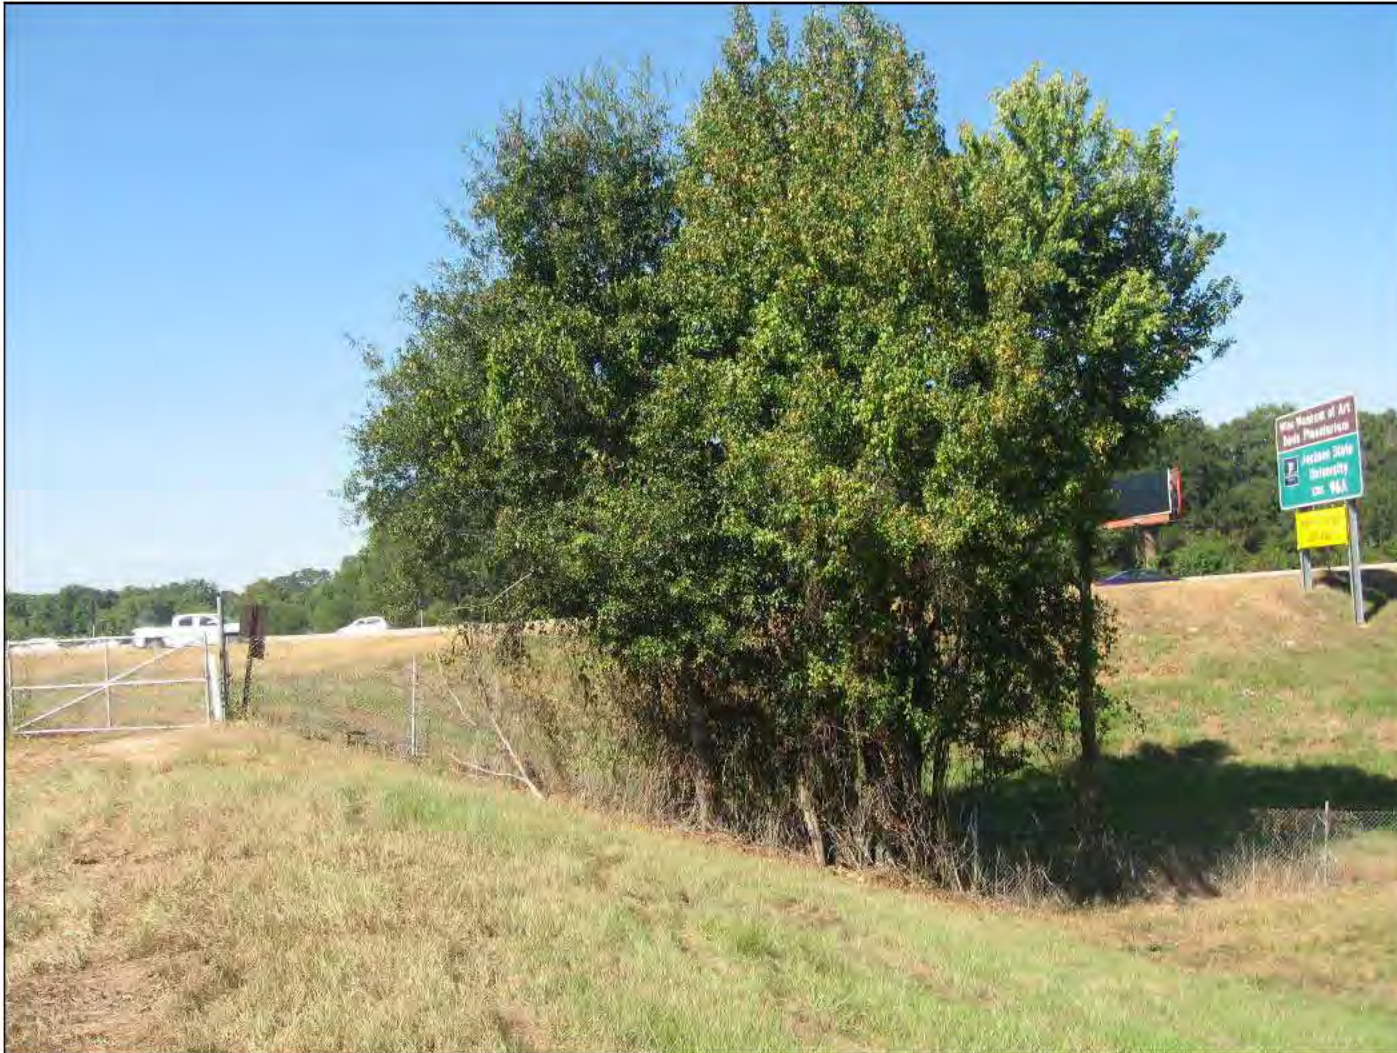
**Inspect ID:** EJFC\_2016\_a\_0011 **Title:** USACE\_CEMVK\_EJFC\_2016\_a\_0011\_1.jpg **Rated Item:** 1. Unwanted Vegetation Growth **Caption:** Rating: Minimally Acceptable; Remarks: STA 320 vegetation in levee slope at intersection of I55 needs to be removed or will be rated U next year; Station\_1: 320

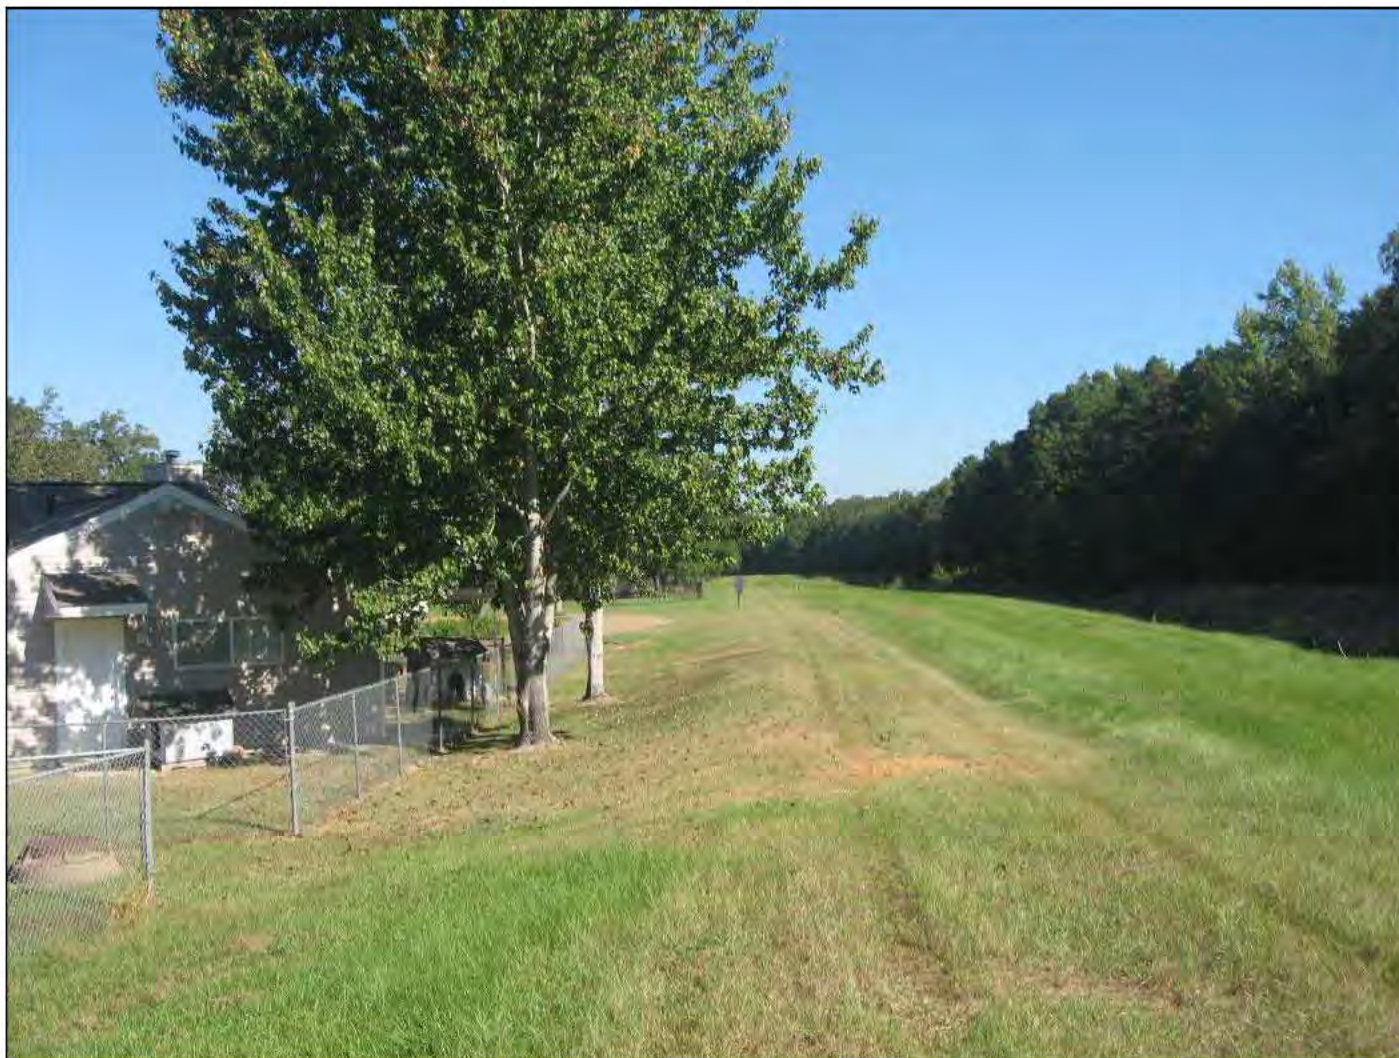
**Inspect ID:** EJFC\_2016\_a\_0002 **Title:** USACE\_CEMVK\_EJFC\_2016\_a\_0002\_1.jpg **Rated Item:** 3. Encroachments **Caption:** Rating: Minimally Acceptable; Remarks: STA 6  
Various residential encroachments (fencing, ornamental trees, utility poles, structures); Station\_1: 6

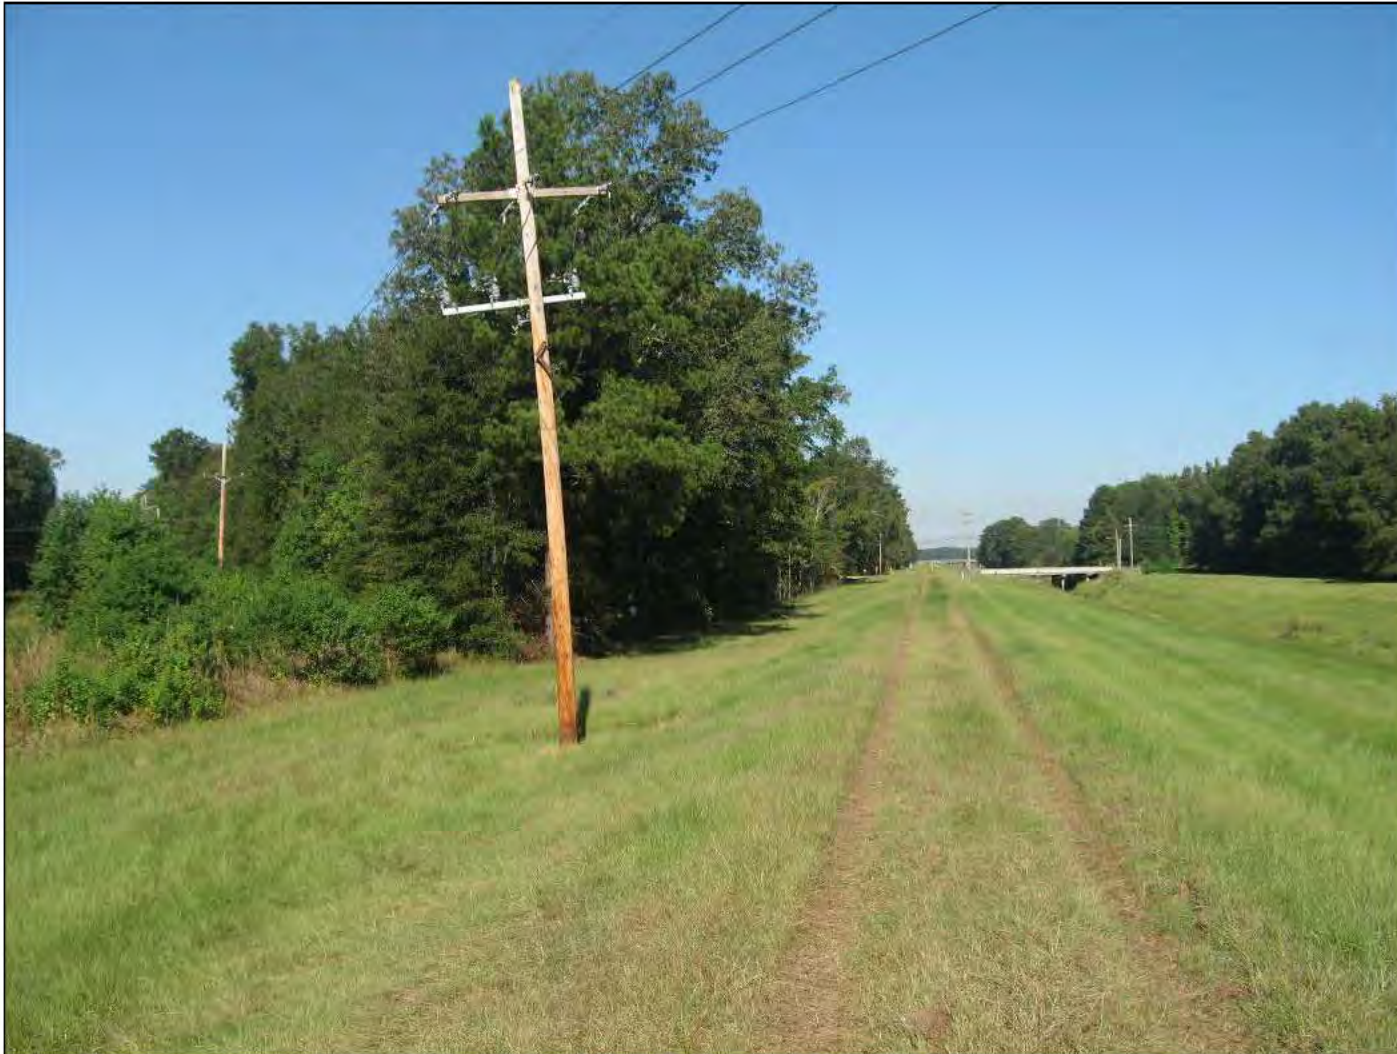
**Inspect ID:** EJFC\_2016\_a\_0004 **Title:** USACE\_CEMVK\_EJFC\_2016\_a\_0004\_1.jpg **Rated Item:** 3. Encroachments **Caption:** Rating: Minimally Acceptable; Remarks: STA 36 LS utility pole; Station\_1: 36

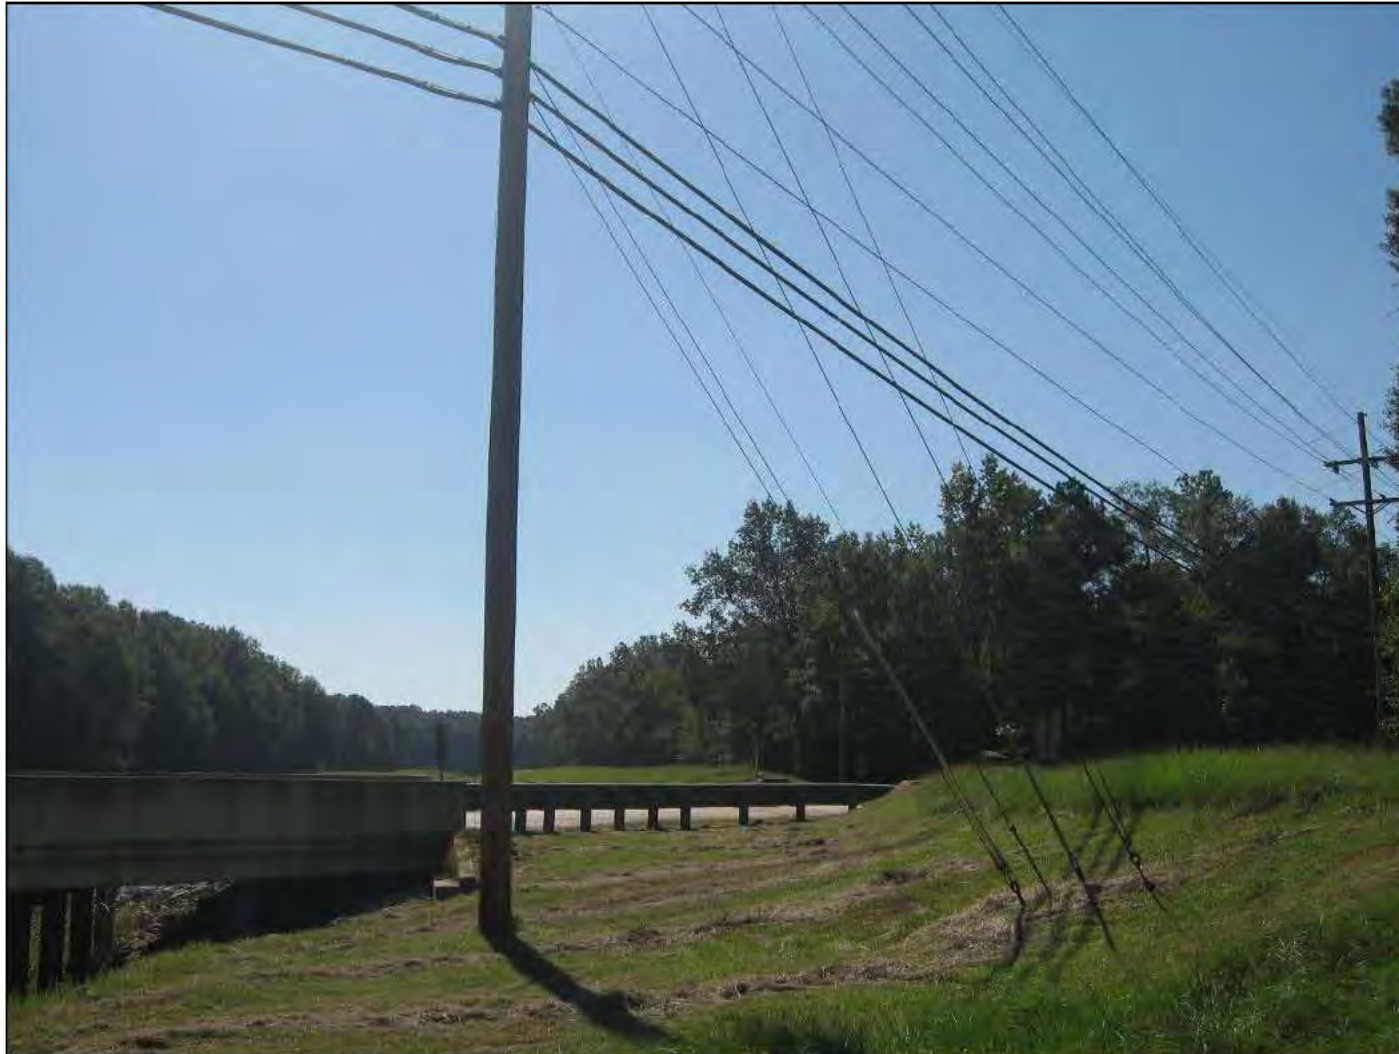
**Inspect ID:** EJFC\_2016\_a\_0006 **Title:** USACE\_CEMVK\_EJFC\_2016\_a\_0006\_1.jpg **Rated Item:** 3. Encroachments **Caption:** Rating: Minimally Acceptable; Remarks: STA 46 RS and LS Utility poles on either side of Mangum Dr. scheduled to be removed ; Station\_1: 46

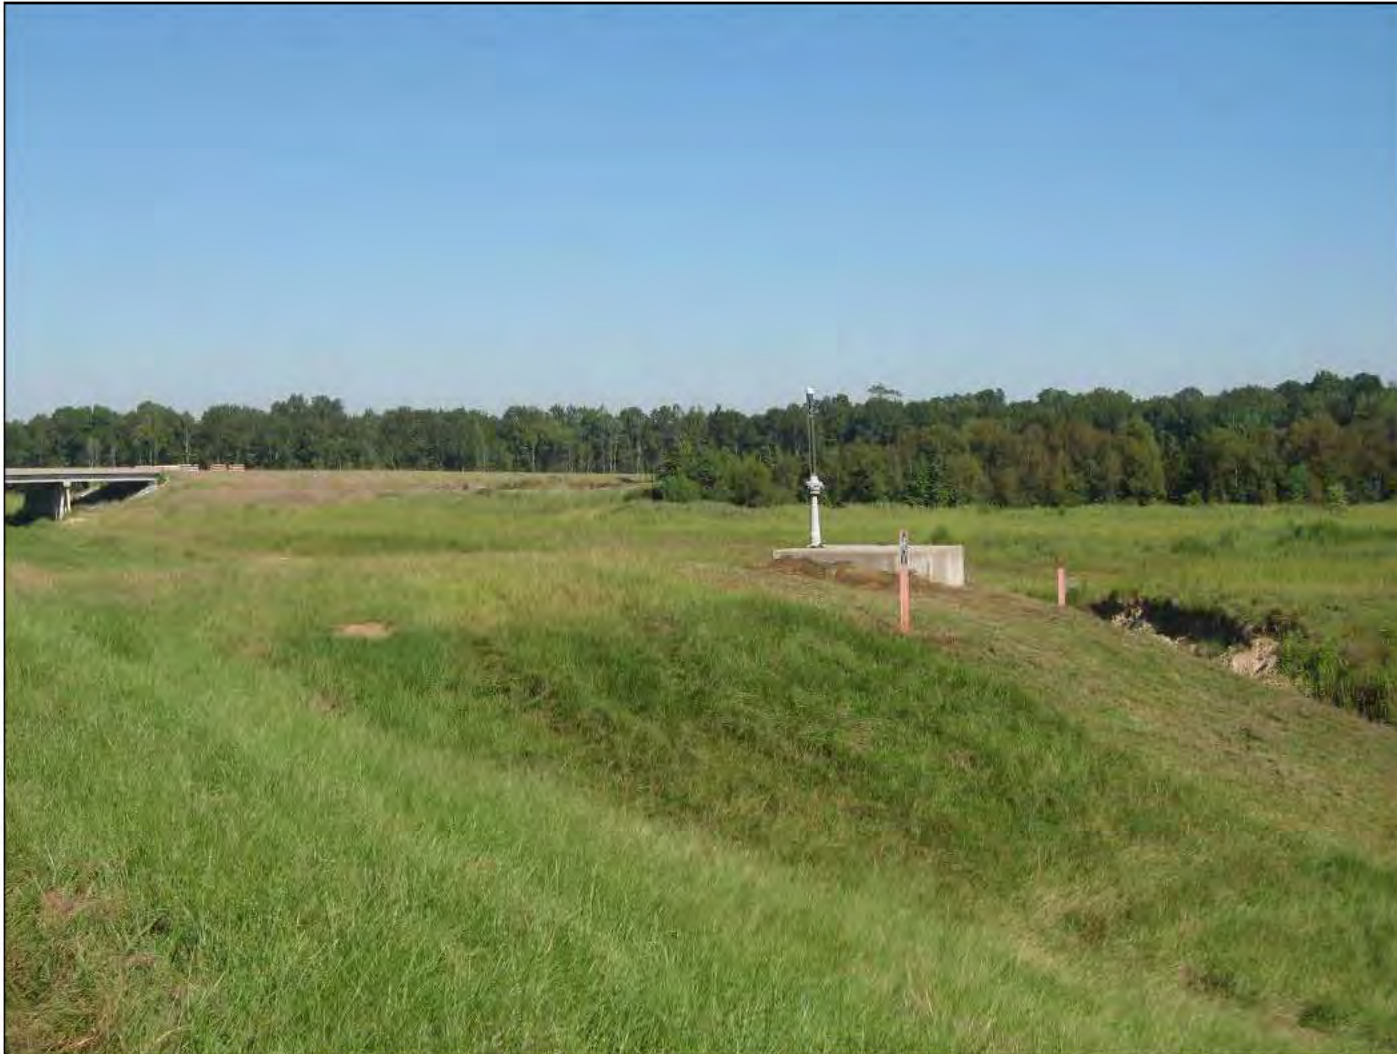
**Inspect ID:** EJFC\_2016\_a\_0008 **Title:** USACE\_CEMVK\_EJFC\_2016\_a\_0008\_1.jpg **Rated Item:** 3. Encroachments **Caption:** Rating: Minimally Acceptable; Remarks: STA 86+32 RS Sanitary gravity sewer, closed system approx 18' below ground level. New control structure installed and slip lined conduit section beneath levee with a Vylon liner approx 3 yrs ago. Sponsor checking status of video inspection.; Station\_1: 86+32

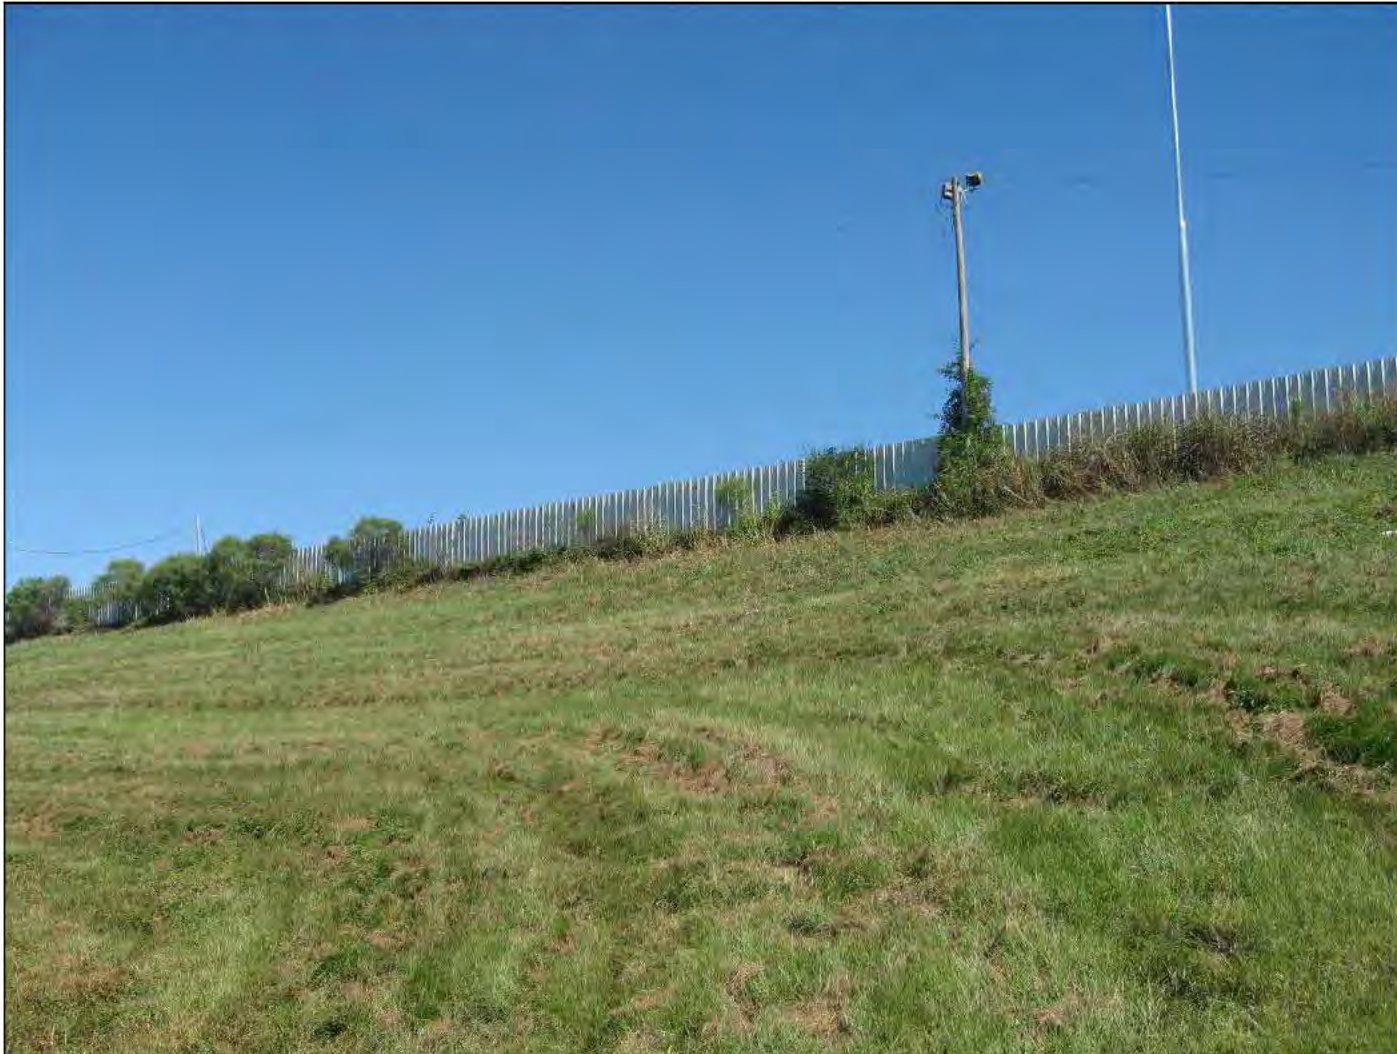
**Inspect ID:** EJFC\_2016\_a\_0013 **Title:** USACE\_CEMVK\_EJFC\_2016\_a\_0013\_1.jpg **Rated Item:** 3. Encroachments **Caption:** Rating: Minimally Acceptable; Remarks: Widened section of levee from Old Brandon Rd to I-20 with various encroachments (fence at top of levee, utility poles, etc). Landowner has filled to levee grade approx 2000+ feet perpendicular to the levee on the land side.; Station\_1: NA

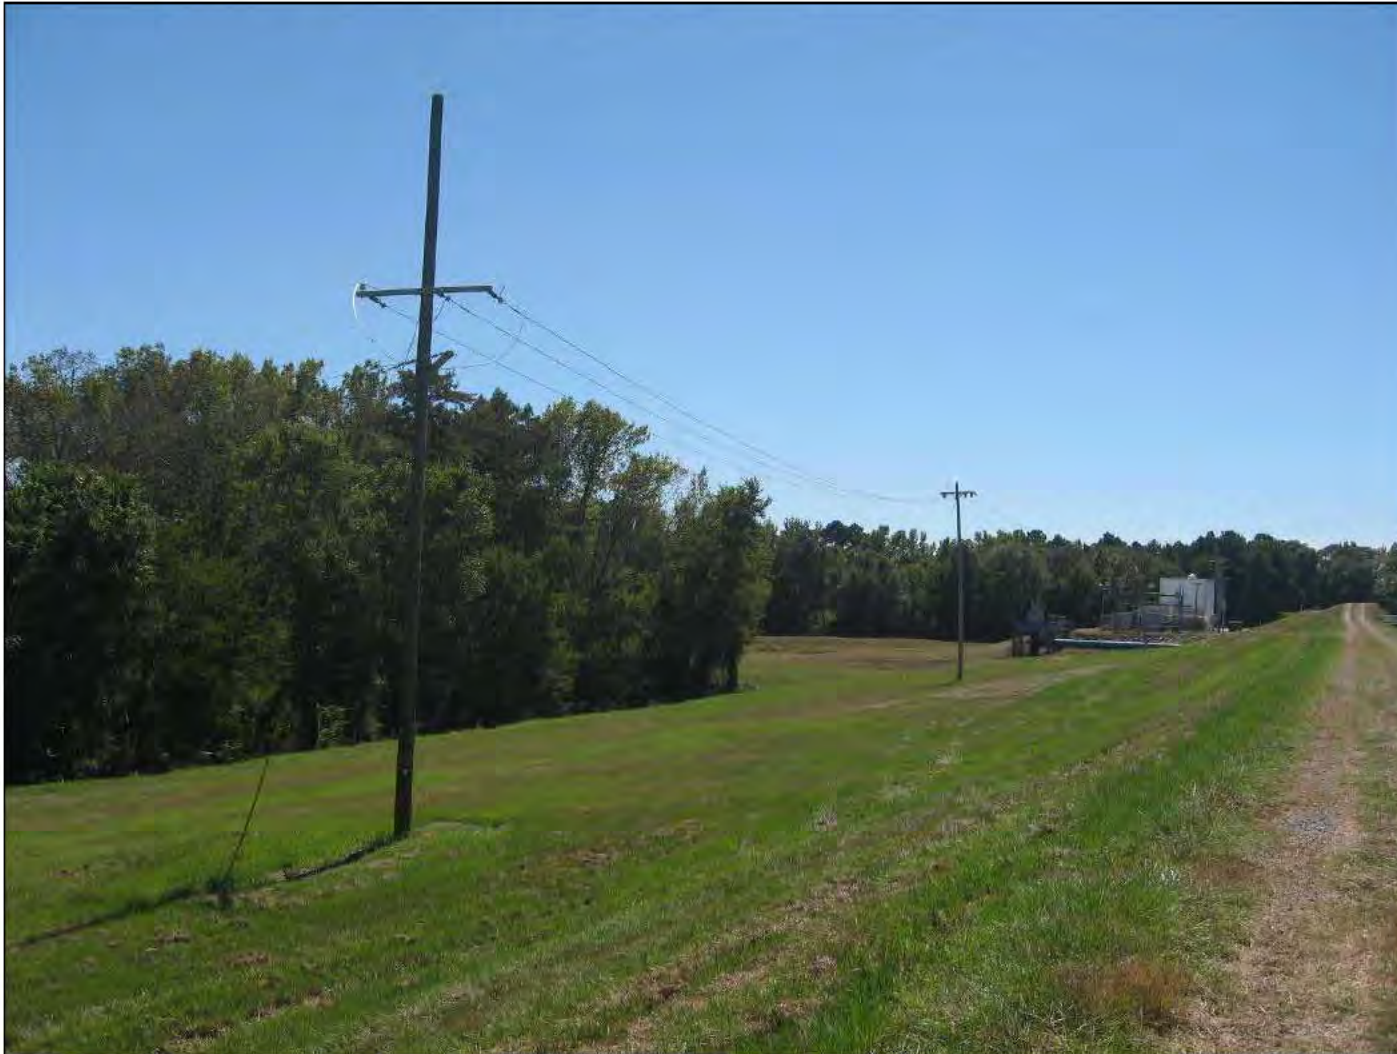
**Inspect ID:** EJFC\_2016\_a\_0014 **Title:** USACE\_CEMVK\_EJFC\_2016\_a\_0014\_1.jpg **Rated Item:** 3. Encroachments **Caption:** Rating: Minimally Acceptable; Remarks: STA 408 Utility poles LS and RS within 40' of toe.; Station\_1: 408

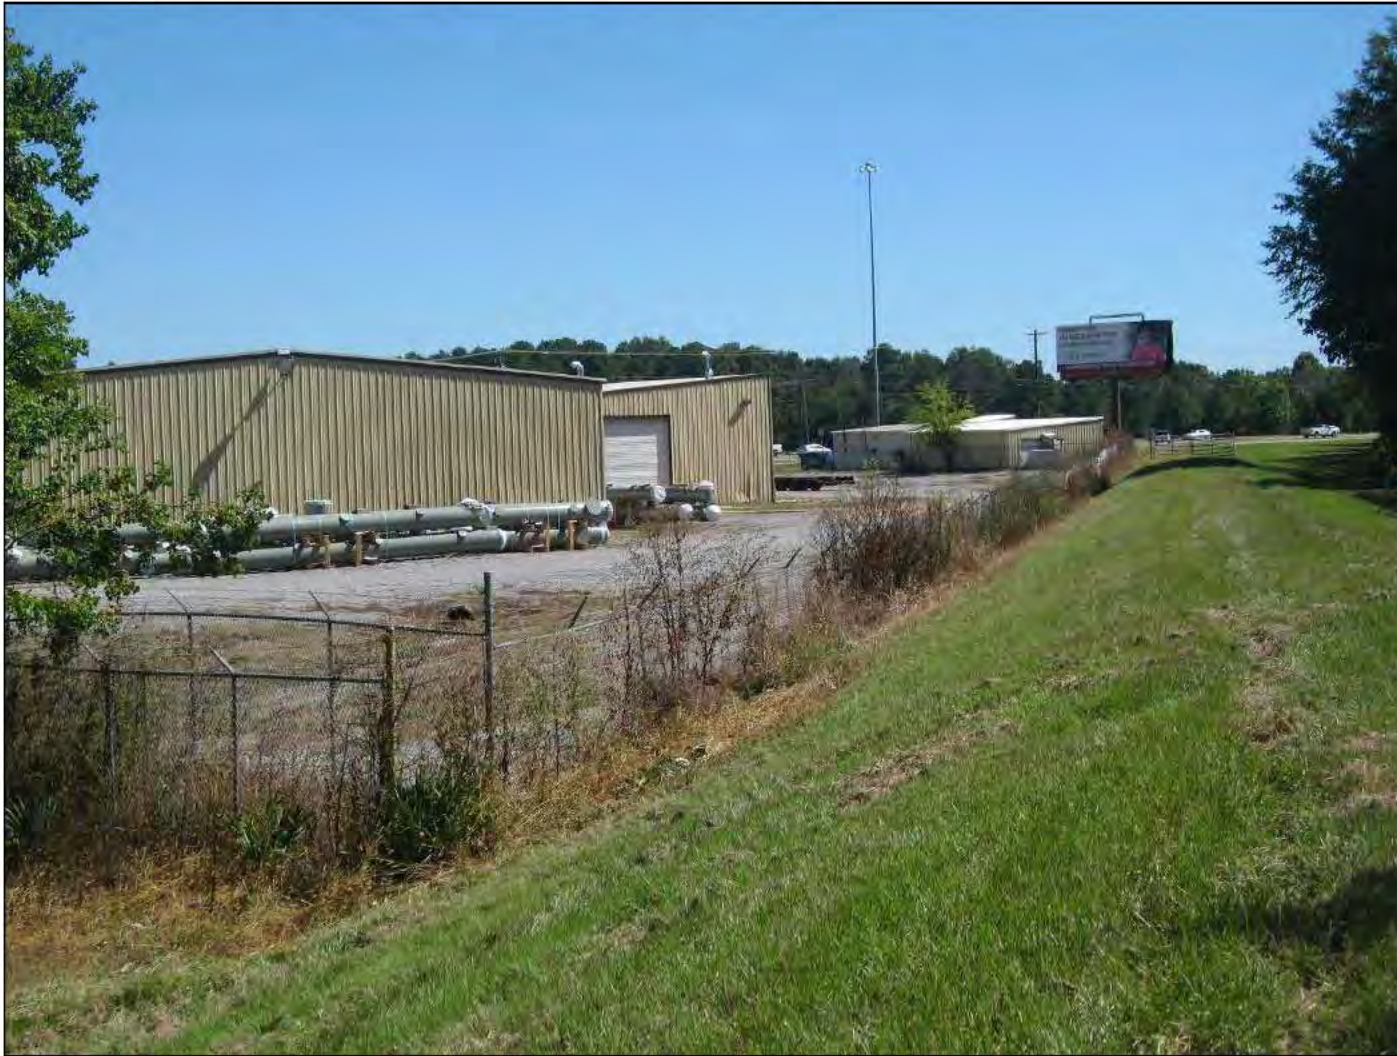
**Inspect ID:** EJFC\_2016\_a\_0018 **Title:** USACE\_CEMVK\_EJFC\_2016\_a\_0018\_1.jpg **Rated Item:** 3. Encroachments **Caption:** Rating: Minimally Acceptable; Remarks: STA 515 LS Fence parallel along toe of levee in federal government/military compound.; Station\_1: 515

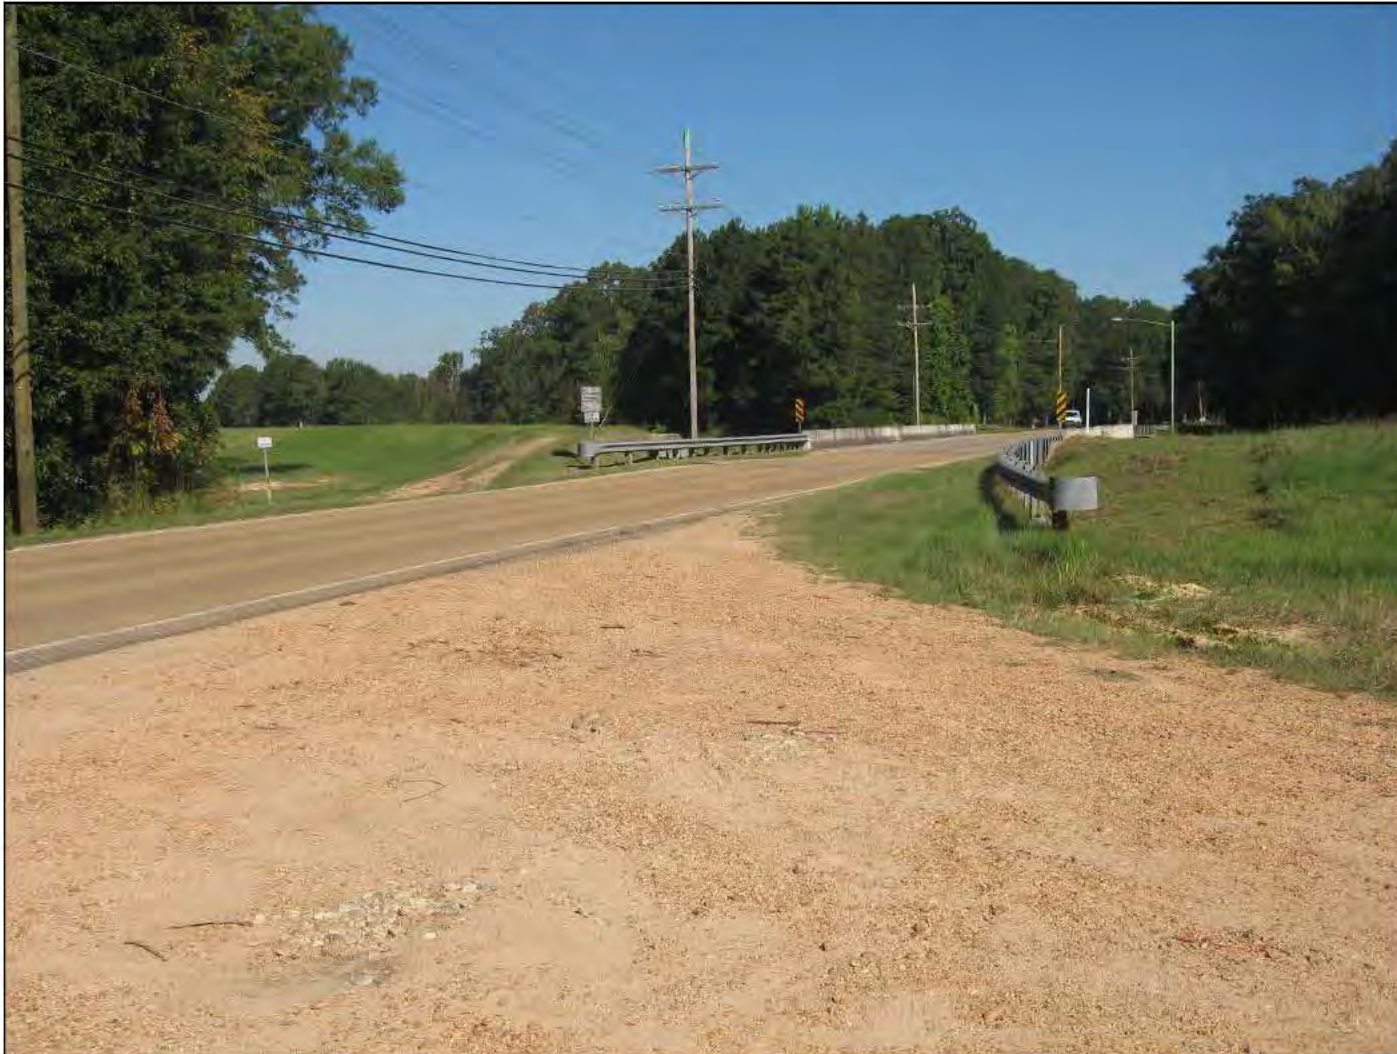
**Inspect ID:** EJFC\_2016\_a\_0005 **Title:** USACE\_CEMVK\_EJFC\_2016\_a\_0005\_1.jpg **Rated Item:** 4. Closure Structures (Stop Log, Earthen Closures, Gates, or Sandbag Closures) (A or U only) **Caption:** Rating: Acceptable; Remarks: STA 45+60 Mangum Drive closure. Sandbags on standby to operate closure when needed. Last closures 1979 and possibly 1983.; Station\_1: 45+60

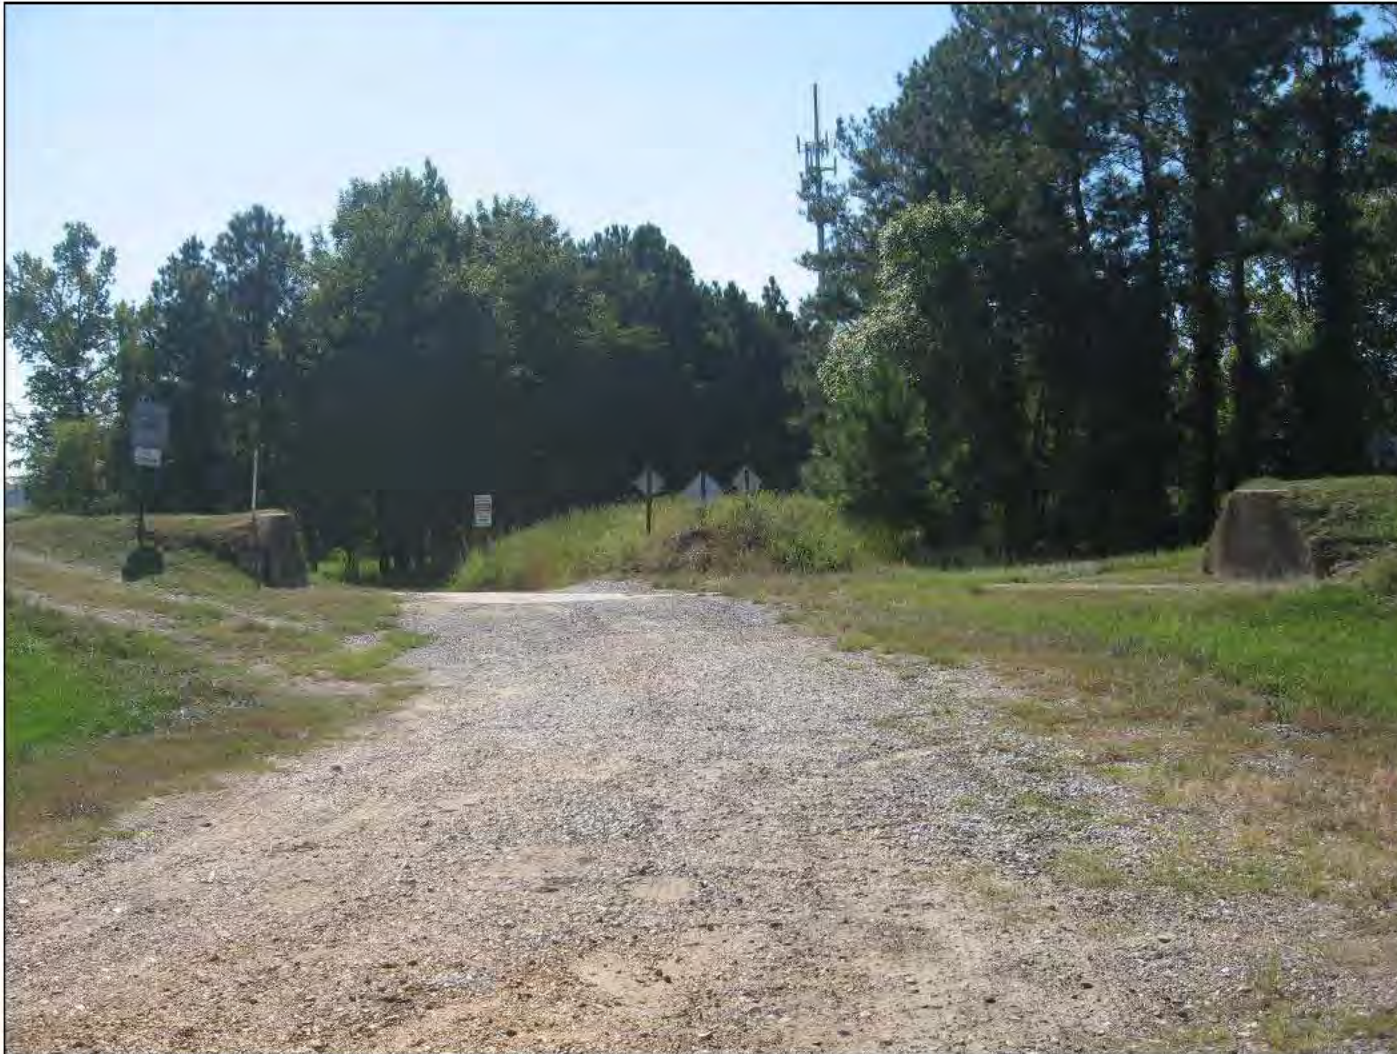
**Inspect ID:** EJFC\_2016\_a\_0009 **Title:** USACE\_CEMVK\_EJFC\_2016\_a\_0009\_1.jpg **Rated Item:** 4. Closure Structures (Stop Log, Earthen Closures, Gates, or Sandbag Closures) (A or U only) **Caption:** Rating: Acceptable; Remarks: STA 138 (Field STA 132+11) Closure Structure. Sandbags on standby to operate closure if needed. ; Station\_1: 138

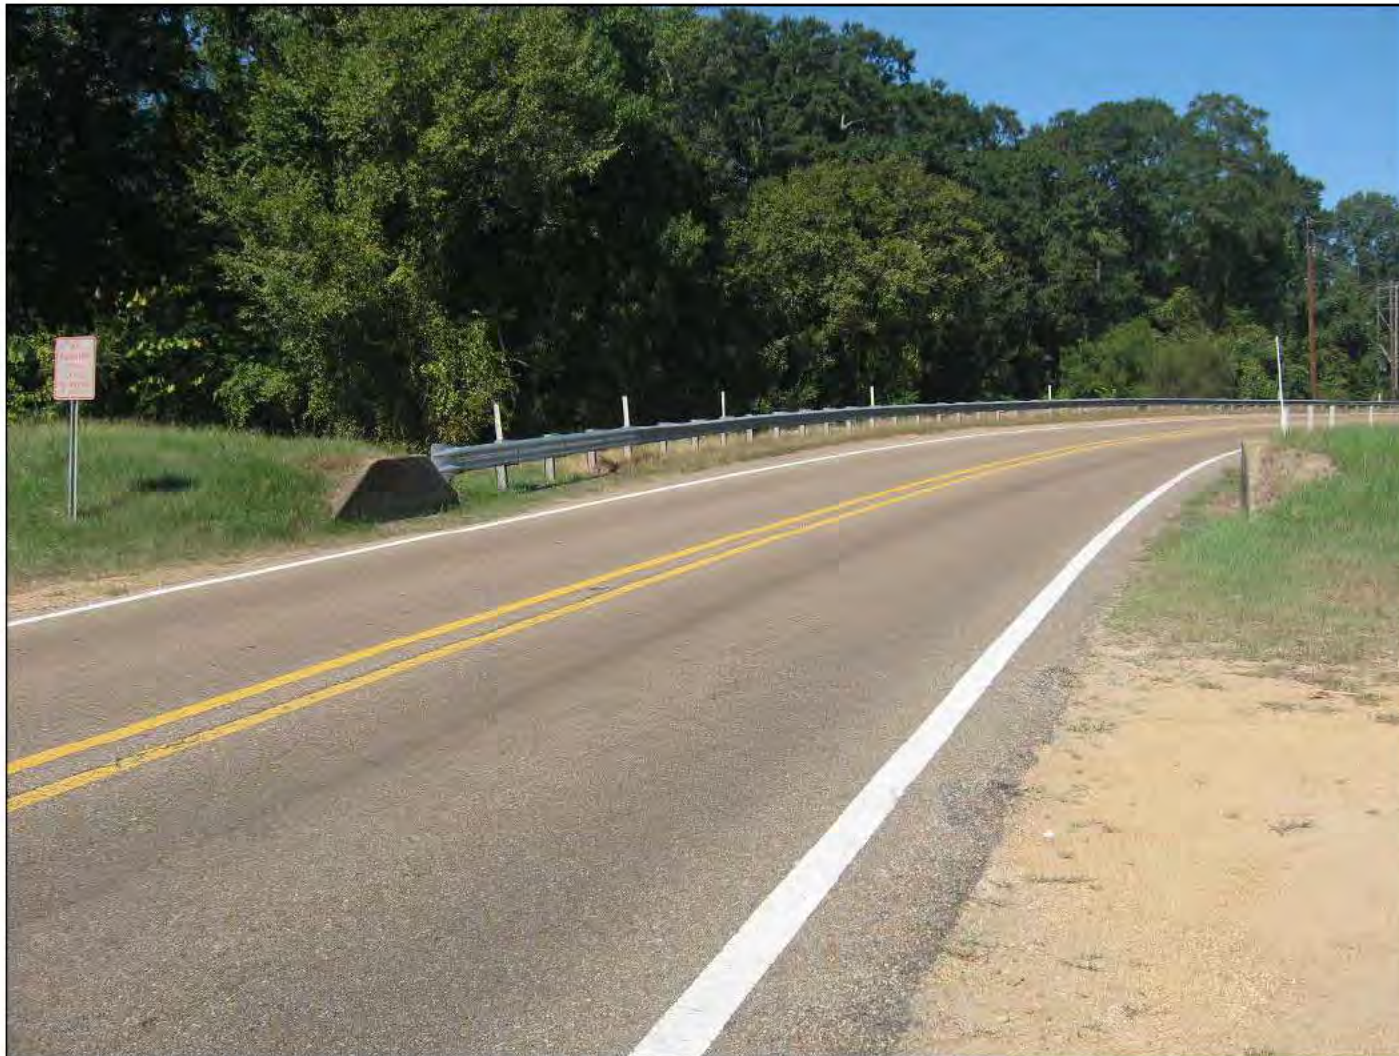
**Inspect ID:** EJFC\_2016\_a\_0012 **Title:** USACE\_CEMVK\_EJFC\_2016\_a\_0012\_1.jpg **Rated Item:** 4. Closure Structures (Stop Log, Earthen Closures, Gates, or Sandbag Closures) (A or U only) **Caption:** Rating: Acceptable; Remarks: STA 348+76 and STA 350+00 Closure structures at Old Brandon Rd and Railroad Crossing respectively. Sand bags on standby to operate closures as needed.; Station\_1: 348+76 and 350+00

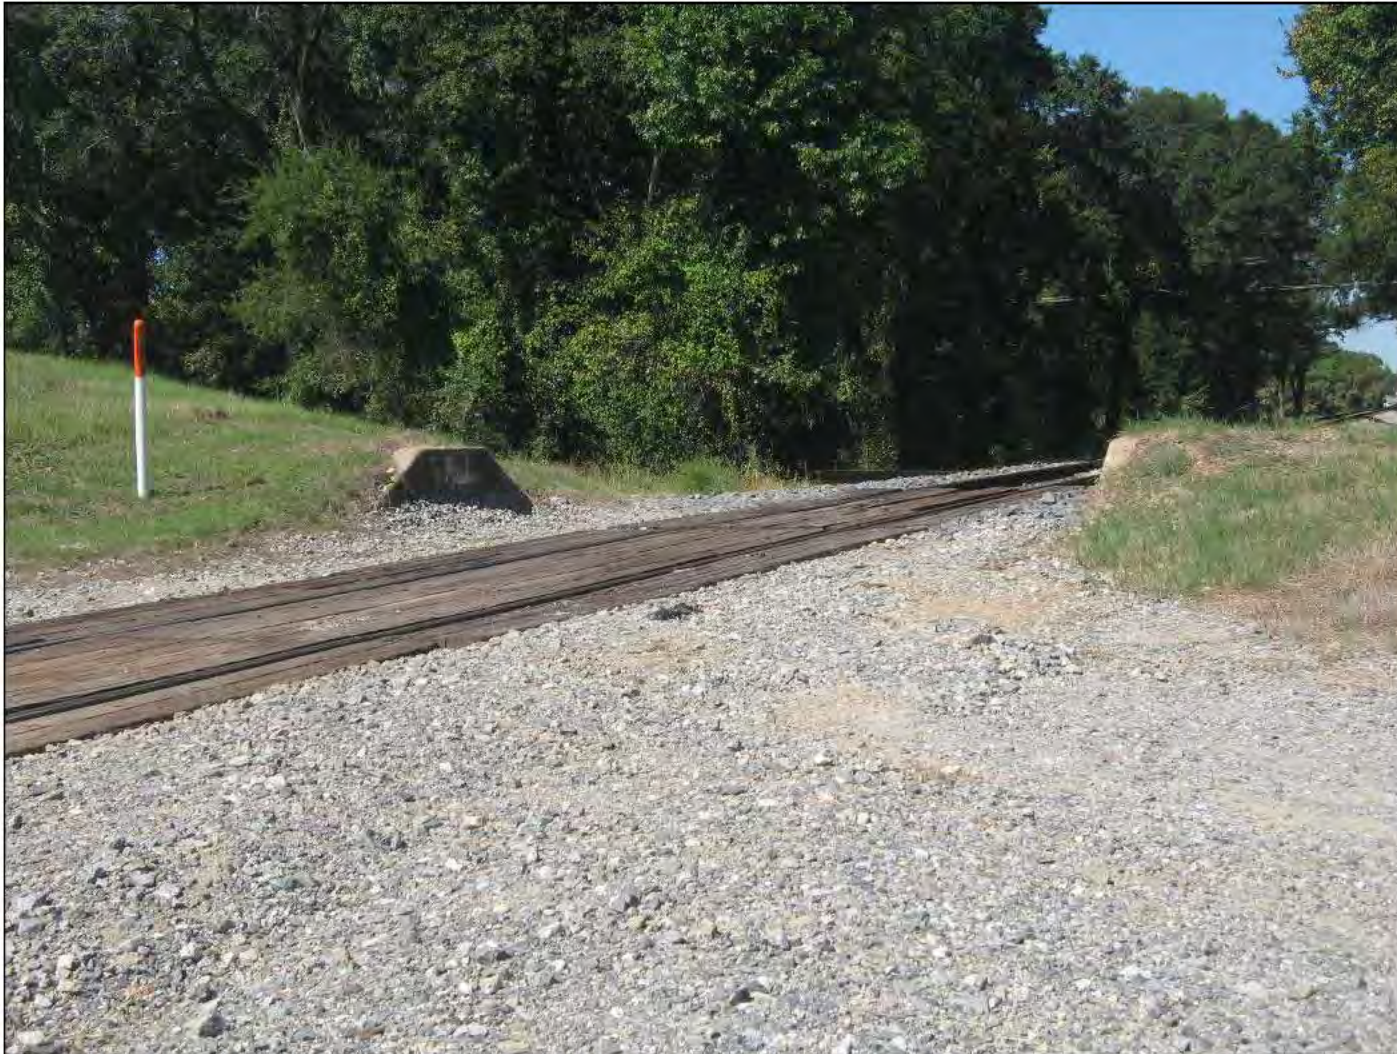
**Inspect ID:** EJFC\_2016\_a\_0012 **Title:** USACE\_CEMVK\_EJFC\_2016\_a\_0012\_2.jpg **Rated Item:** 4. Closure Structures (Stop Log, Earthen Closures, Gates, or Sandbag Closures) (A or U only) **Caption:** Rating: Acceptable; Remarks: STA 348+76 and STA 350+00 Closure structures at Old Brandon Rd and Railroad Crossing respectively. Sand bags on standby to operate closures as needed.; Station\_1: 348+76 and 350+00

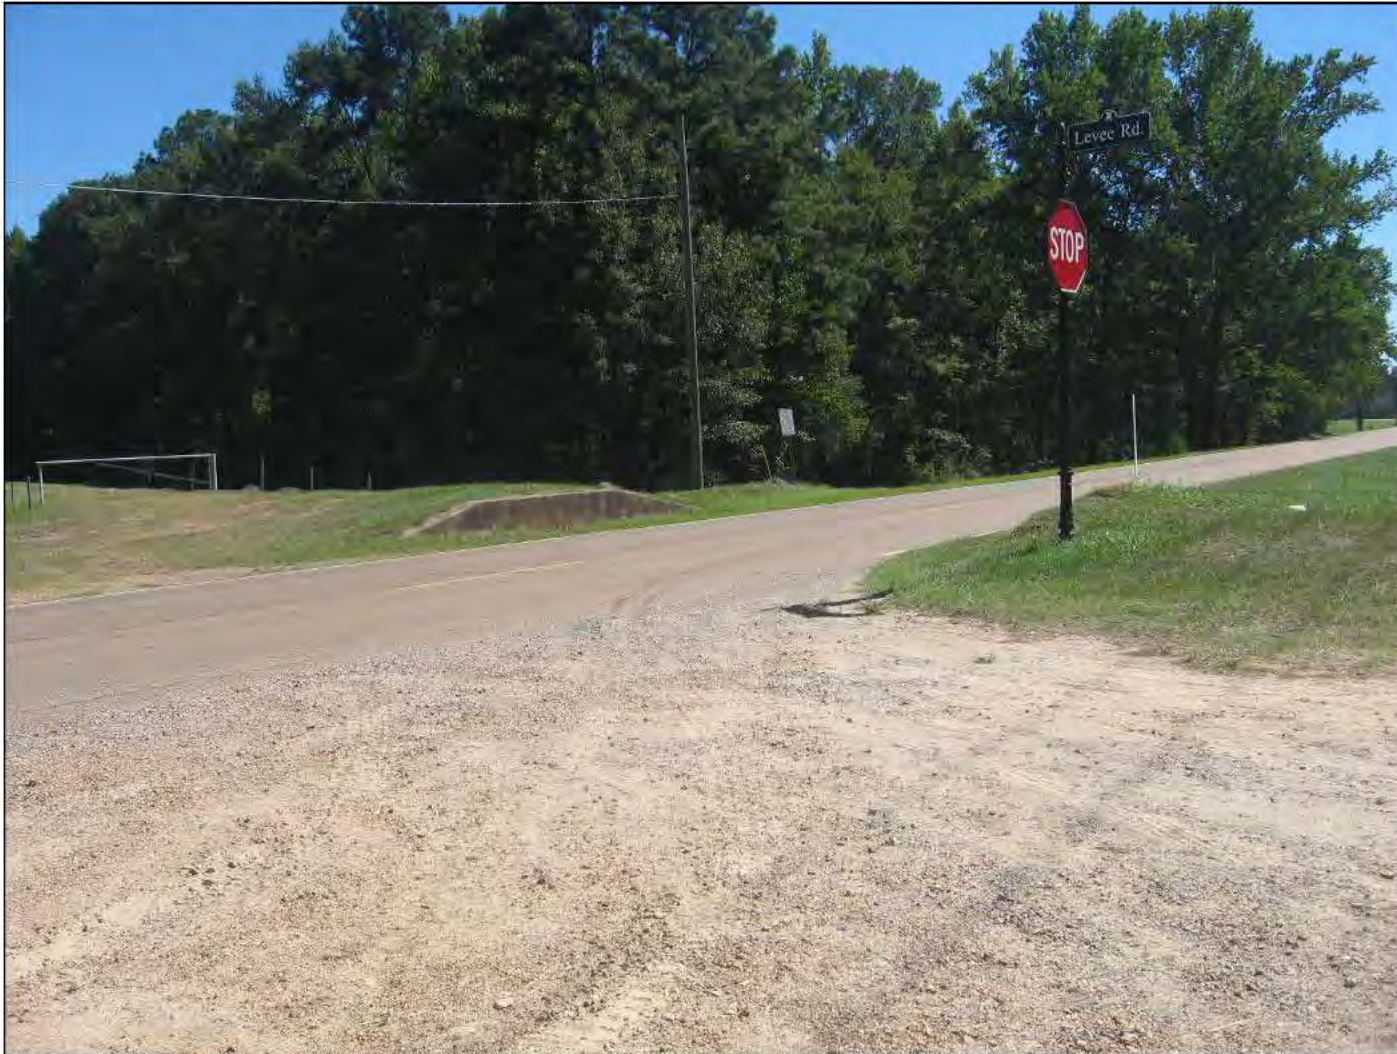
**Inspect ID:** EJFC\_2016\_a\_0017 **Title:** USACE\_CEMVK\_EJFC\_2016\_a\_0017\_1.jpg **Rated Item:** 4. Closure Structures (Stop Log, Earthen Closures, Gates, or Sandbag Closures) (A or U only) **Caption:** Rating: Acceptable; Remarks: STA 472+39 Old Hwy 49 closure. Sand bags on stand by if closure needs to be operated. ; Station\_1: 472+39
