# Flood Damage Reduction Segment / System Inspection Report

Name of Segment / System: East Jackson Flood Control Project

Public Sponsor(s): Rankin-Hinds Pearl River Flood and Drainage Control District

Corps of Engineers Inspector: (b) (6) Inspection Start Date: 9/28/2016

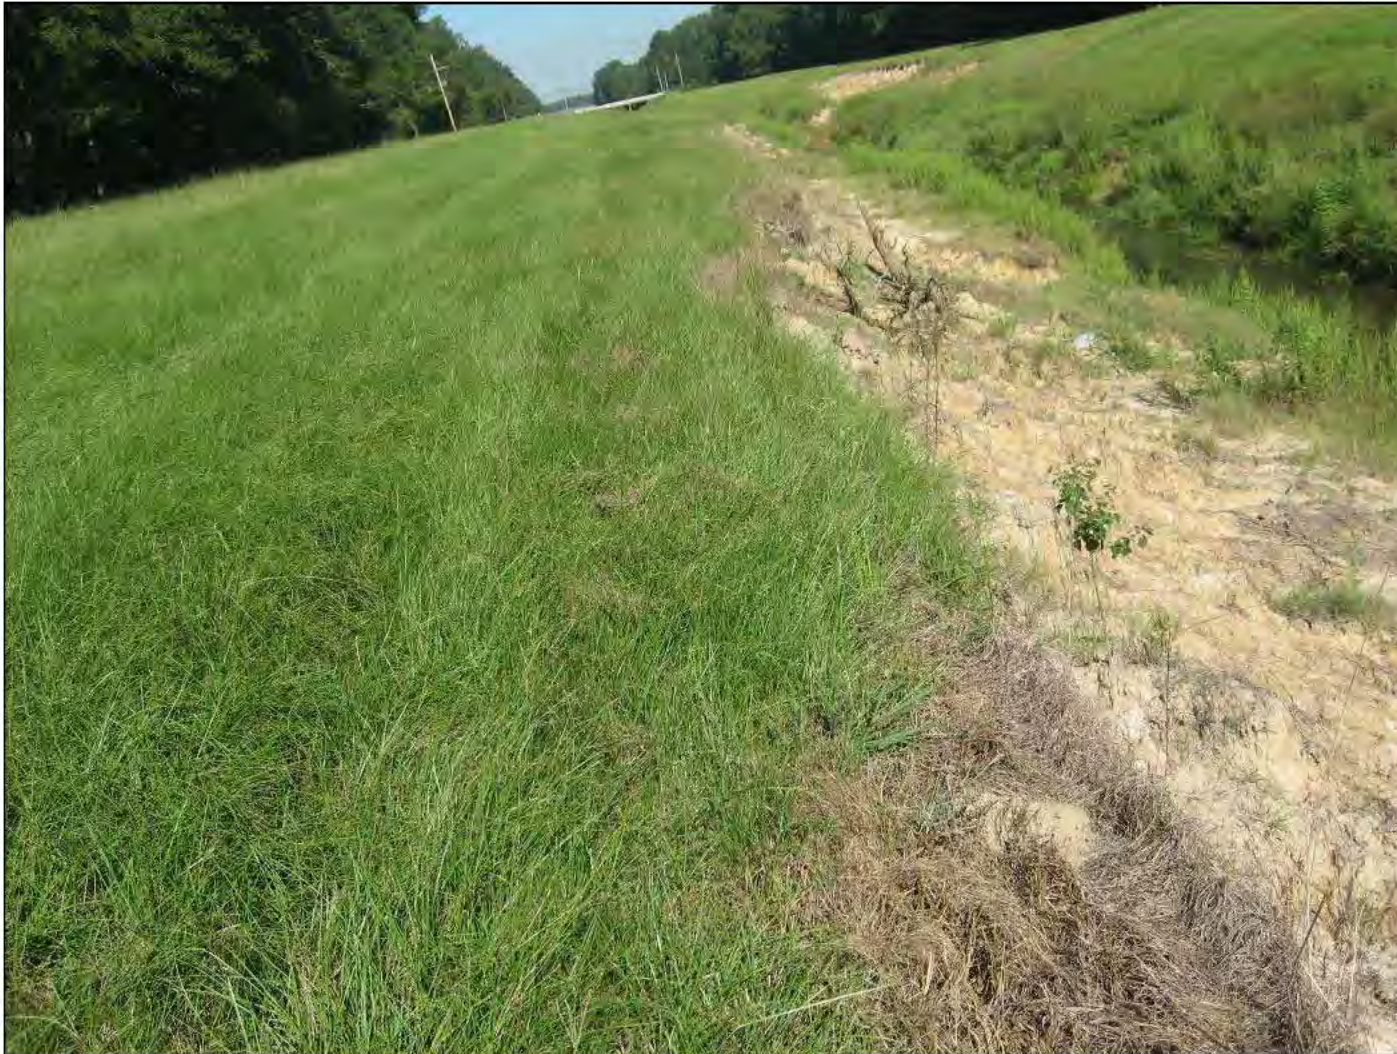
**Inspect ID:** EJFC\_2016\_a\_0003 **Title:** USACE\_CEMVK\_EJFC\_2016\_a\_0003\_1.jpg **Rated Item:** 6. Erosion/ Bank Caving **Caption:** Rating: Acceptable; Remarks: RS Erosion 20' from the toe. The Levee Board is working on the solution for the problem.; Station\_1: 30

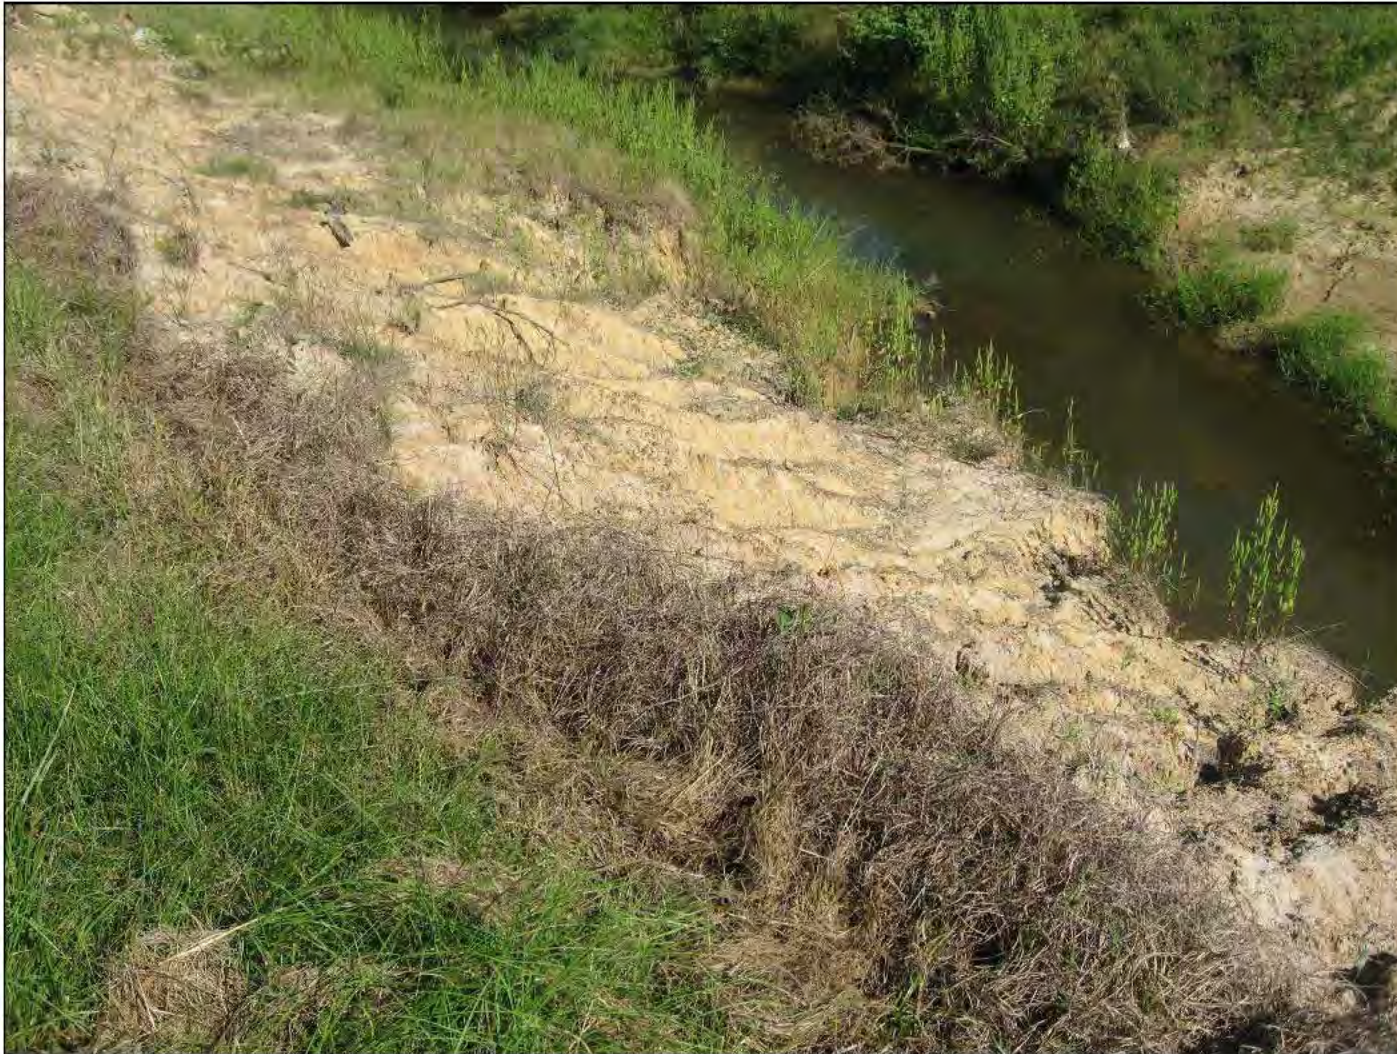
**Inspect ID:** EJFC\_2016\_a\_0003 **Title:** USACE\_CEMVK\_EJFC\_2016\_a\_0003\_2.jpg **Rated Item:** 6. Erosion/ Bank Caving **Caption:** Rating: Acceptable; Remarks: RS Erosion 20' from the toe. The Levee Board is working on the solution for the problem.; Station\_1: 30

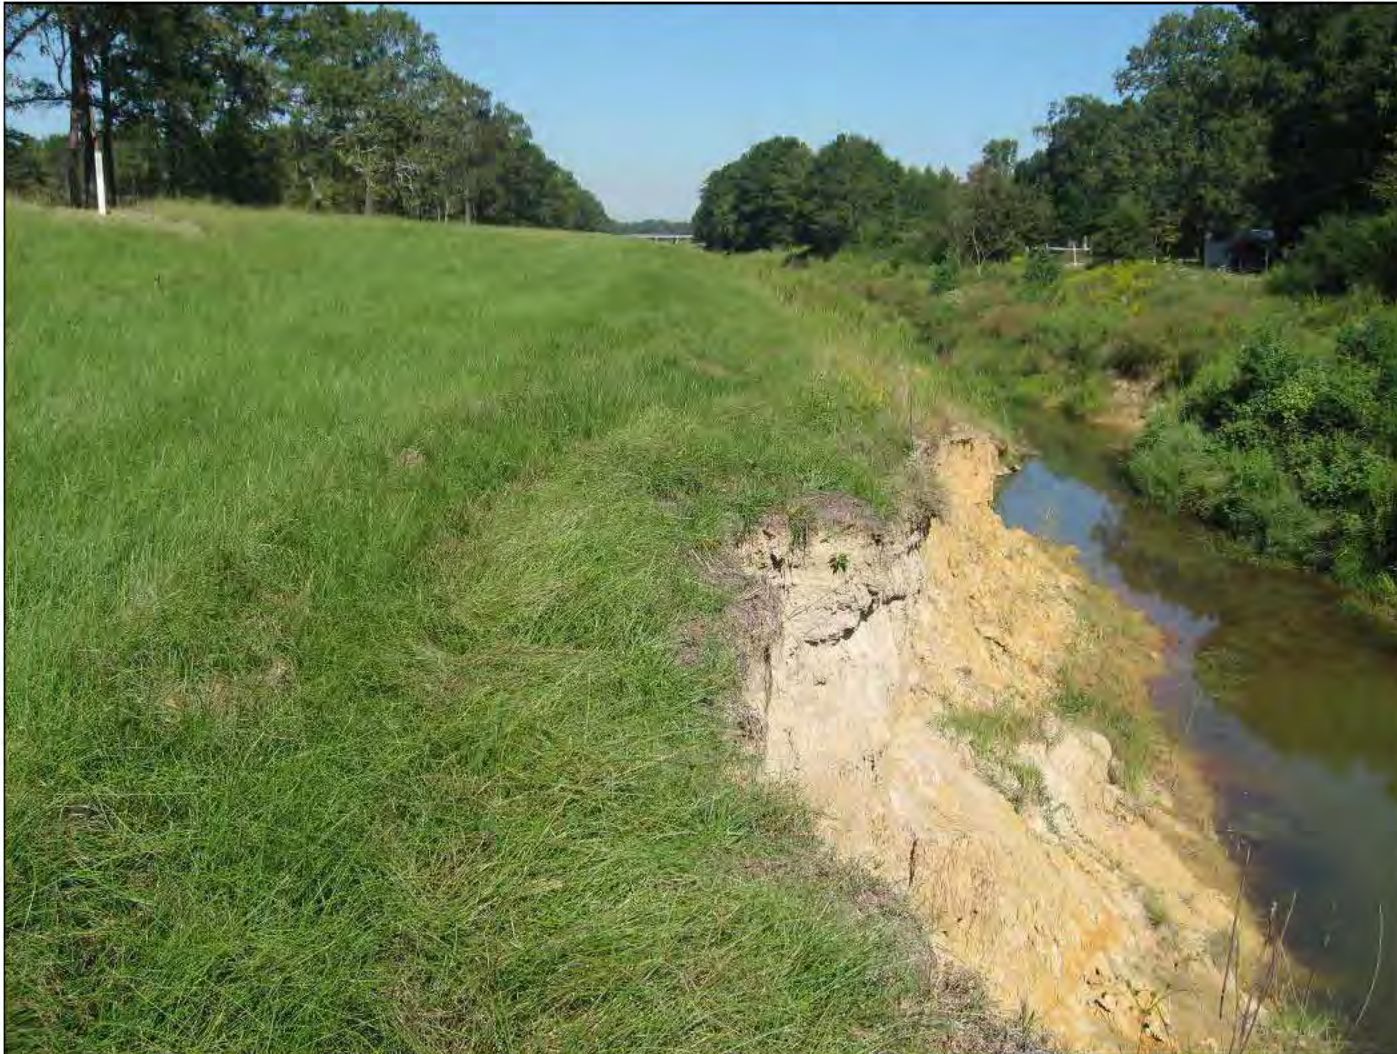
**Inspect ID:** EJFC\_2016\_a\_0007 **Title:** USACE\_CEMVK\_EJFC\_2016\_a\_0007\_1.jpg **Rated Item:** 6. Erosion/ Bank Caving **Caption:** Rating: Acceptable; Remarks: RS Erosion about 30' from the toe.; Station\_1: 47

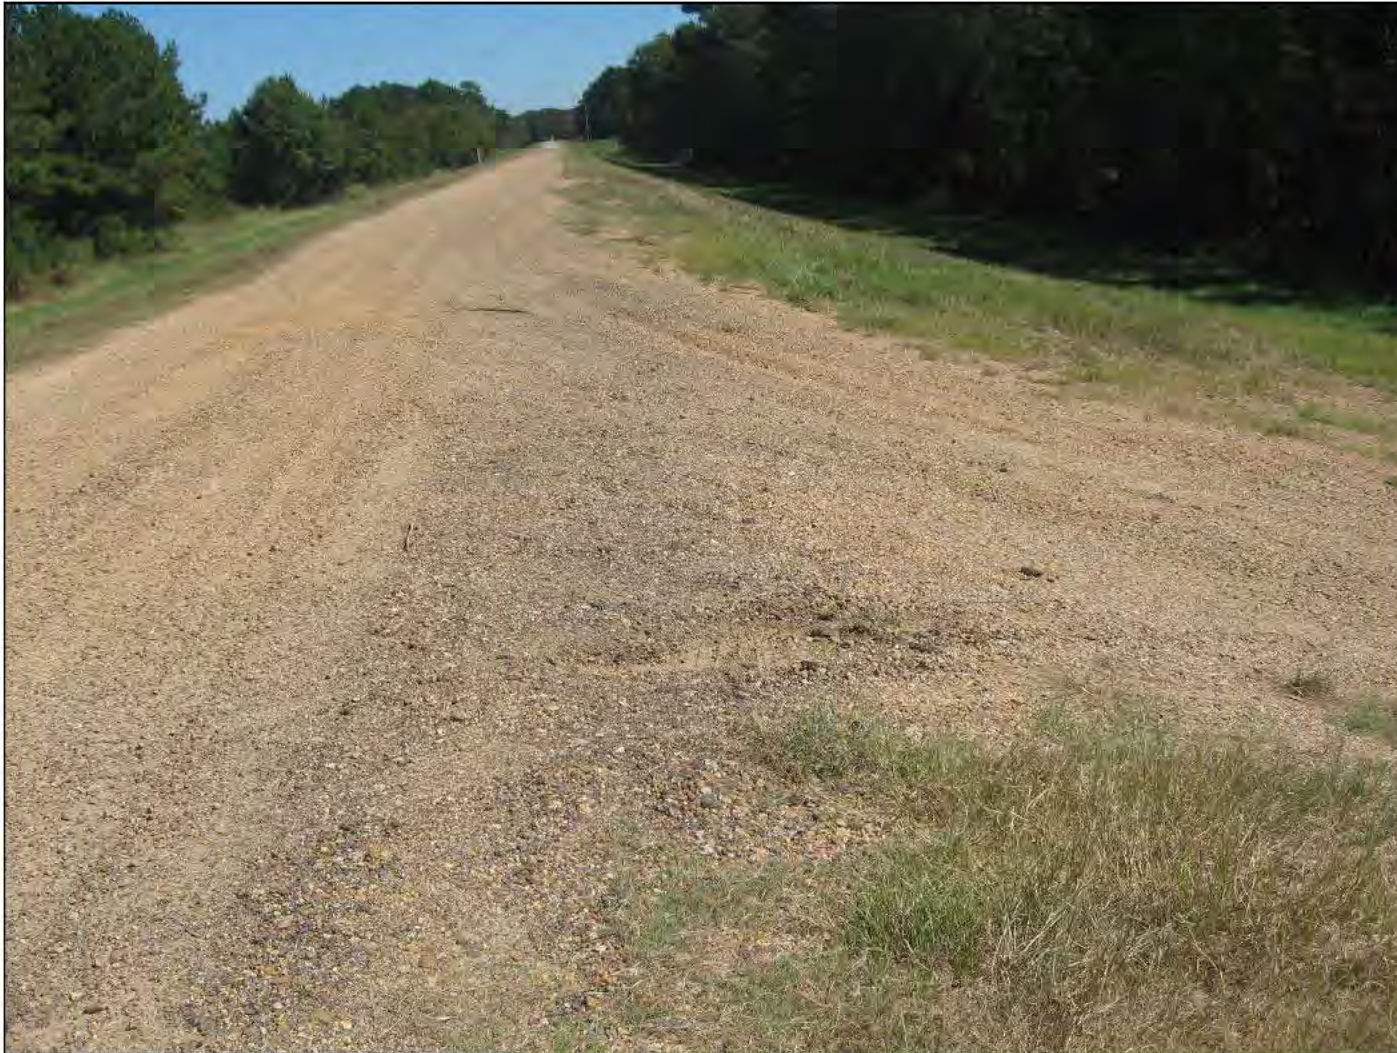
**Inspect ID:** EJFC\_2016\_a\_0016 **Title:** USACE\_CEMVK\_EJFC\_2016\_a\_0016\_1.jpg **Rated Item:** 8. Depressions/ Rutting **Caption:** Rating: Minimally Acceptable; Remarks: LS Wash at top of ramp. Levee crown grade not affected; Station\_1: 455

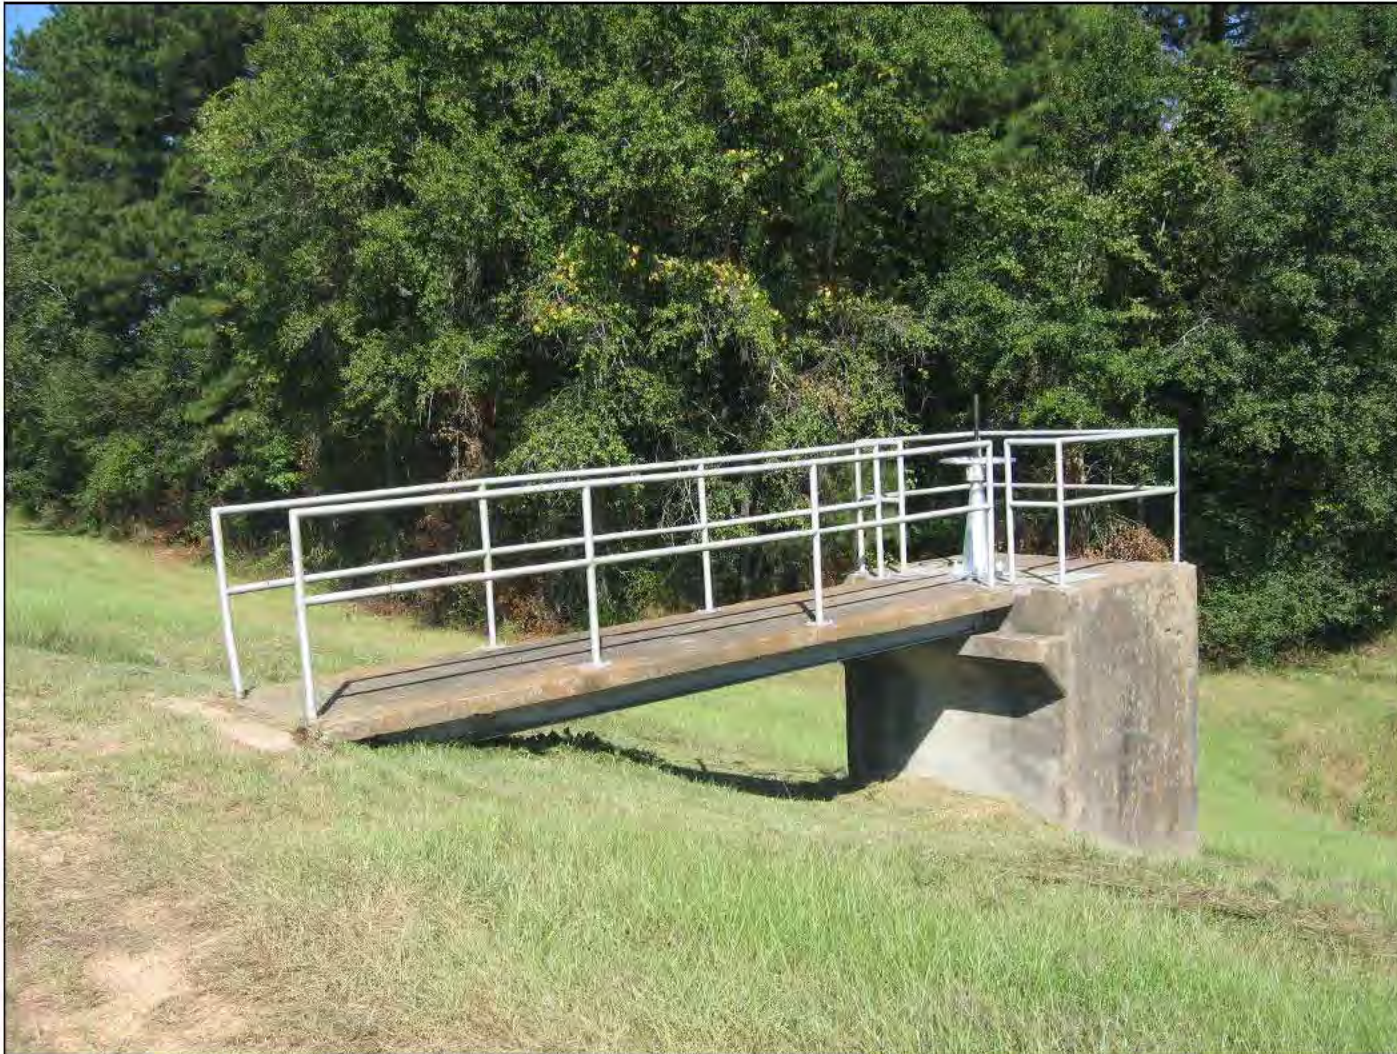
**Inspect ID:** EJFC\_2016\_a\_0010 **Title:** USACE\_CEMVK\_EJFC\_2016\_a\_0010\_1.jpg **Rated Item:** 11. Culverts/ Discharge Pipes (This item includes both concrete and corrugated metal pipes.) **Caption:** Rating: Unacceptable; Remarks: STA 166+65 36" manual sluice. Cure in place type liner has been installed since USACE video inspection in 2010. Liner installed in 2010 and re-videoed. The LSO has determined that the lack of video within 5 years for this structure would not affect levee integrity. Small spall on walkway bridge near footing. logs in conduit at inlet and outlet.; Station\_1: 166+65

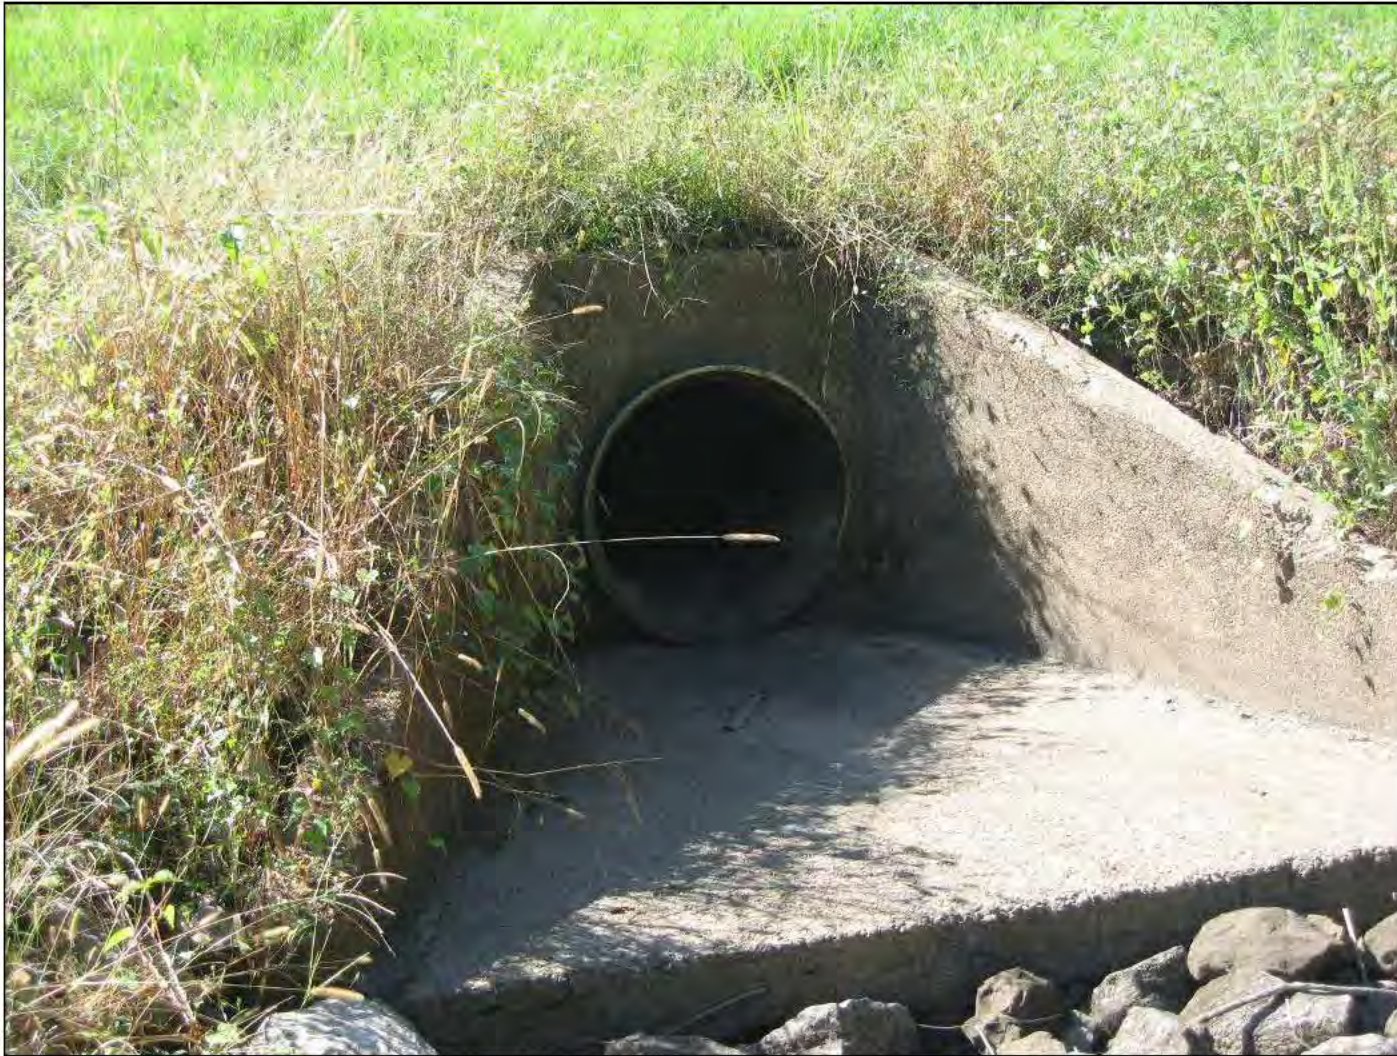
**Inspect ID:** EJFC\_2016\_a\_0010 **Title:** USACE\_CEMVK\_EJFC\_2016\_a\_0010\_2.jpg **Rated Item:** 11. Culverts/ Discharge Pipes (This item includes both concrete and corrugated metal pipes.) **Caption:** Rating: Unacceptable; Remarks: STA 166+65 36" manual sluice. Cure in place type liner has been installed since USACE video inspection in 2010. Liner installed in 2010 and re-videoed. The LSO has determined that the lack of video within 5 years for this structure would not affect levee integrity. Small spall on walkway bridge near footing, logs in conduit at inlet and outlet.; Station\_1: 166+65

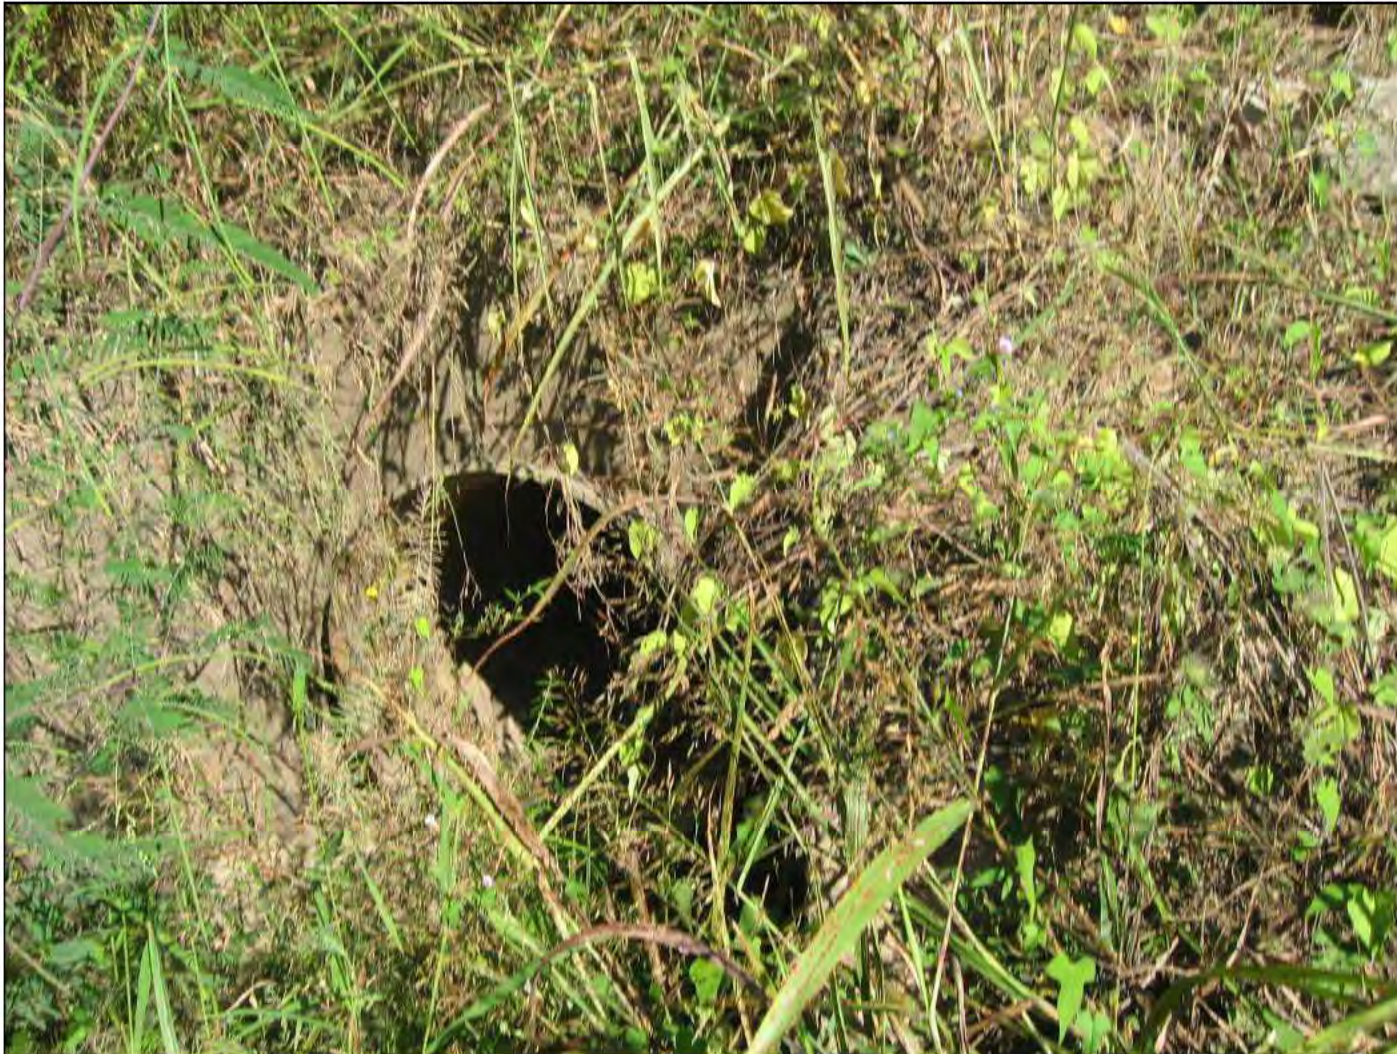
**Inspect ID:** EJFC\_2016\_a\_0010 **Title:** USACE\_CEMVK\_EJFC\_2016\_a\_0010\_3.jpg **Rated Item:** 11. Culverts/ Discharge Pipes (This item includes both concrete and corrugated metal pipes.) **Caption:** Rating: Unacceptable; Remarks: STA 166+65 36" manual sluice. Cure in place type liner has been installed since USACE video inspection in 2010. Liner installed in 2010 and re-videoed. The LSO has determined that the lack of video within 5 years for this structure would not affect levee integrity. Small spall on walkway bridge near footing, logs in conduit at inlet and outlet.; Station\_1: 166+65

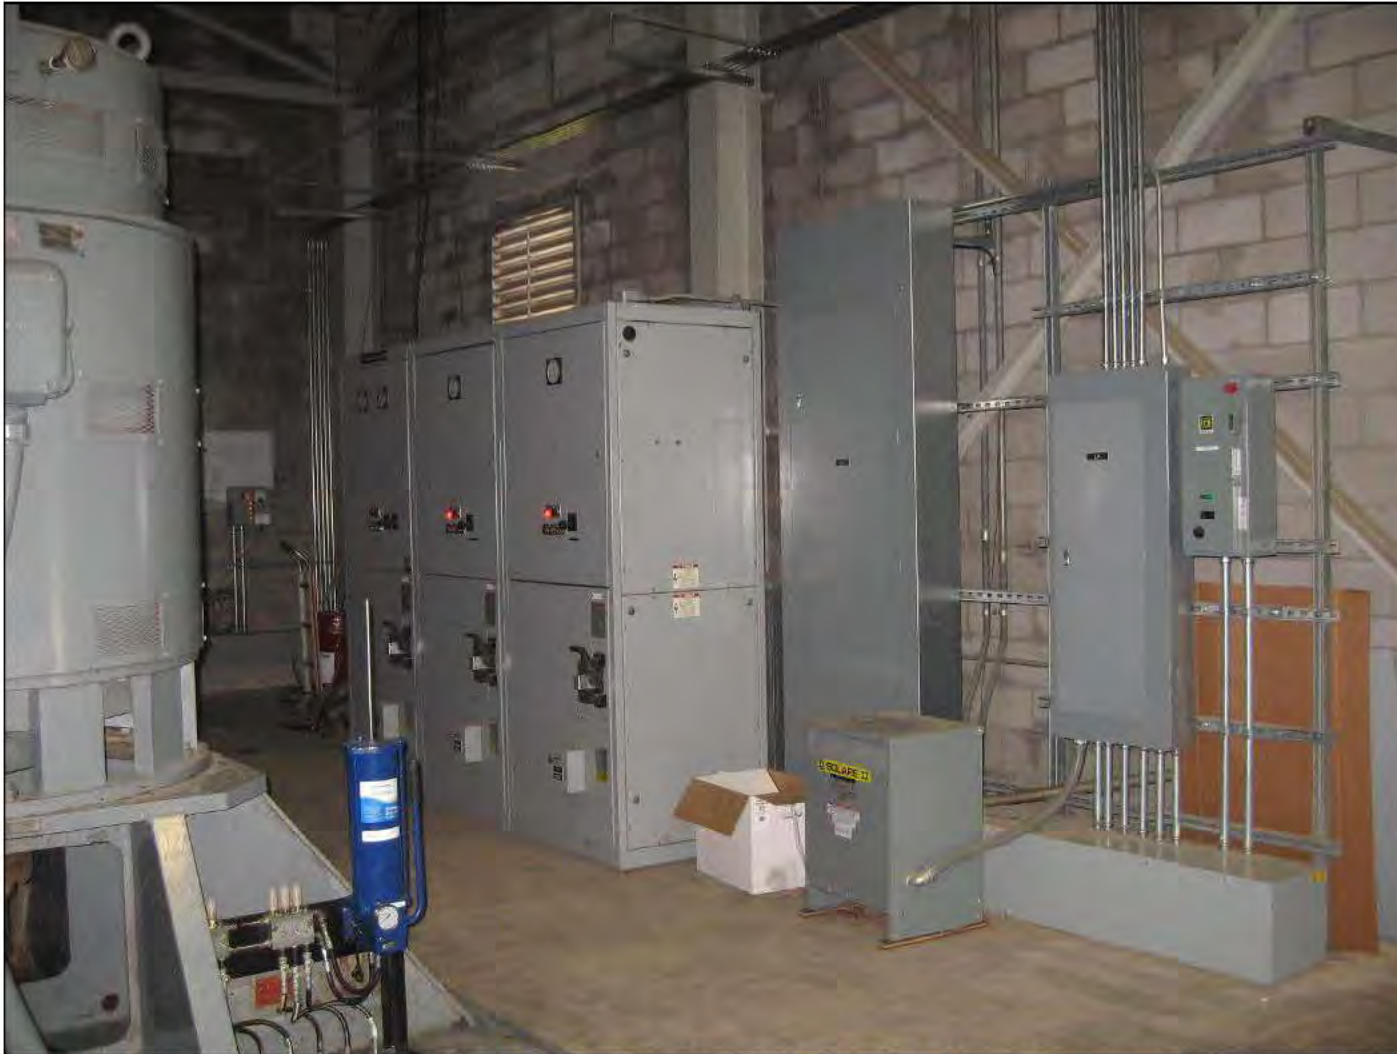
**Inspect ID:** EJFC\_2016\_a\_0015 **Title:** USACE\_CEMVK\_EJFC\_2016\_a\_0015\_11.jpg **Rated Item:** 11. Culverts/ Discharge Pipes (This item includes both concrete and corrugated metal pipes.) **Caption:** Rating: Acceptable; Remarks: STA 413+50 East Bank PS and DS. Structures appear well maintained. Gravity inlet debris buildup. Pump discharge pipes light rust visible inside at the ends. Pump rehab completed 2013 & 2014 on pump 2 & 3 respectively. Crane cert 2014. Mod wash gravity str; Station\_1: 413+50

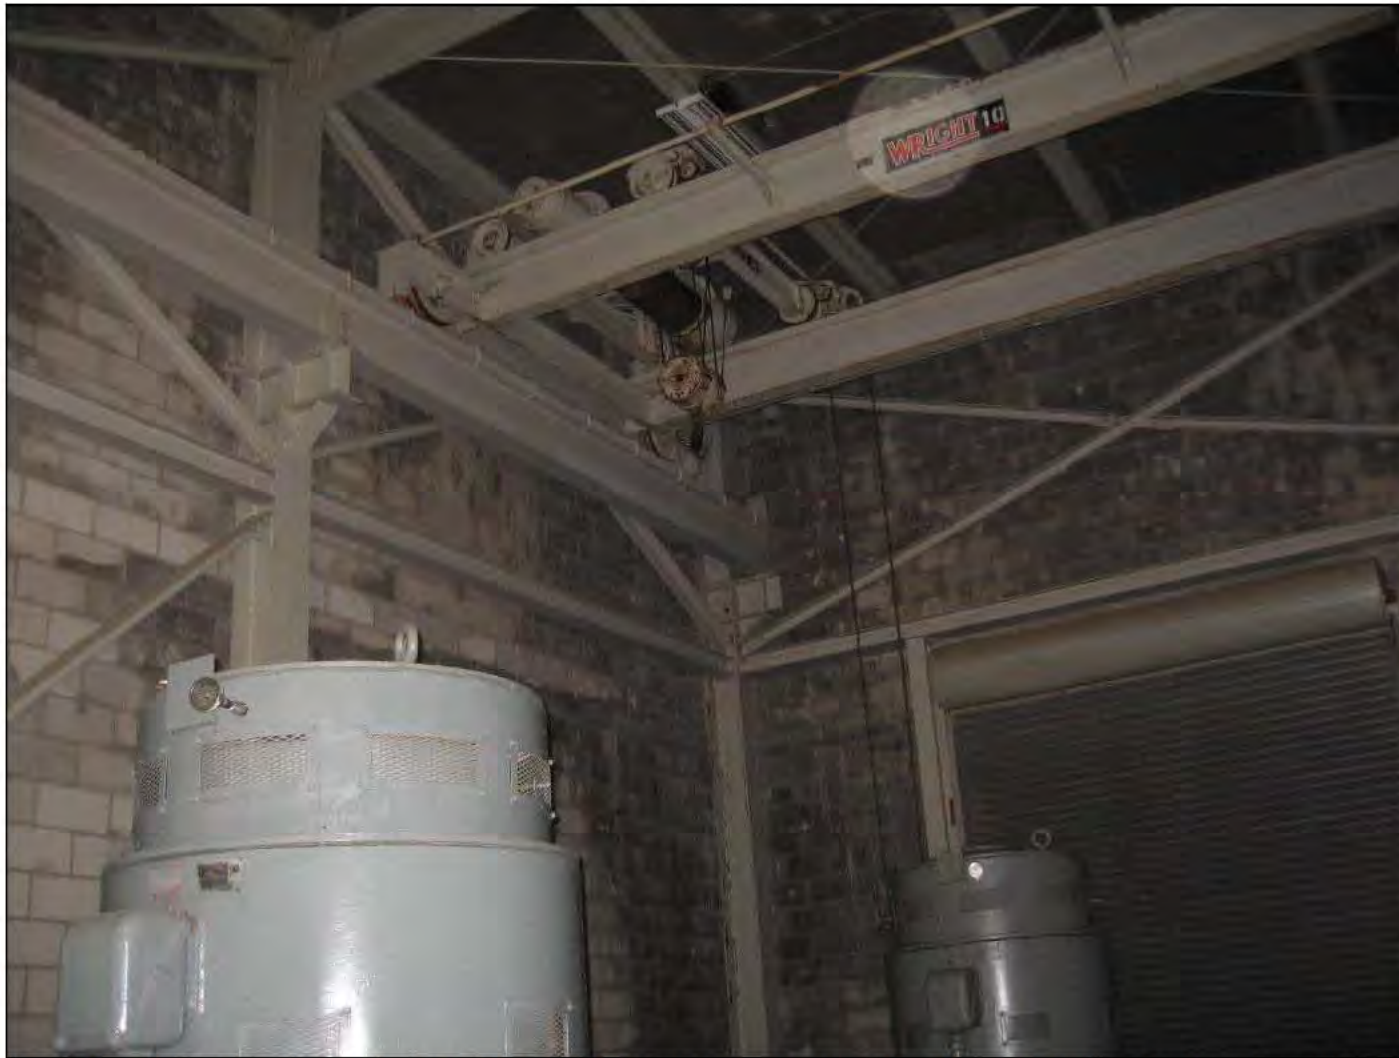
**Inspect ID:** EJFC\_2016\_a\_0015 **Title:** USACE\_CEMVK\_EJFC\_2016\_a\_0015\_12.jpg **Rated Item:** 11. Culverts/ Discharge Pipes (This item includes both concrete and corrugated metal pipes.) **Caption:** Rating: Acceptable; Remarks: STA 413+50 East Bank PS and DS. Structures appear well maintained. Gravity inlet debris buildup. Pump discharge pipes light rust visible inside at the ends. Pump rehab completed 2013 & 2014 on pump 2 & 3 respectively. Crane cert 2014. Mod wash gravity str; Station\_1: 413+50

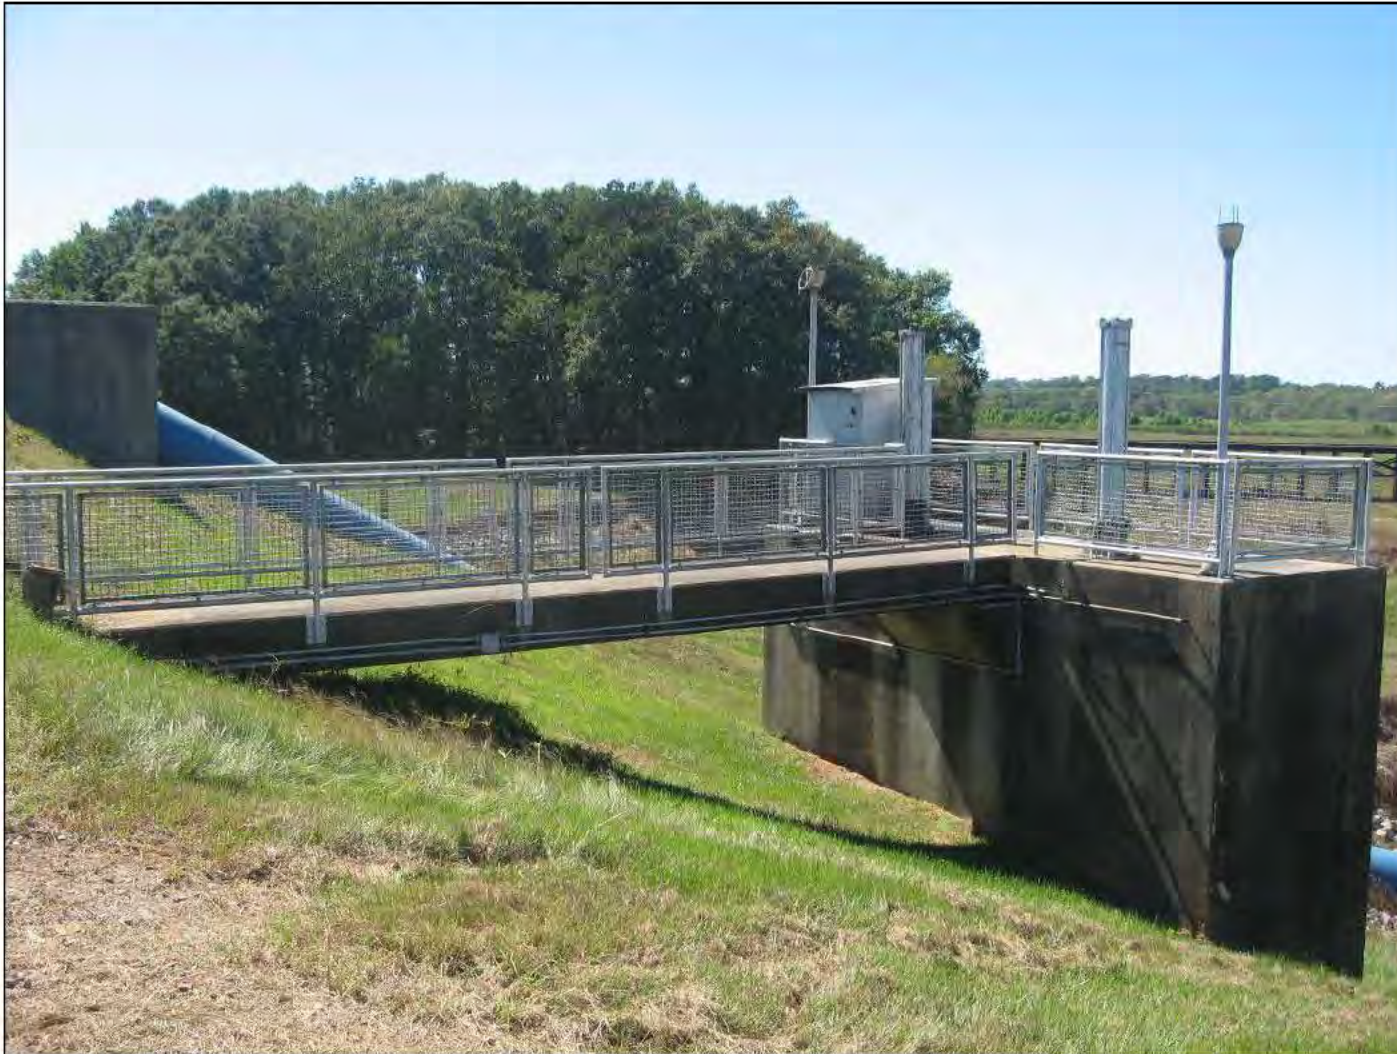
**Inspect ID:** EJFC\_2016\_a\_0015 **Title:** USACE\_CEMVK\_EJFC\_2016\_a\_0015\_1.jpg **Rated Item:** 11. Culverts/ Discharge Pipes (This item includes both concrete and corrugated metal pipes.) **Caption:** Rating: Acceptable; Remarks: STA 413+50 East Bank PS and DS. Structures appear well maintained. Gravity inlet debris buildup. Pump discharge pipes light rust visible inside at the ends. Pump rehab completed 2013 & 2014 on pump 2 & 3 respectively. Crane cert 2014. Mod wash gravity str; Station\_1: 413+50

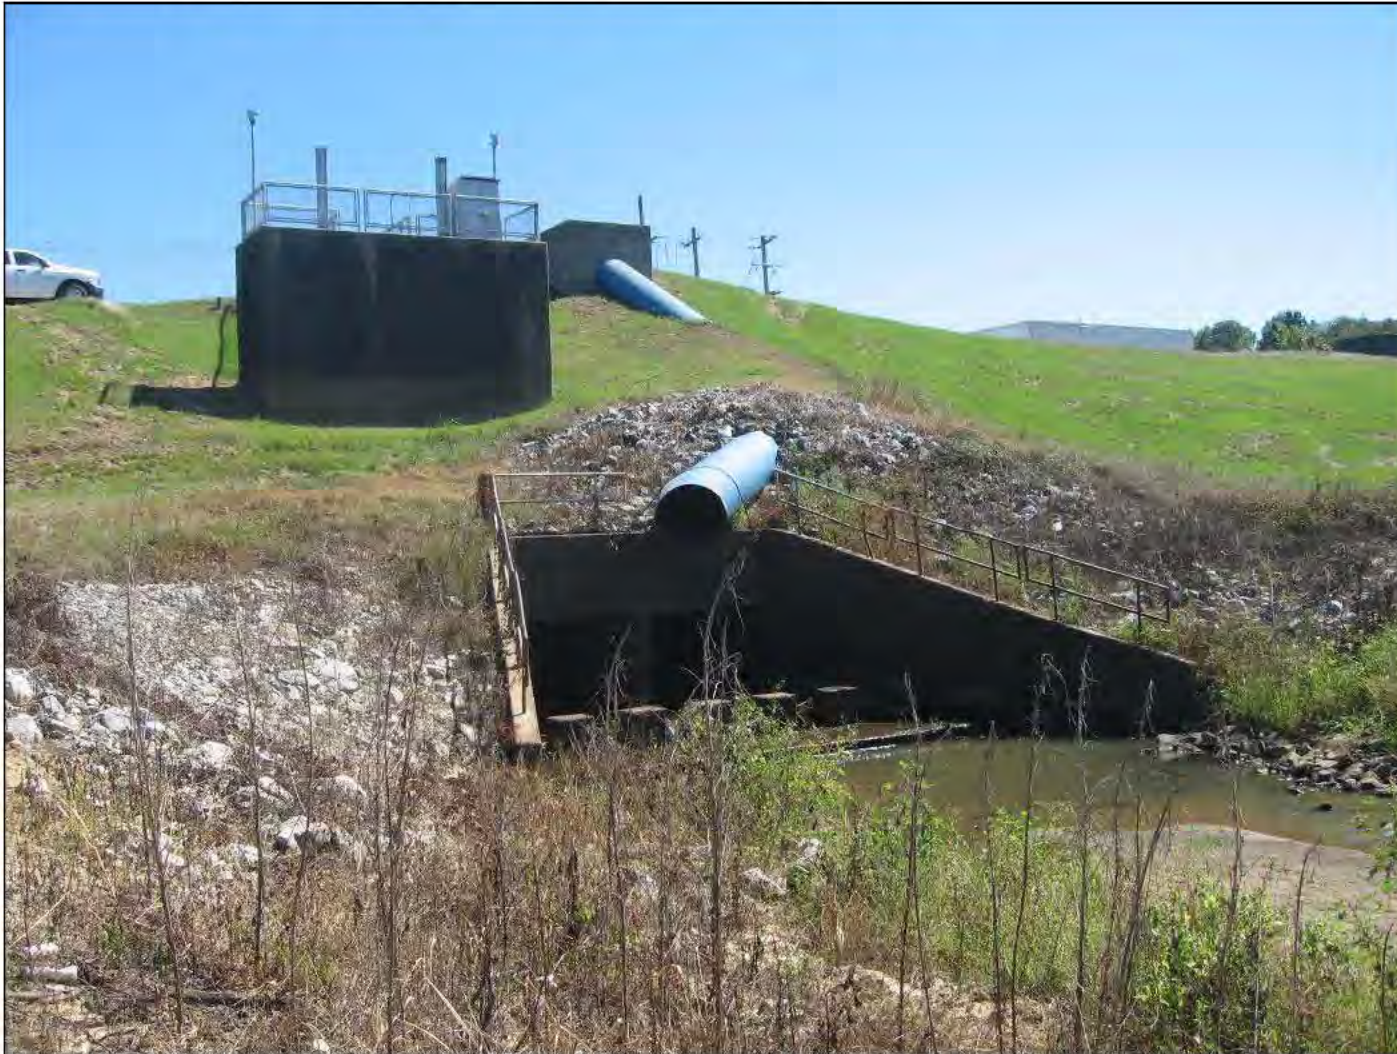
**Inspect ID:** EJFC\_2016\_a\_0015 **Title:** USACE\_CEMVK\_EJFC\_2016\_a\_0015\_2.jpg **Rated Item:** 11. Culverts/ Discharge Pipes (This item includes both concrete and corrugated metal pipes.) **Caption:** Rating: Acceptable; Remarks: STA 413+50 East Bank PS and DS. Structures appear well maintained. Gravity inlet debris buildup. Pump discharge pipes light rust visible inside at the ends. Pump rehab completed 2013 & 2014 on pump 2 & 3 respectively. Crane cert 2014. Mod wash gravity str; Station\_1: 413+50

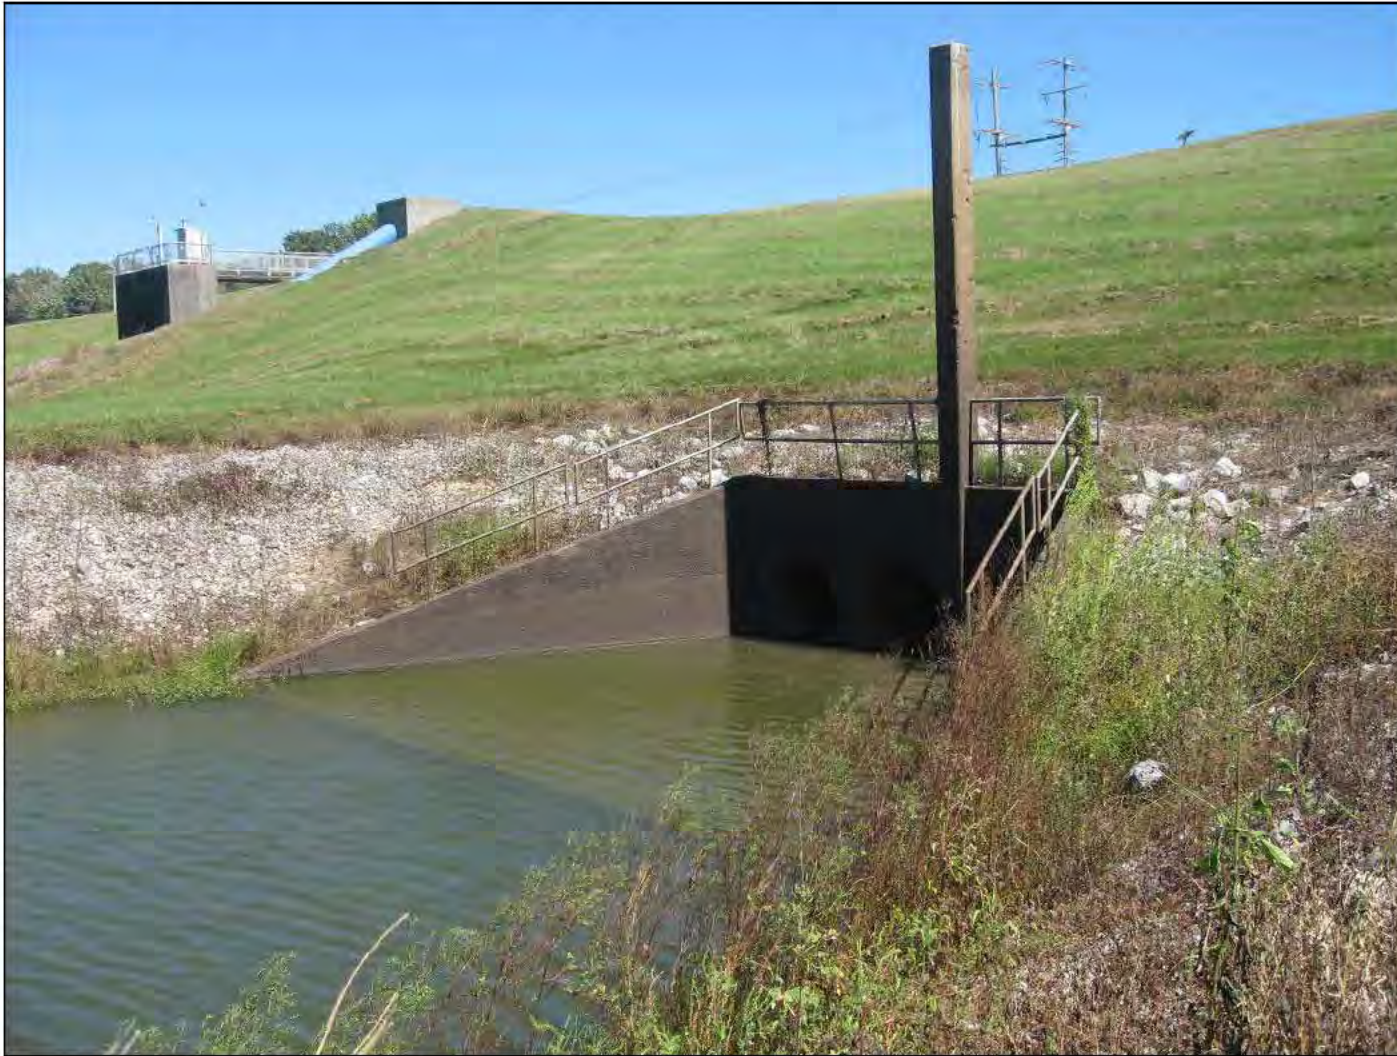
**Inspect ID:** EJFC\_2016\_a\_0015 **Title:** USACE\_CEMVK\_EJFC\_2016\_a\_0015\_3.jpg **Rated Item:** 11. Culverts/ Discharge Pipes (This item includes both concrete and corrugated metal pipes.) **Caption:** Rating: Acceptable; Remarks: STA 413+50 East Bank PS and DS. Structures appear well maintained. Gravity inlet debris buildup. Pump discharge pipes light rust visible inside at the ends. Pump rehab completed 2013 & 2014 on pump 2 & 3 respectively. Crane cert 2014. Mod wash gravity str; Station\_1: 413+50

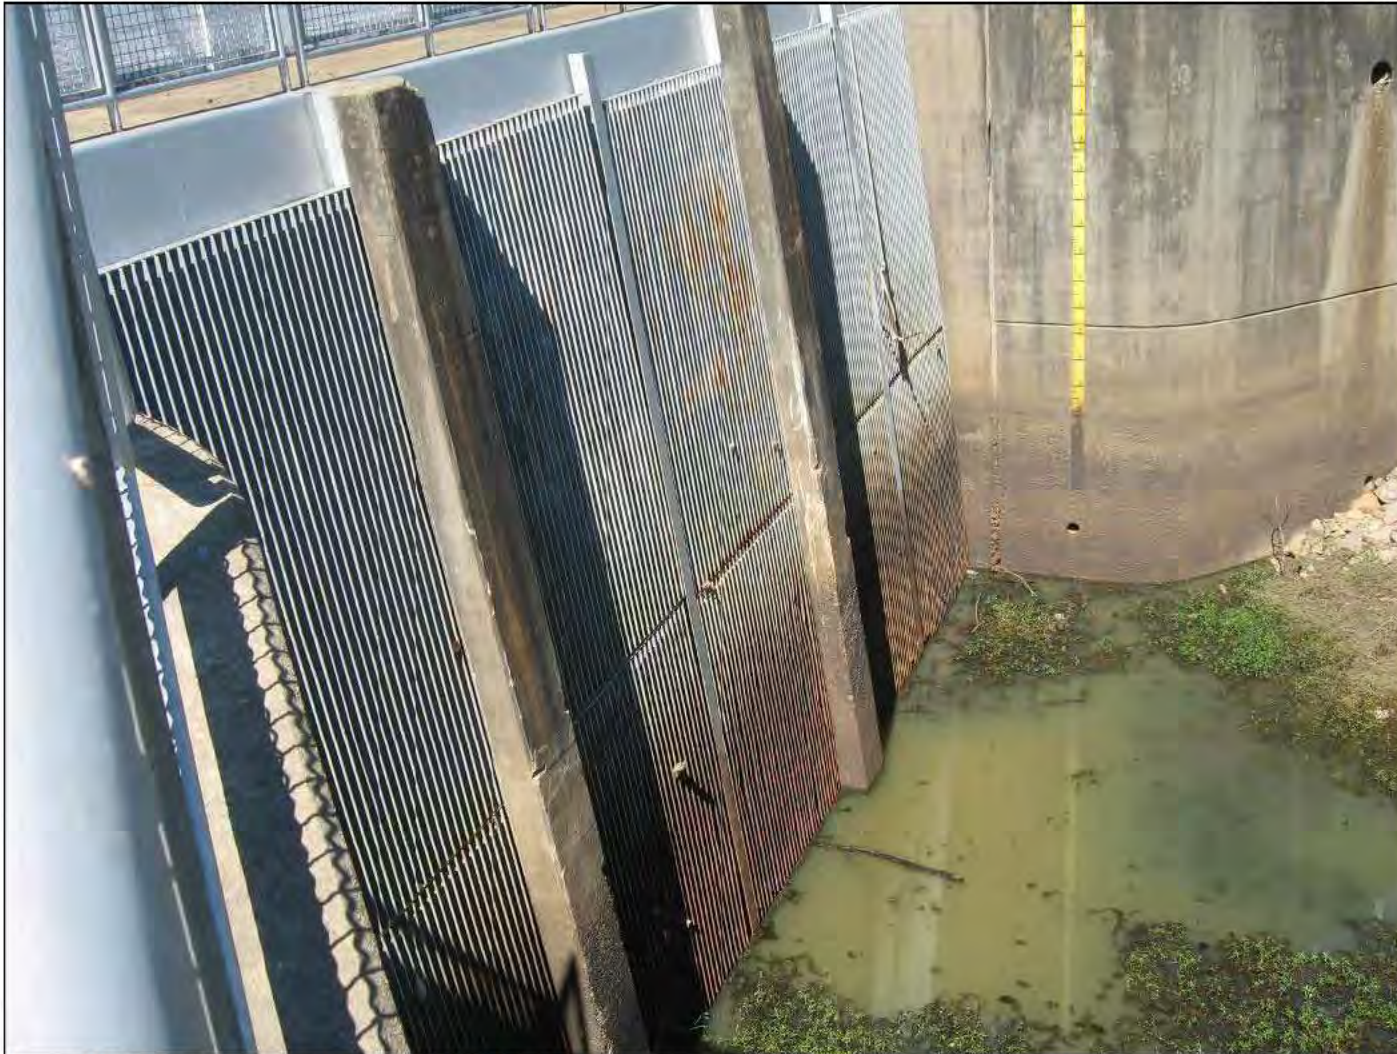
**Inspect ID:** EJFC\_2016\_a\_0015 **Title:** USACE\_CEMVK\_EJFC\_2016\_a\_0015\_4.jpg **Rated Item:** 11. Culverts/ Discharge Pipes (This item includes both concrete and corrugated metal pipes.) **Caption:** Rating: Acceptable; Remarks: STA 413+50 East Bank PS and DS. Structures appear well maintained. Gravity inlet debris buildup. Pump discharge pipes light rust visible inside at the ends. Pump rehab completed 2013 & 2014 on pump 2 & 3 respectively. Crane cert 2014. Mod wash gravity str; Station\_1: 413+50

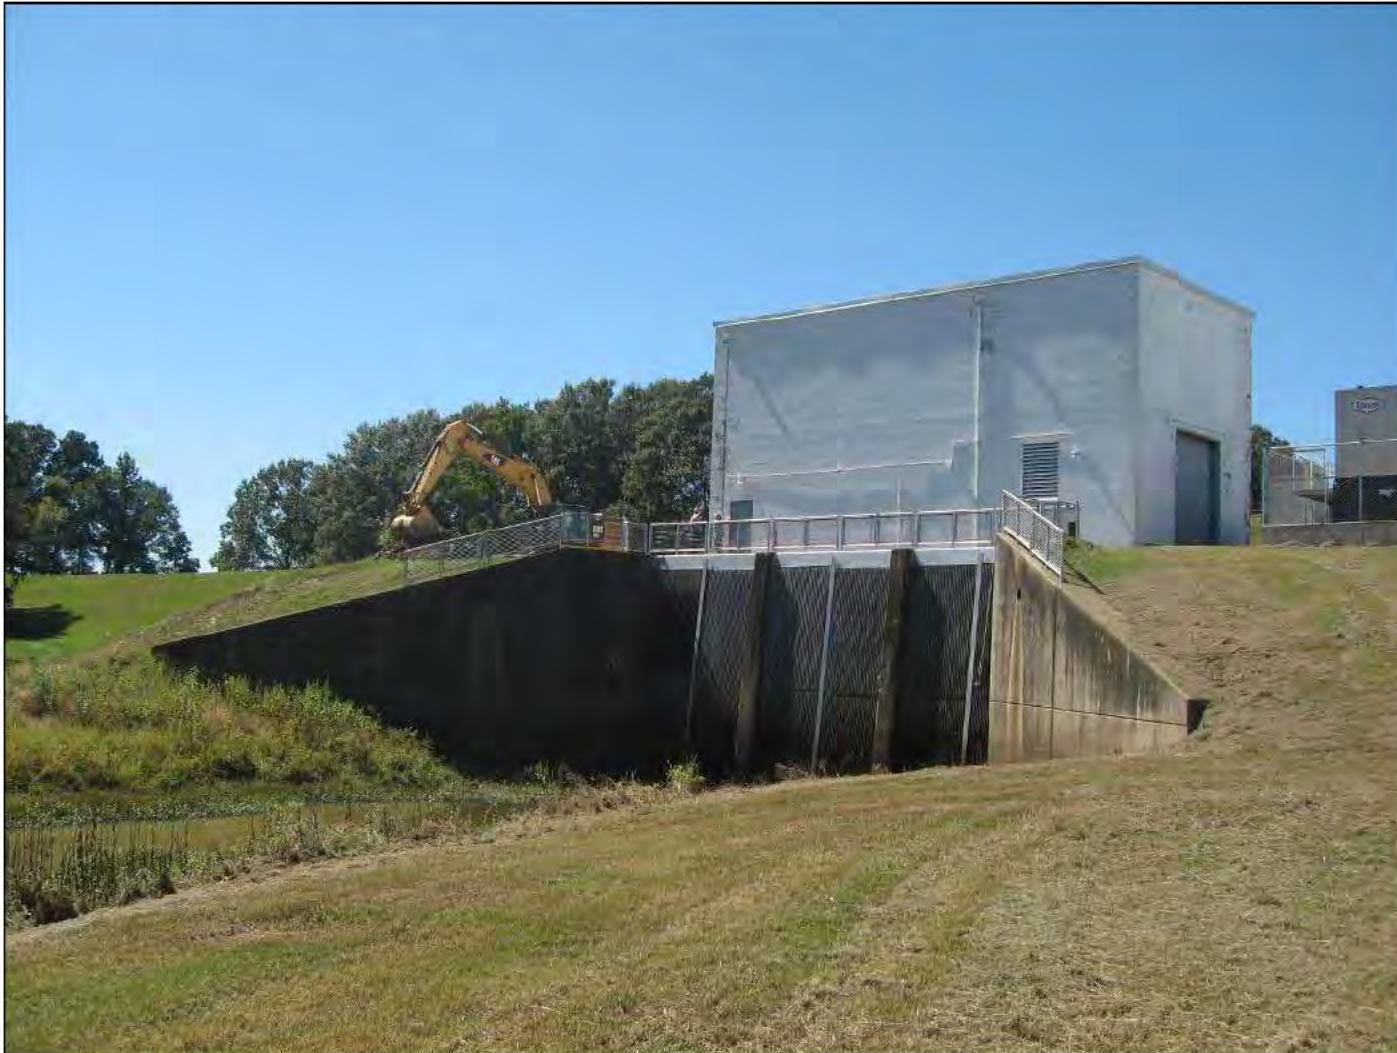
**Inspect ID:** EJFC\_2016\_a\_0015 **Title:** USACE\_CEMVK\_EJFC\_2016\_a\_0015\_5.jpg **Rated Item:** 11. Culverts/ Discharge Pipes (This item includes both concrete and corrugated metal pipes.) **Caption:** Rating: Acceptable; Remarks: STA 413+50 East Bank PS and DS. Structures appear well maintained. Gravity inlet debris buildup. Pump discharge pipes light rust visible inside at the ends. Pump rehab completed 2013 & 2014 on pump 2 & 3 respectively. Crane cert 2014. Mod wash gravity str; Station\_1: 413+50
