# Flood Damage Reduction Segment / System Inspection Report

Name of Segment / System: East Jackson Flood Control Project

Public Sponsor(s): Rankin-Hinds Pearl River Flood and Drainage Control District

Corps of Engineers Inspector: (b) (6) Inspection Start Date: 9/28/2016

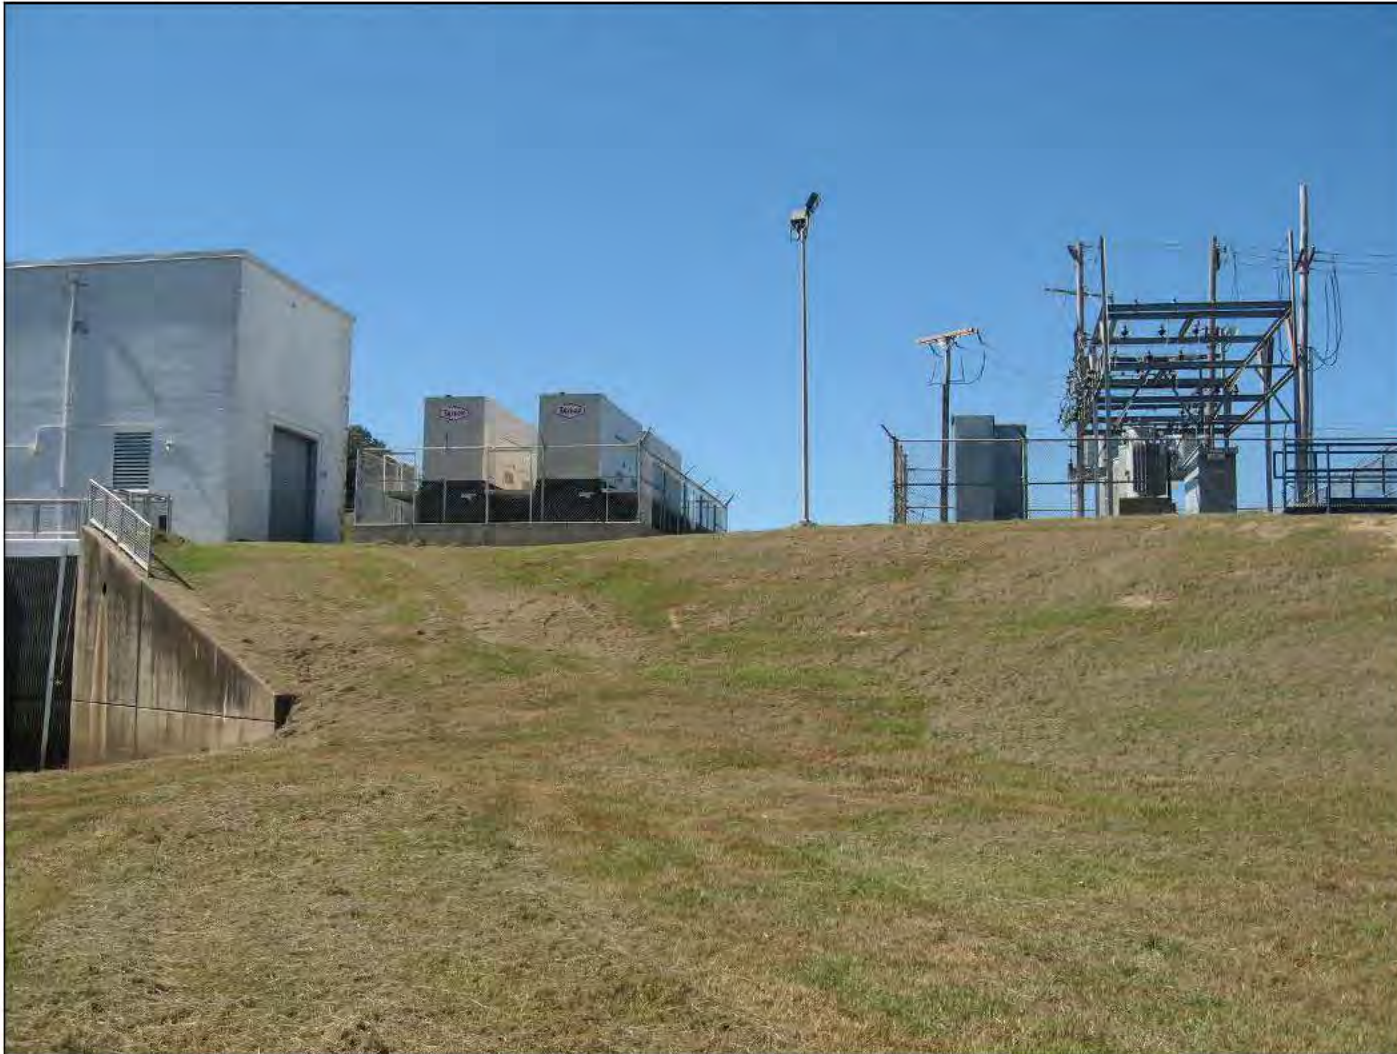
**Inspect ID:** EJFC\_2016\_a\_0015 **Title:** USACE\_CEMVK\_EJFC\_2016\_a\_0015\_6.jpg **Rated Item:** 11. Culverts/ Discharge Pipes (This item includes both concrete and corrugated metal pipes.) **Caption:** Rating: Acceptable; Remarks: STA 413+50 East Bank PS and DS. Structures appear well maintained. Gravity inlet debris buildup. Pump discharge pipes light rust visible inside at the ends. Pump rehab completed 2013 & 2014 on pump 2 & 3 respectively. Crane cert 2014. Mod wash gravity str; Station\_1: 413+50

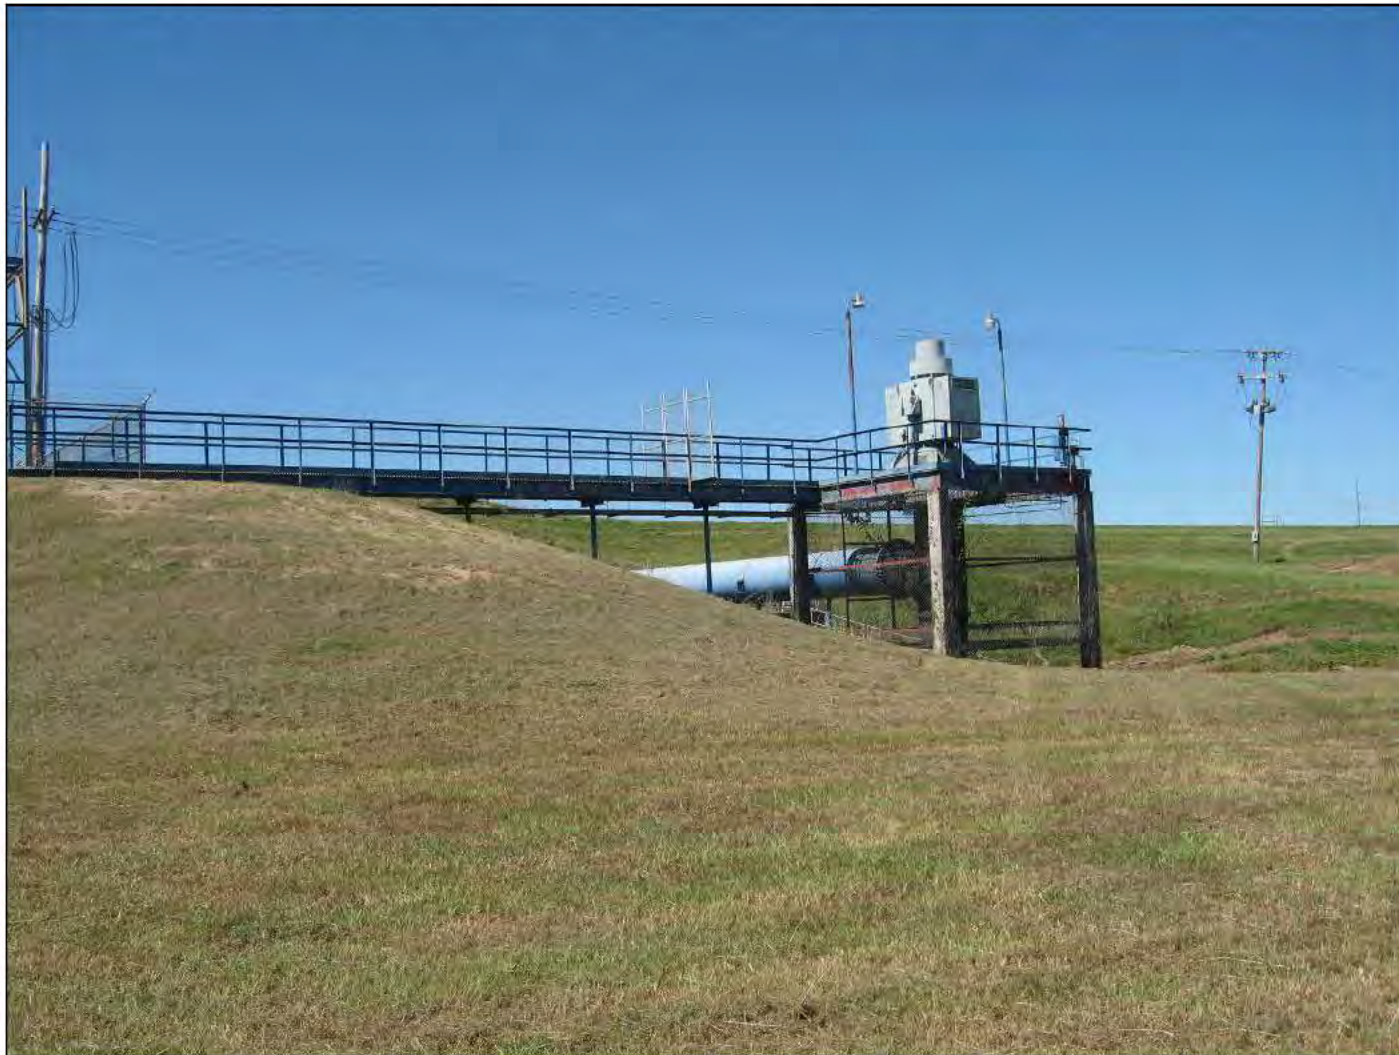
**Inspect ID:** EJFC\_2016\_a\_0015 **Title:** USACE\_CEMVK\_EJFC\_2016\_a\_0015\_7.jpg **Rated Item:** 11. Culverts/ Discharge Pipes (This item includes both concrete and corrugated metal pipes.) **Caption:** Rating: Acceptable; Remarks: STA 413+50 East Bank PS and DS. Structures appear well maintained. Gravity inlet debris buildup. Pump discharge pipes light rust visible inside at the ends. Pump rehab completed 2013 & 2014 on pump 2 & 3 respectively. Crane cert 2014. Mod wash gravity str; Station\_1: 413+50

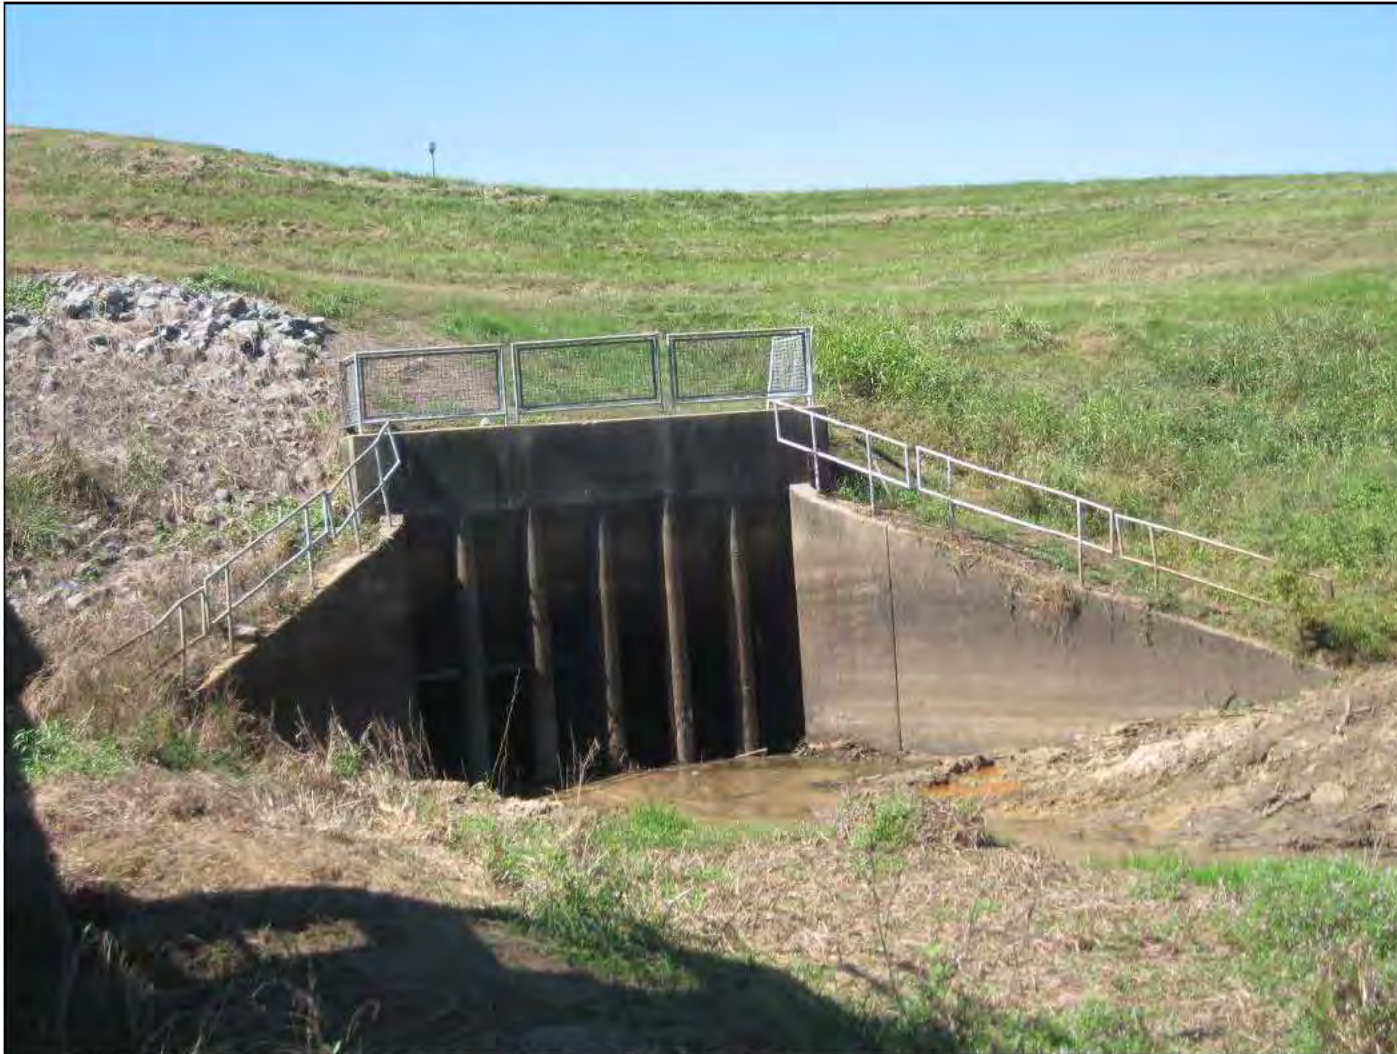
**Inspect ID:** EJFC\_2016\_a\_0015 **Title:** USACE\_CEMVK\_EJFC\_2016\_a\_0015\_8.jpg **Rated Item:** 11. Culverts/ Discharge Pipes (This item includes both concrete and corrugated metal pipes.) **Caption:** Rating: Acceptable; Remarks: STA 413+50 East Bank PS and DS. Structures appear well maintained. Gravity inlet debris buildup. Pump discharge pipes light rust visible inside at the ends. Pump rehab completed 2013 & 2014 on pump 2 & 3 respectively. Crane cert 2014. Mod wash gravity str; Station\_1: 413+50

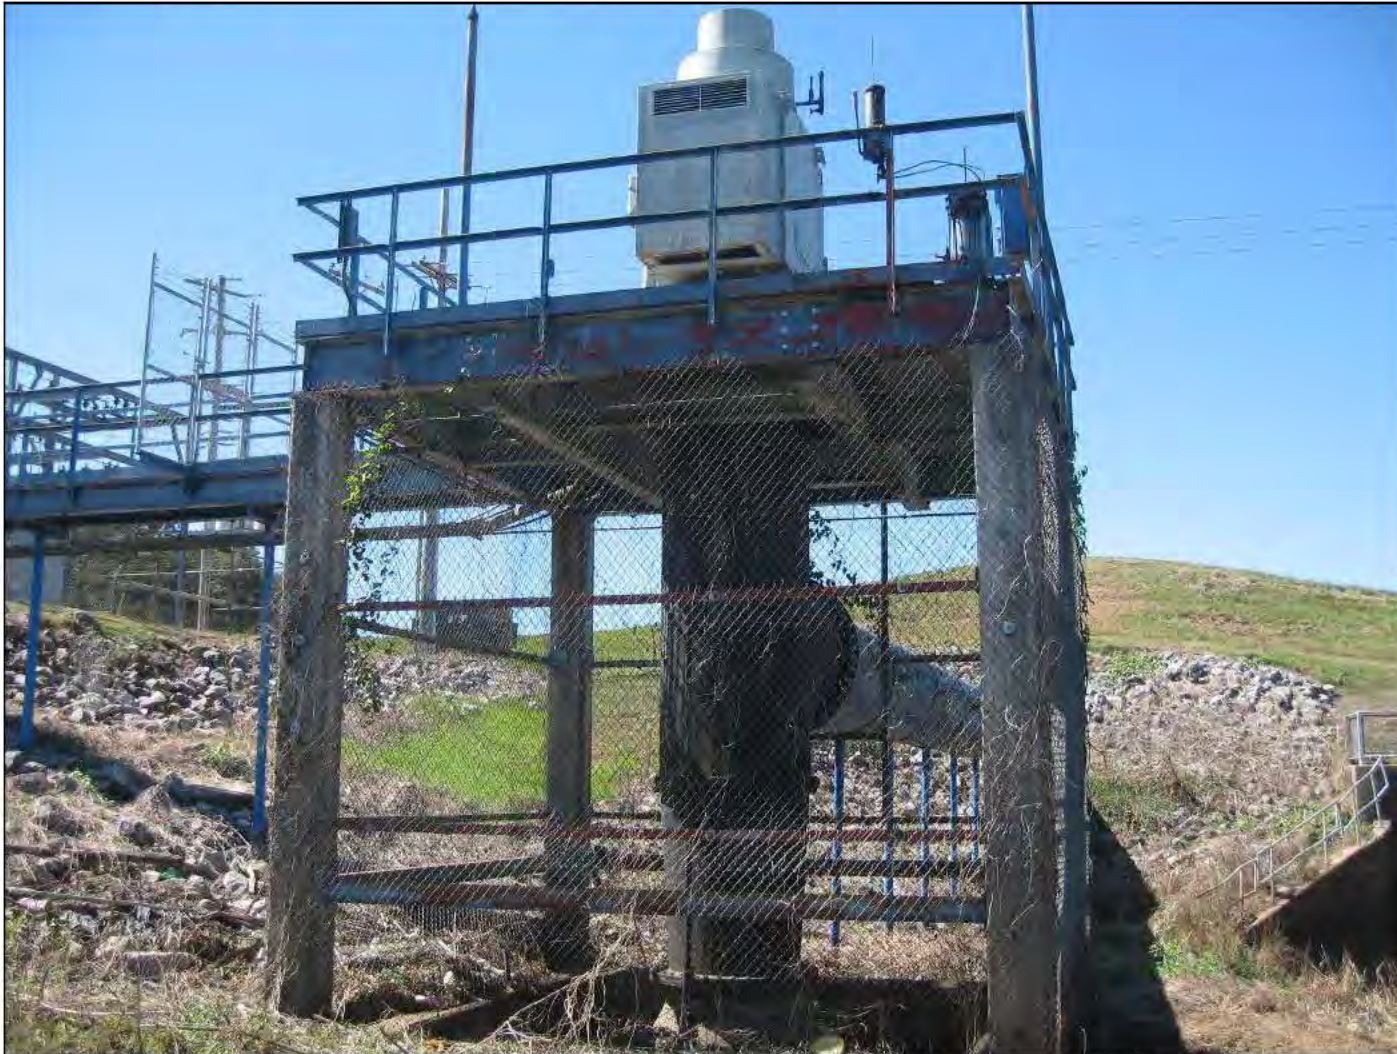
**Inspect ID:** EJFC\_2016\_a\_0015 **Title:** USACE\_CEMVK\_EJFC\_2016\_a\_0015\_9.jpg **Rated Item:** 11. Culverts/ Discharge Pipes (This item includes both concrete and corrugated metal pipes.) **Caption:** Rating: Acceptable; Remarks: STA 413+50 East Bank PS and DS. Structures appear well maintained. Gravity inlet debris buildup. Pump discharge pipes light rust visible inside at the ends. Pump rehab completed 2013 & 2014 on pump 2 & 3 respectively. Crane cert 2014. Mod wash gravity str; Station\_1: 413+50

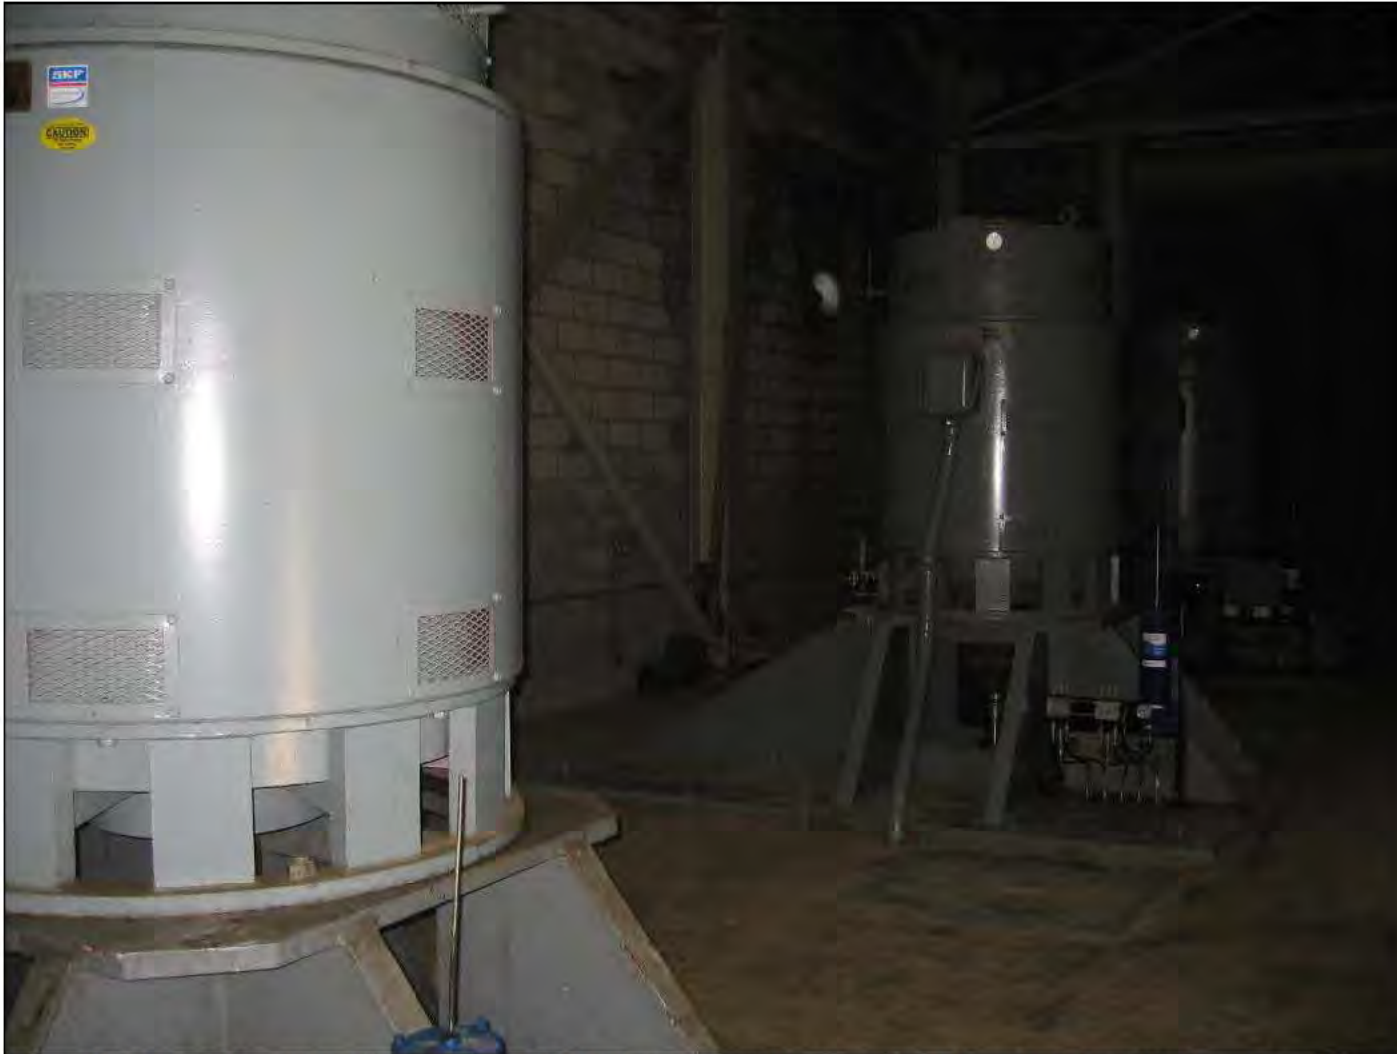
**Inspect ID:** EJFC\_2016\_a\_0015 **Title:** USACE\_CEMVK\_EJFC\_2016\_a\_0015\_10.jpg **Rated Item:** 11. Culverts/ Discharge Pipes (This item includes both concrete and corrugated metal pipes.) **Caption:** Rating: Acceptable; Remarks: STA 413+50 East Bank PS and DS. Structures appear well maintained. Gravity inlet debris buildup. Pump discharge pipes light rust visible inside at the ends. Pump rehab completed 2013 & 2014 on pump 2 & 3 respectively. Crane cert 2014. Mod wash gravity str; Station\_1: 413+50
