Flood Damage Reduction Segment / System Inspection Report

Name of Segment / System: Jackson-Fairgrounds Flood Control Project

MVK Routine Levee Inspection

Flood Damage Reduction Segment / System
Inspection Report
Jackson-Fairgrounds Flood Control Project

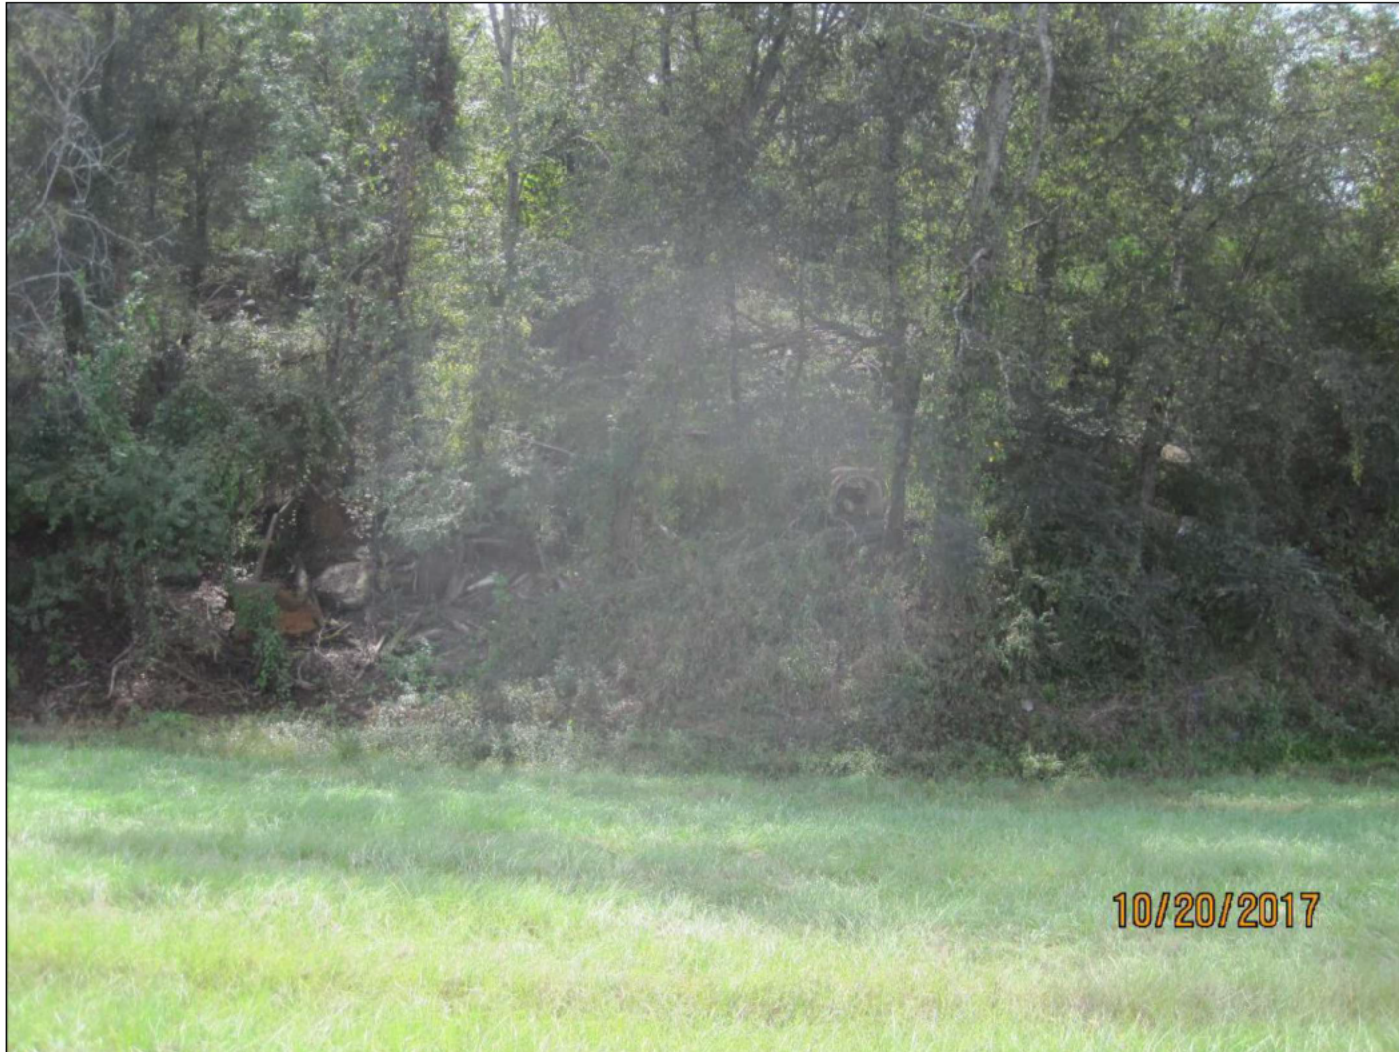
Inspect ID: JAXF_2017_a_0002 **Title:** USACE_CEMVK_JAXF_2017_a_0002_1.jpg **Rated Item:** 1. Unwanted Vegetation Growth **Caption:** Rating: Minimally Acceptable;
Remarks: STA 106 RS Trees/brush within 15' of toe; **Action:** NA; **Station_1:** 106

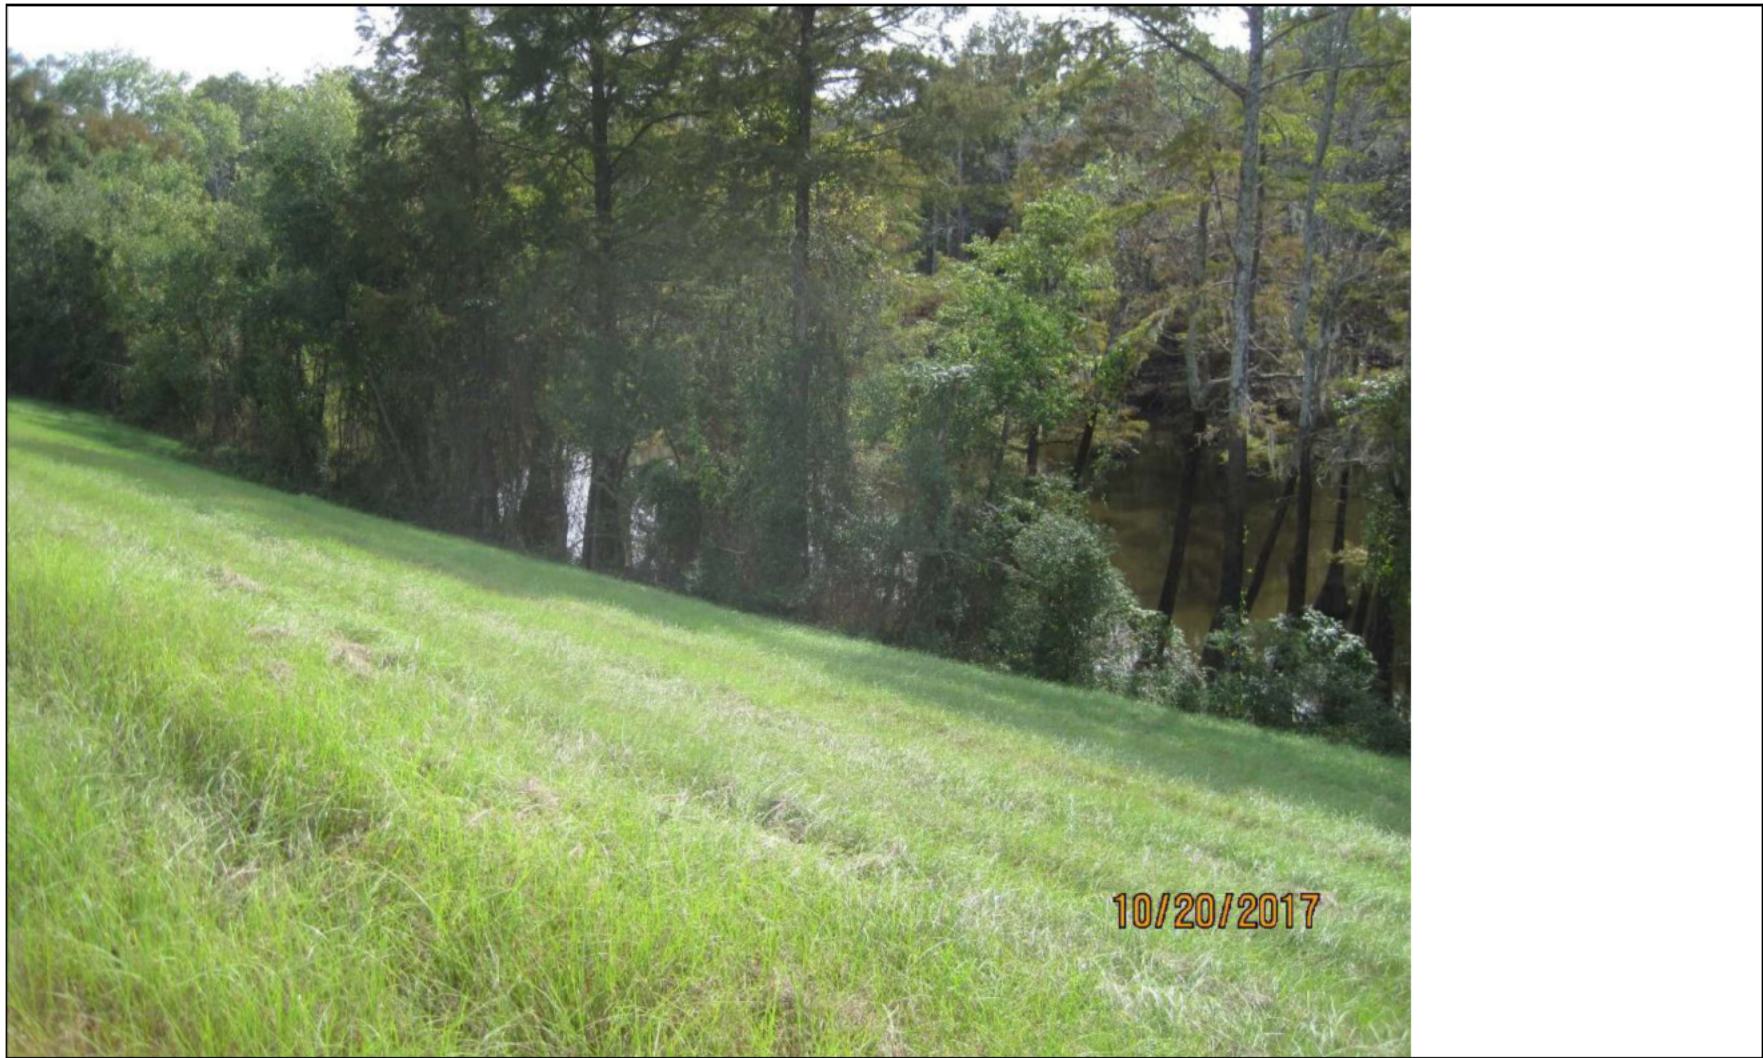
Inspect ID: JAXF_2017_a_0004 **Title:** USACE_CEMVK_JAXF_2017_a_0004_1.jpg **Rated Item:** 1. Unwanted Vegetation Growth **Caption:** Rating: Minimally Acceptable; Remarks: STA 88 RS Vegetation within 15' of toe; Action: NA; Station_1: 88

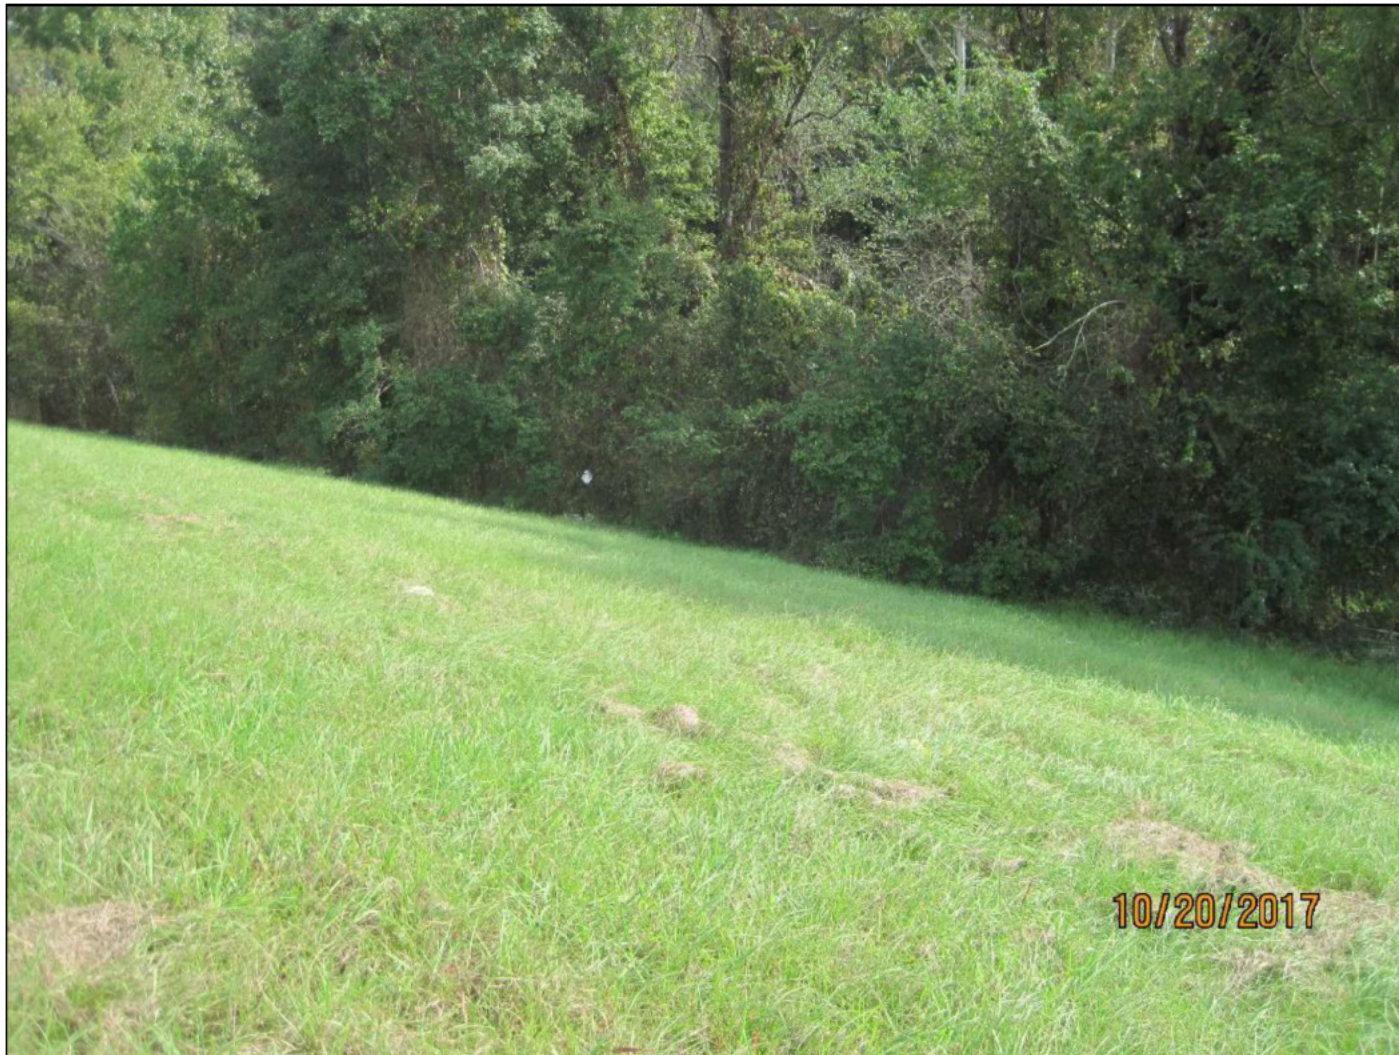
Inspect ID: JAXF_2017_a_0008 **Title:** USACE_CEMVK_JAXF_2017_a_0008_1.jpg **Rated Item:** 1. Unwanted Vegetation Growth **Caption:** Rating: Minimally Acceptable;
Remarks: RS Vegetation within 15' of the toe.; **Action:** NA; **Station_1:** 1+50; **Station_2:** 9

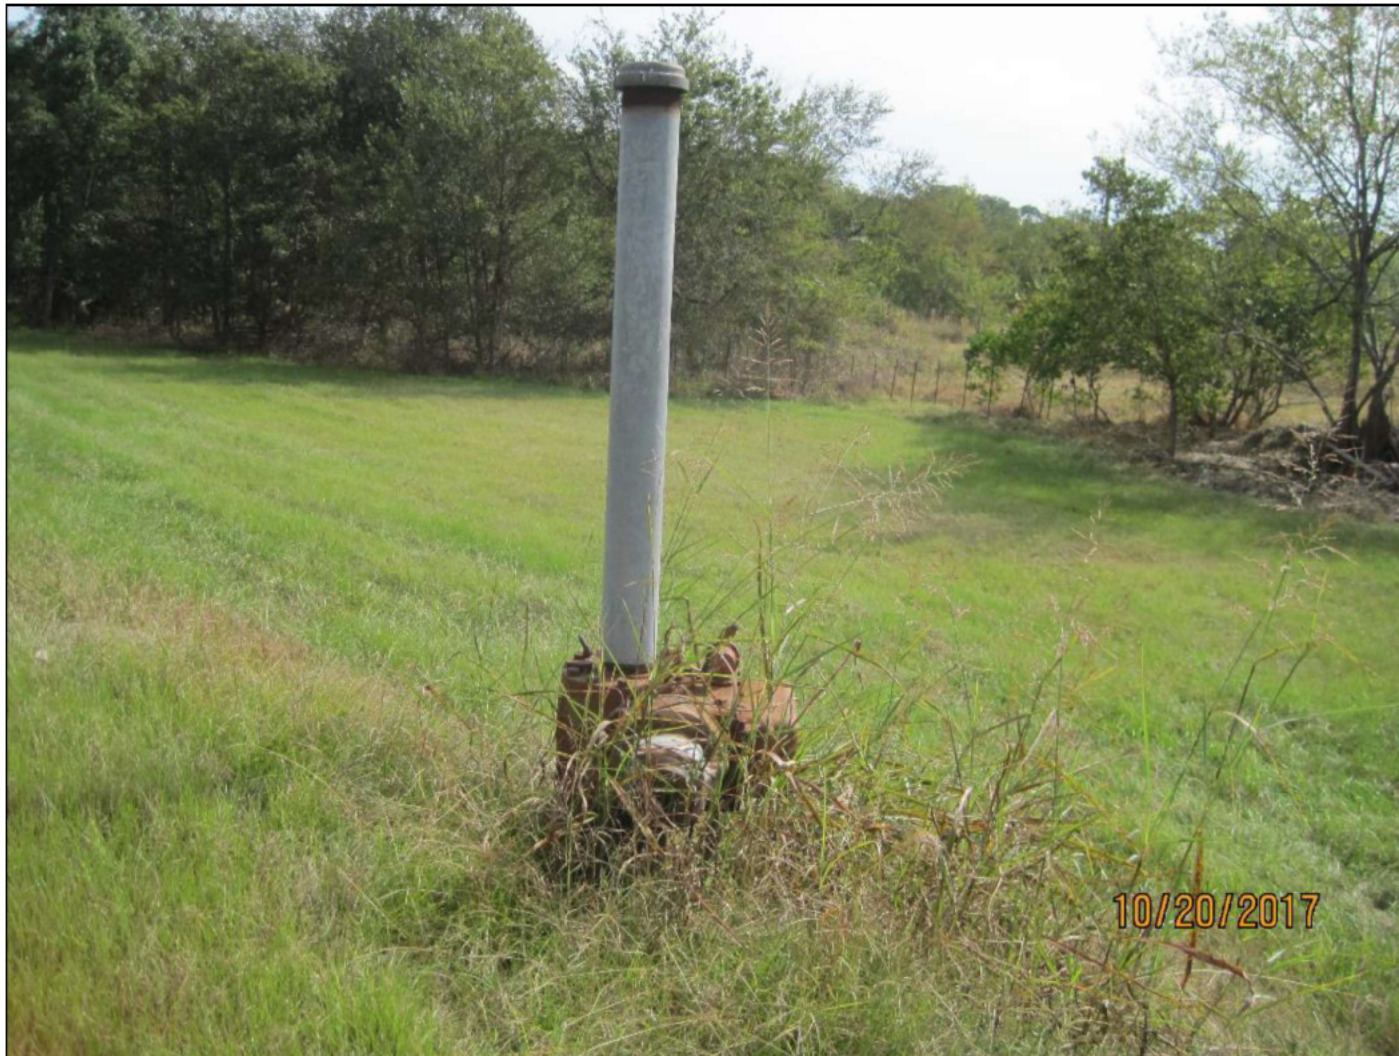
Inspect ID: JAXF_2017_a_0001 **Title:** USACE_CEMVK_JAXF_2017_a_0001_1.jpg **Rated Item:** 3. Encroachments **Caption:** Rating: Minimally Acceptable; Remarks: 110 RS Sanitary sewer valve on slope. 96" sewer line had water back through it during high water event in 2014. City of Jackson has repairs underway as part of sewage rehab project.; Action: NA; Station_1: 110

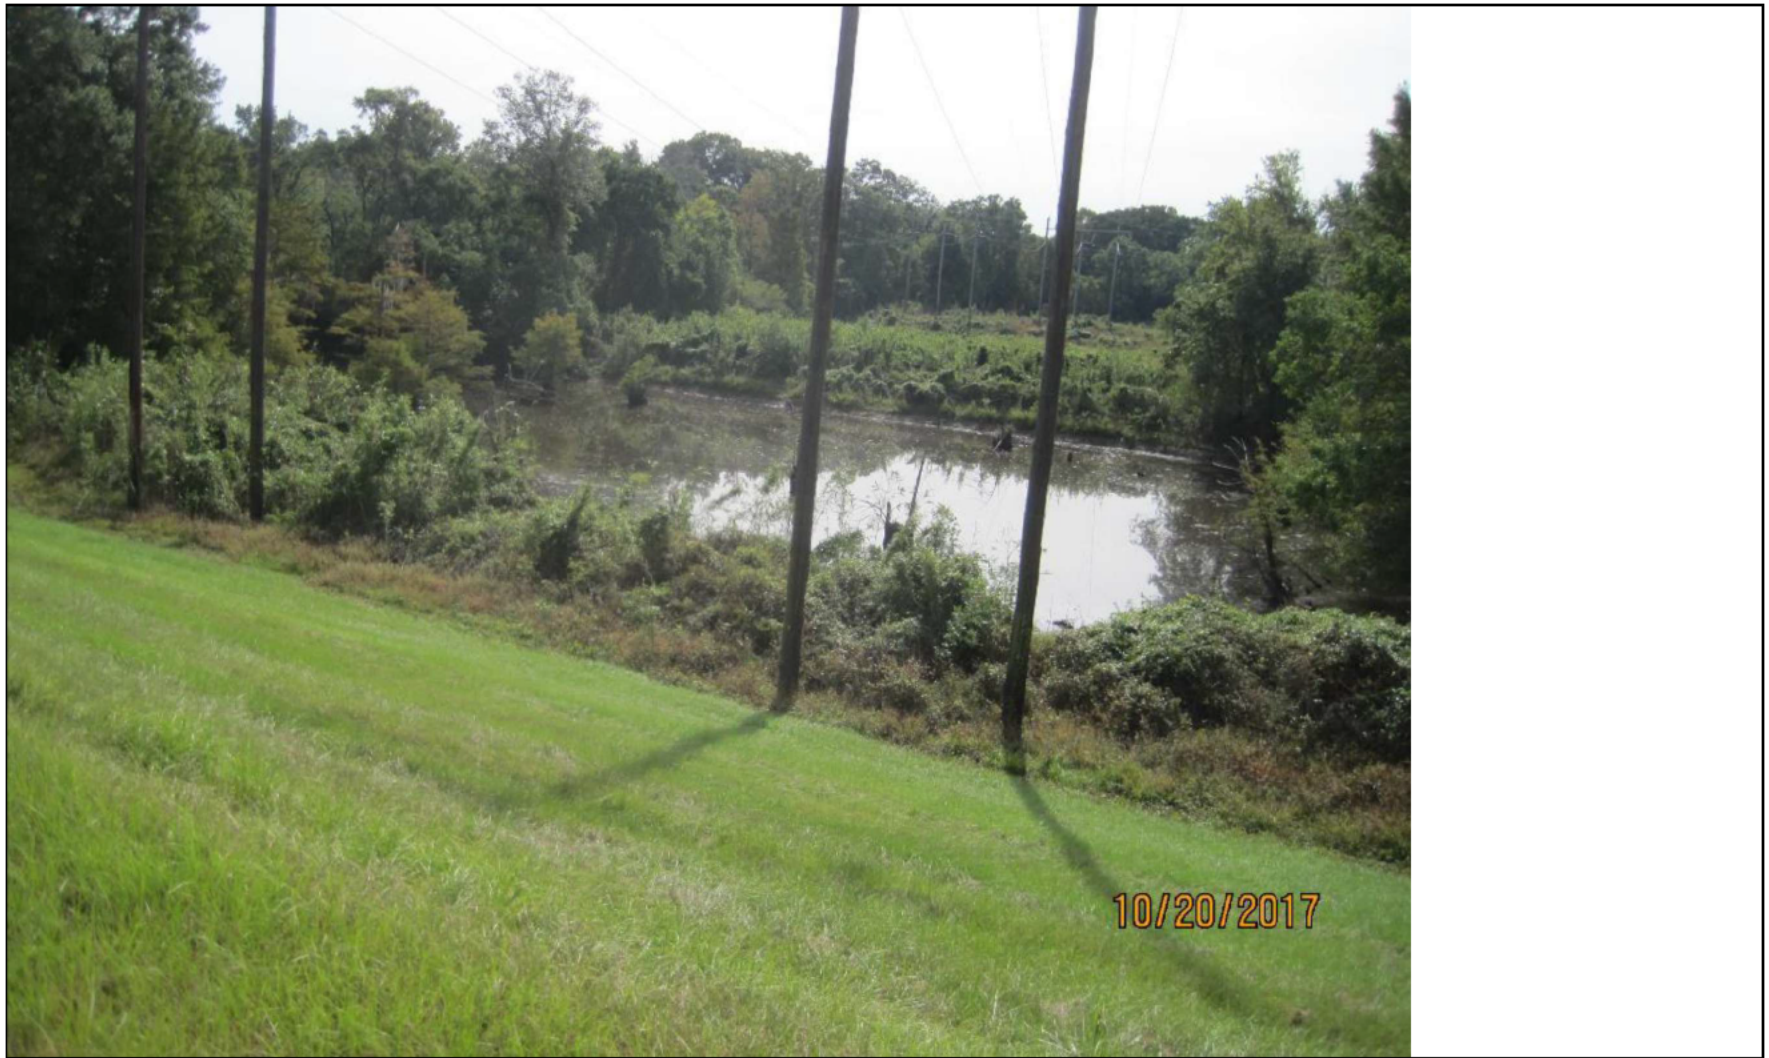
Inspect ID: JAXF_2017_a_0003 **Title:** USACE_CEMVK_JAXF_2017_a_0003_1.jpg **Rated Item:** 3. Encroachments **Caption:** Rating: Minimally Acceptable; Remarks: STA 100 RS 2 large double pole electric transmission lines within 10' of toe.; Action: NA; Station_1: 100

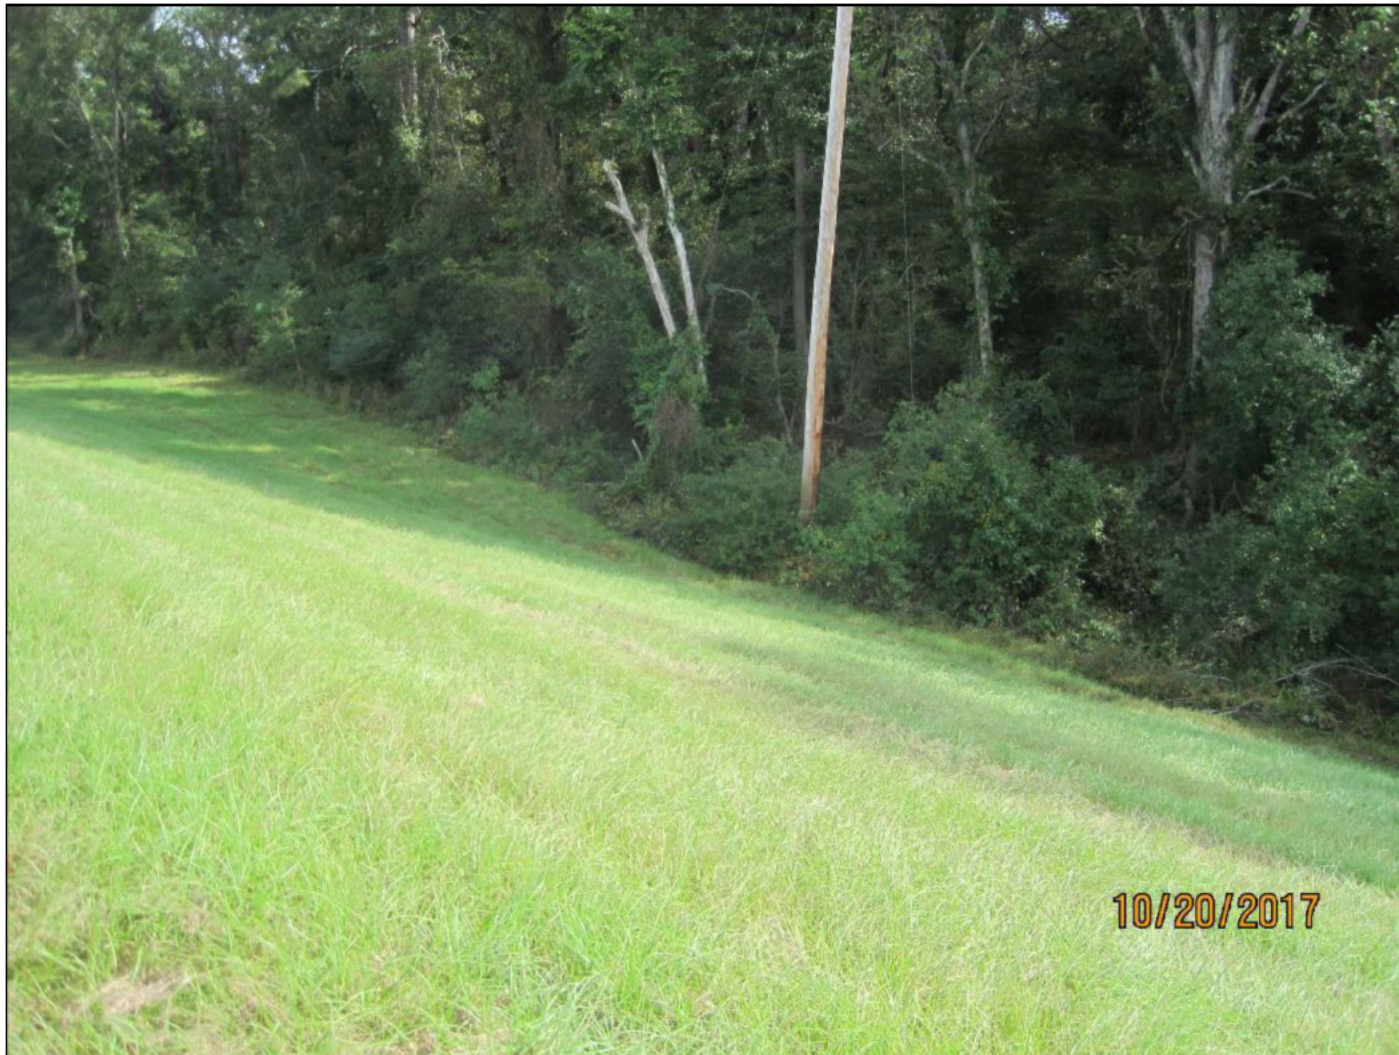
Inspect ID: JAXF_2017_a_0005 **Title:** USACE_CEMVK_JAXF_2017_a_0005_1.jpg **Rated Item:** 3. Encroachments **Caption:** Rating: Minimally Acceptable; Remarks: STA 65 & 70 2 Utility poles RS near levee toe; Action: NA; Station_1: 65 & 70

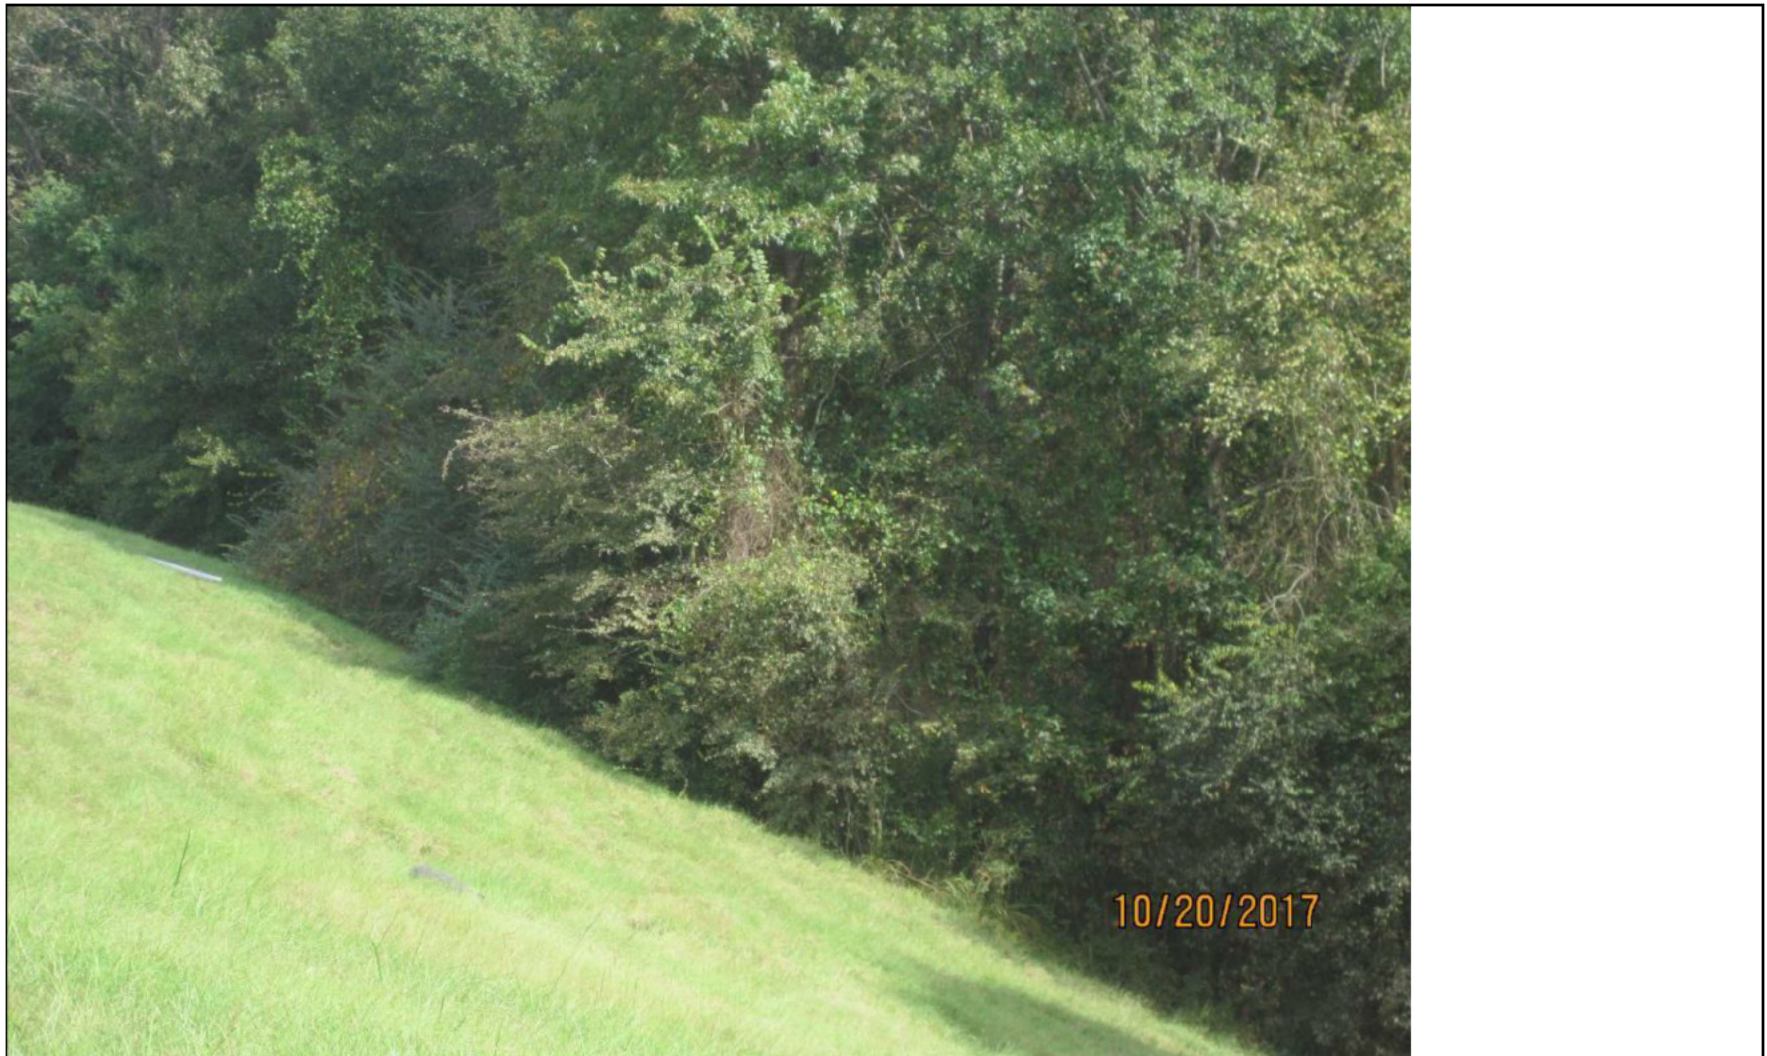
Inspect ID: JAXF_2017_a_0007 **Title:** USACE_CEMVK_JAXF_2017_a_0007_1.jpg **Rated Item:** 3. Encroachments **Caption:** Rating: Acceptable; Remarks: STA 19 Section of levee at end of Fortification Street/I-55 interchange with widened section. Trees near toe RS and on widened slope LS. Also various encroachments (utility/light poles, mail boxes, signs, etc) This is a Highway ROW.; Action: NA; Station_1: 19

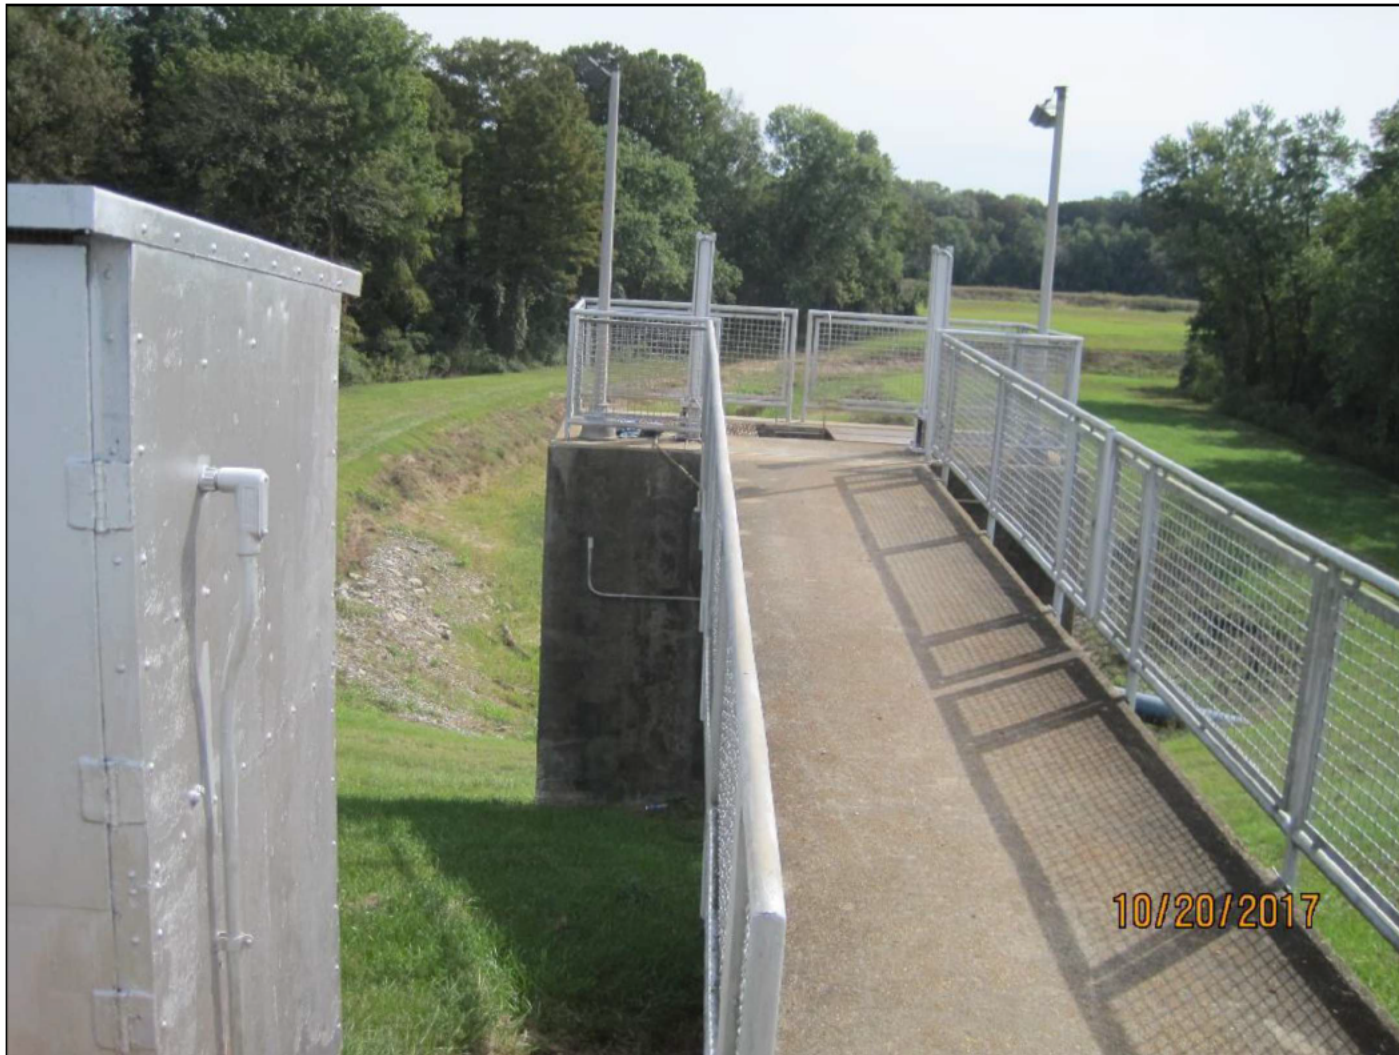
Inspect ID: JAXF_2017_a_0006 **Title:** USACE_CEMVK_JAXF_2017_a_0006_1.jpg **Rated Item:** 11. Culverts/ Discharge Pipes (This item includes both concrete and corrugated metal pipes.) **Caption:** Rating: Acceptable; Remarks: STA 31+30 Double 48"x48" box culverts. Fairgrounds Pumping Station. Cracking in inlet wing wall. Backup generator was installed in 2014. Crane certified in 2014. Sediment affecting operation of pump discharge flaps. Depression near gravity gate structure.; Action: NA; Station_1: 31+30

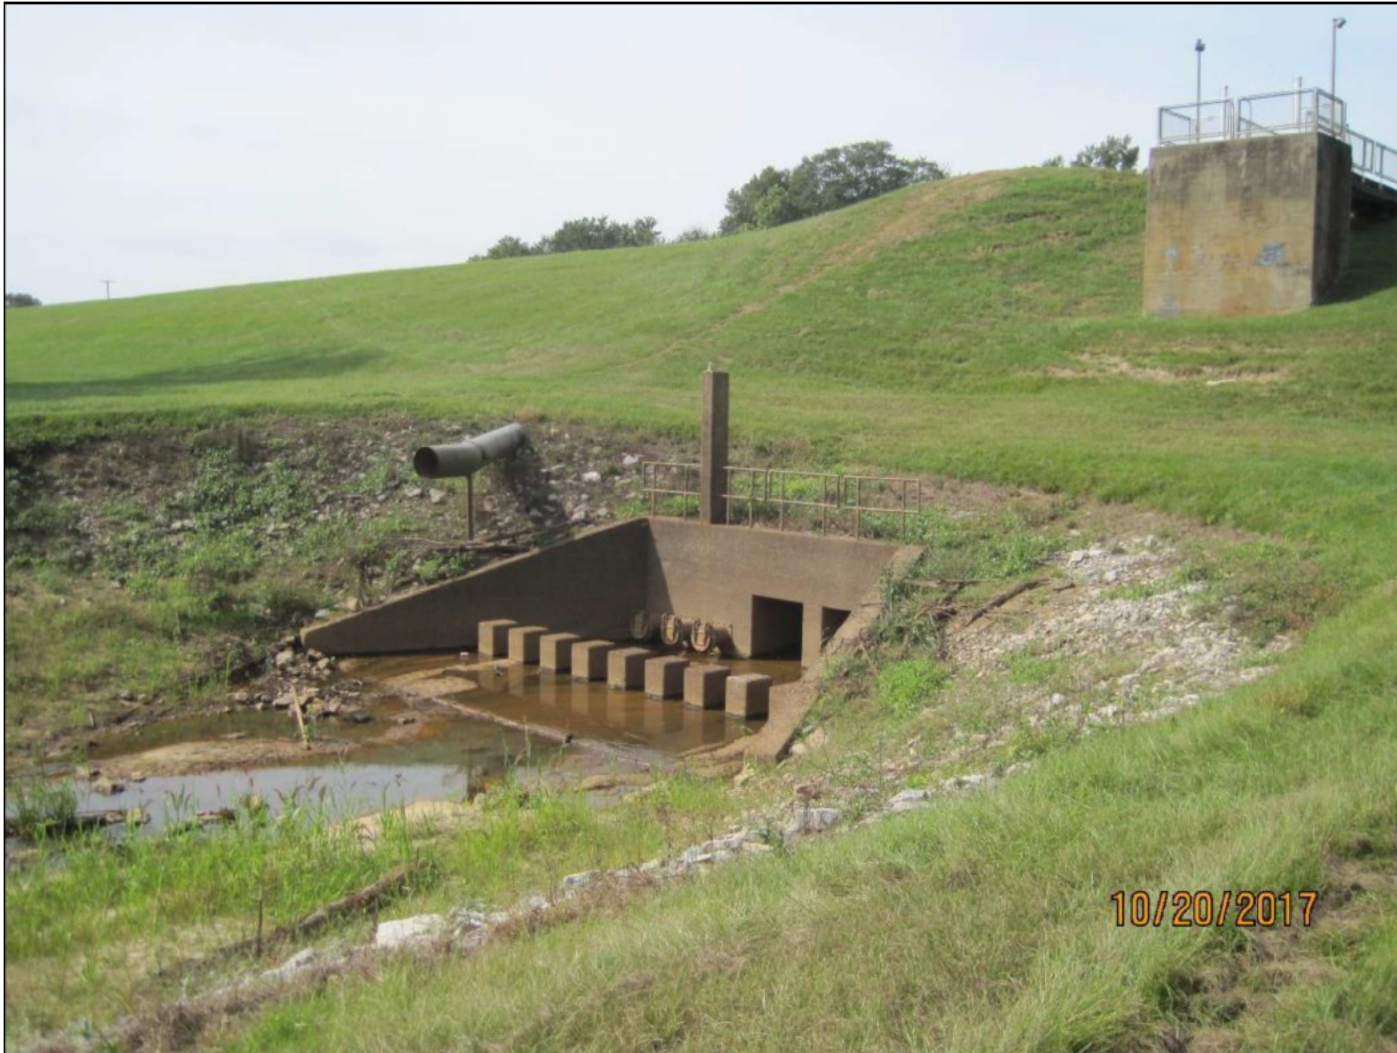
Inspect ID: JAXF_2017_a_0006 **Title:** USACE_CEMVK_JAXF_2017_a_0006_2.jpg **Rated Item:** 11. Culverts/ Discharge Pipes (This item includes both concrete and corrugated metal pipes.) **Caption:** Rating: Acceptable; Remarks: STA 31+30 Double 48"x48" box culverts. Fairgrounds Pumping Station. Cracking in inlet wing wall. Backup generator was installed in 2014. Crane certified in 2014. Sediment affecting operation of pump discharge flaps. Depression near gravity gate structure.; Action: NA; Station_1: 31+30

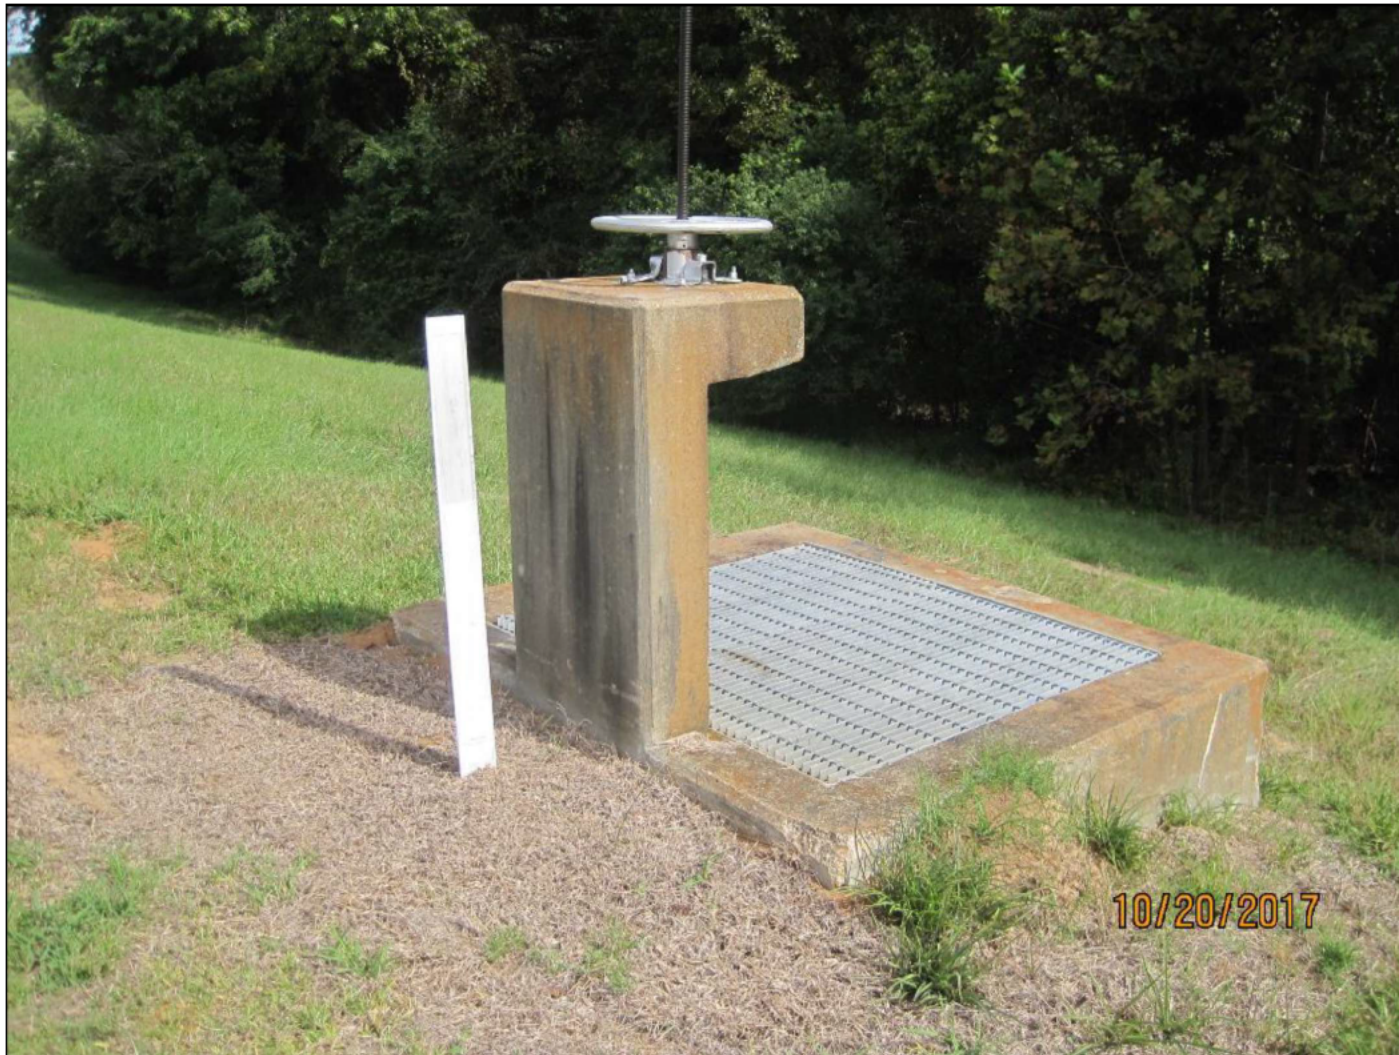
Inspect ID: JAXF_2017_a_0009 **Title:** USACE_CEMVK_JAXF_2017_a_0009_1.jpg **Rated Item:** 11. Culverts/ Discharge Pipes (This item includes both concrete and corrugated metal pipes.) **Caption:** Rating: Acceptable; Remarks: STA 3+86 18" rcp manual sluice. Some erosion down slope of the structure. Surface rust noted on gate. No evidence of bent stem as noted in the 2012 PI. ; Action: NA; Station_1: 3+86; ; ;

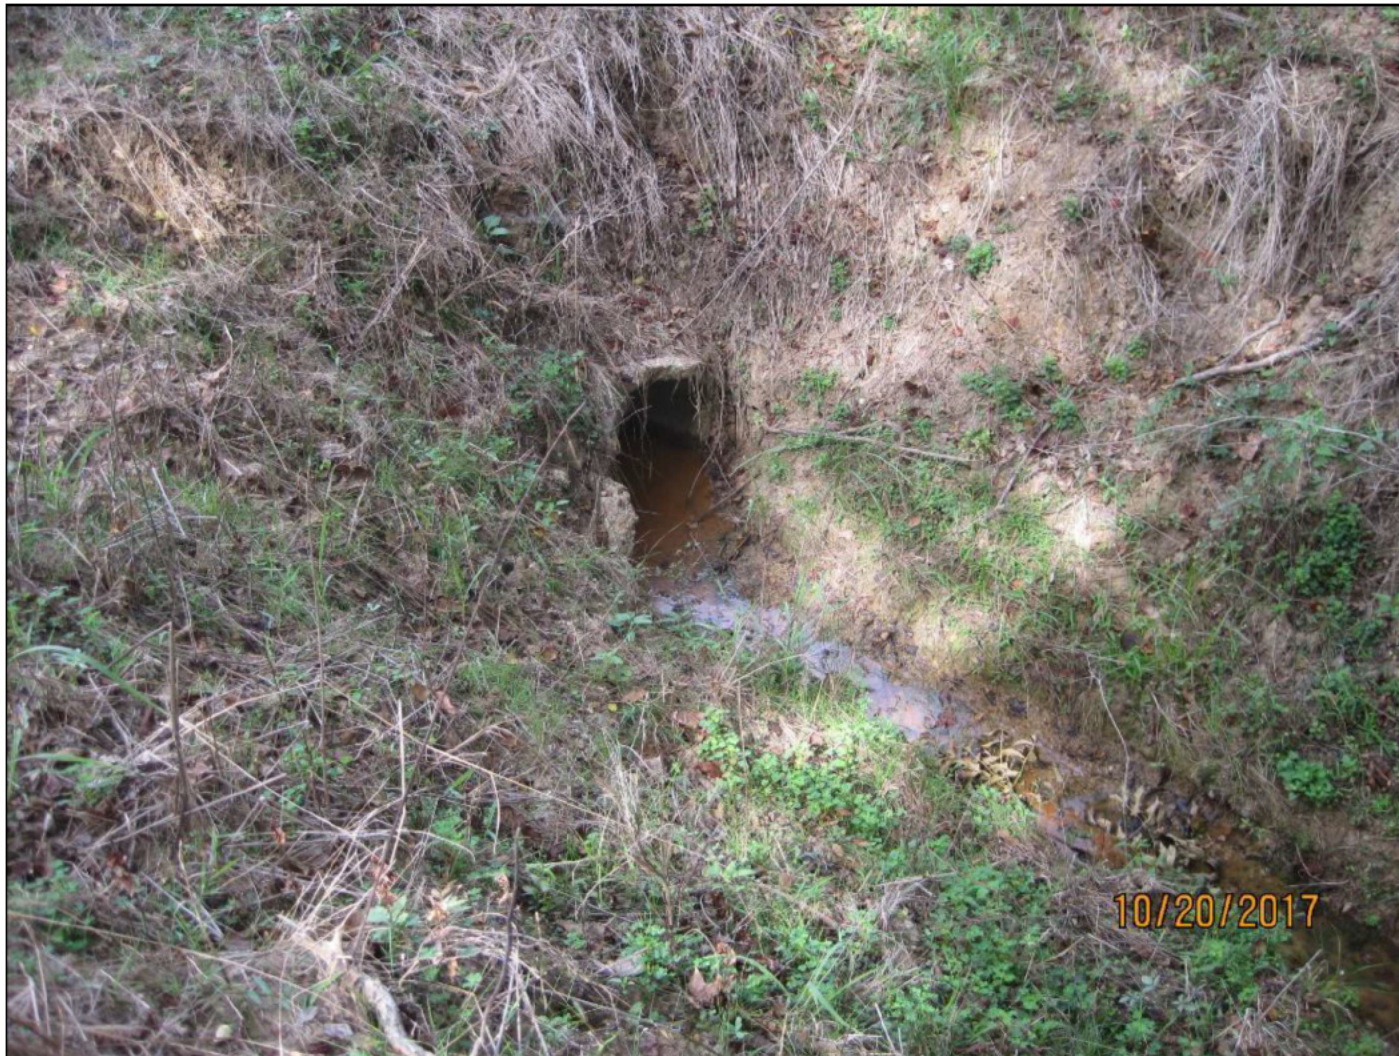
Inspect ID: JAXF_2017_a_0009 **Title:** USACE_CEMVK_JAXF_2017_a_0009_2.jpg **Rated Item:** 11. Culverts/ Discharge Pipes (This item includes both concrete and corrugated metal pipes.) **Caption:** Rating: Acceptable; Remarks: STA 3+86 18" rcp manual sluice. Some erosion down slope of the structure. Surface rust noted on gate. No evidence of bent stem as noted in the 2012 PI. ; Action: NA; Station_1: 3+86; ; ;
